2019 Upper Clark Fork Stream Survey
Clark Fork Coalition
May, 2019

Introduction

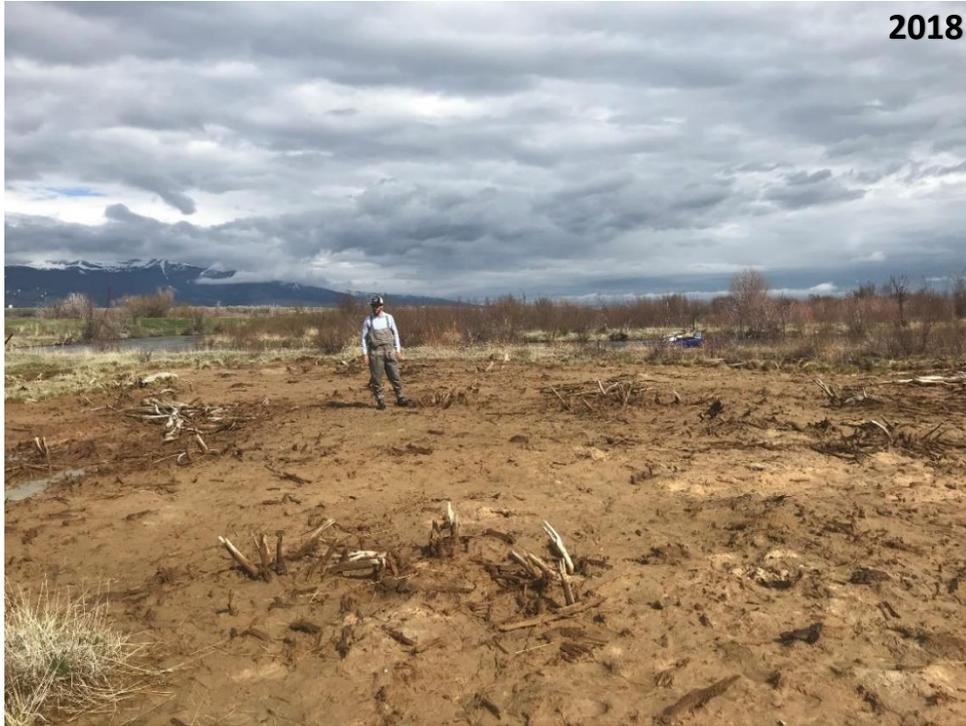
Photo 1- Taken at Point 1. This photo was taken from the middle of a slicken that is stable with a berm still intact.

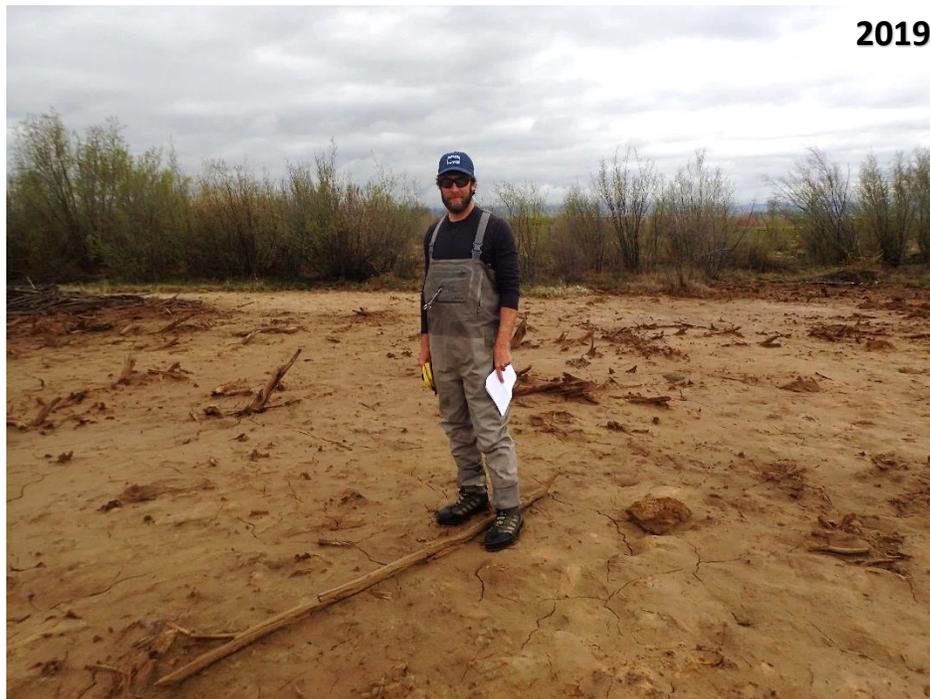
Photo 2- Taken at Point 1. This slicken continues to remain stable and is disconnected from the surface water flow of the mainstem. The berm at this location remains intact and isn't at risk of failure.

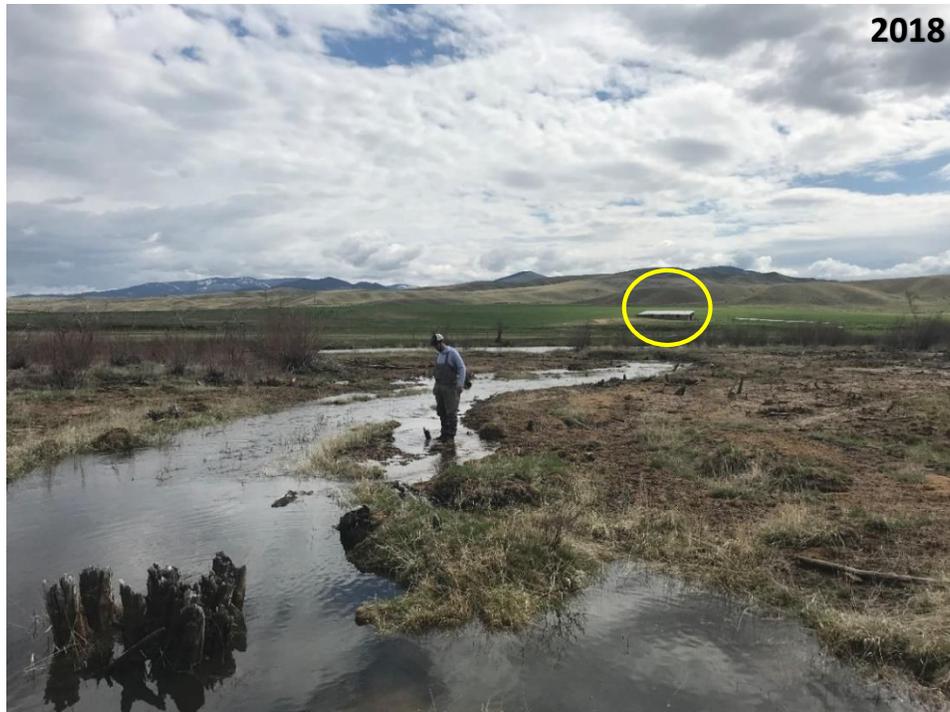
Photo 3- Taken at Point 2. This photo shows a slicken with an incipient avulsion that was activated during the June 2017 rain event. This photo is taken on the upstream portion of the avulsion looking downstream towards Point 3.

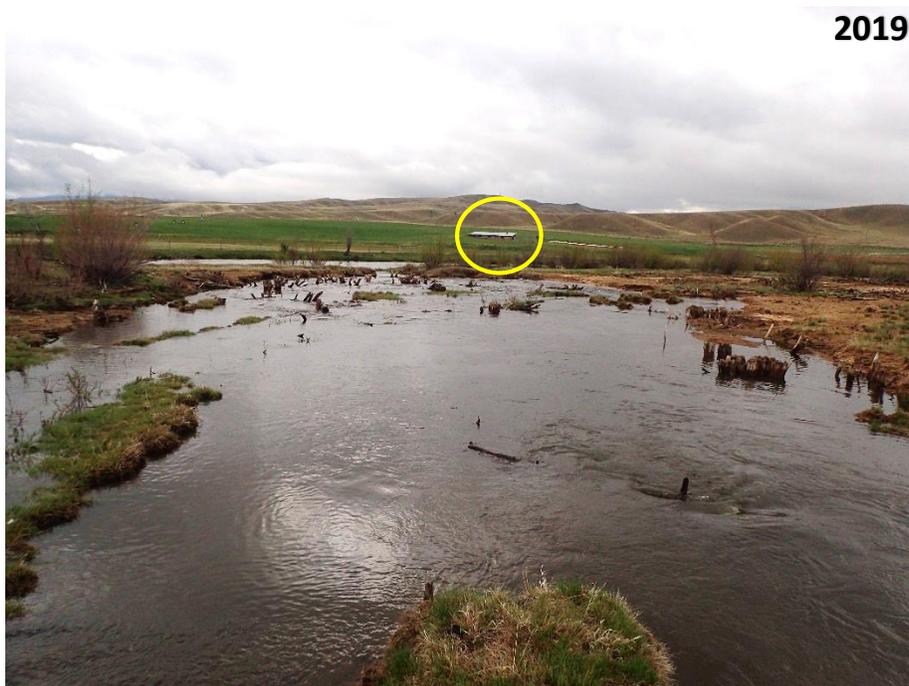
Photo 4- Taken at Point 2. This photo is taken on the upstream portion of the avulsion looking downstream towards Point 3. As evidenced in the photo, there has been considerable amounts of additional channel scour through this slicken.

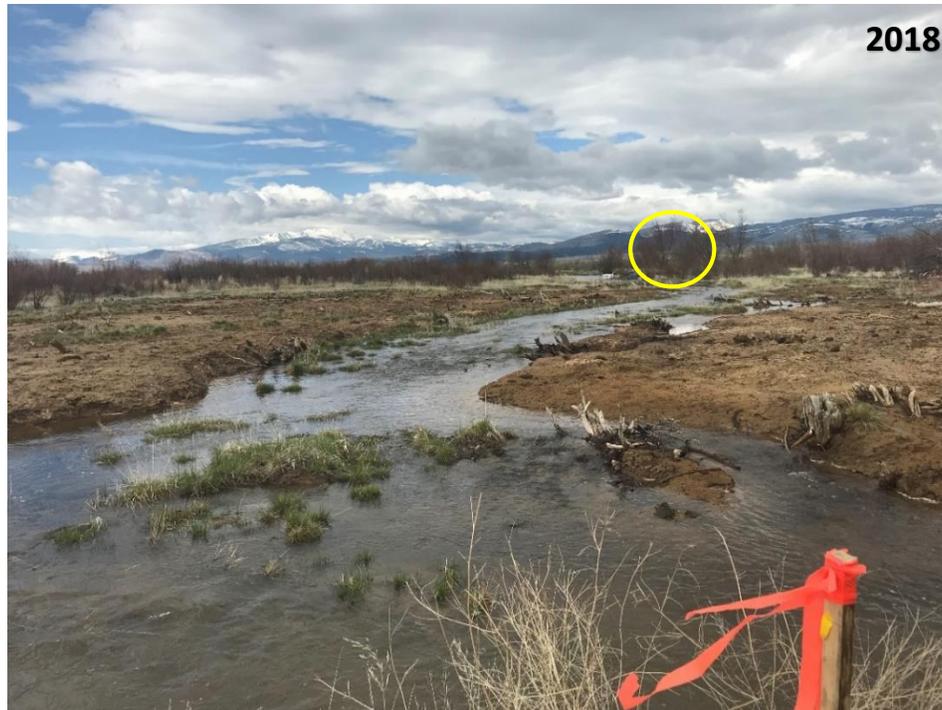
Photo 5- Taken at Point 3. This photo shows a slicken with an incipient avulsion that was activated during the June 2017 rain event. This photo is taken on the downstream portion of the avulsion looking upstream towards Point 2.

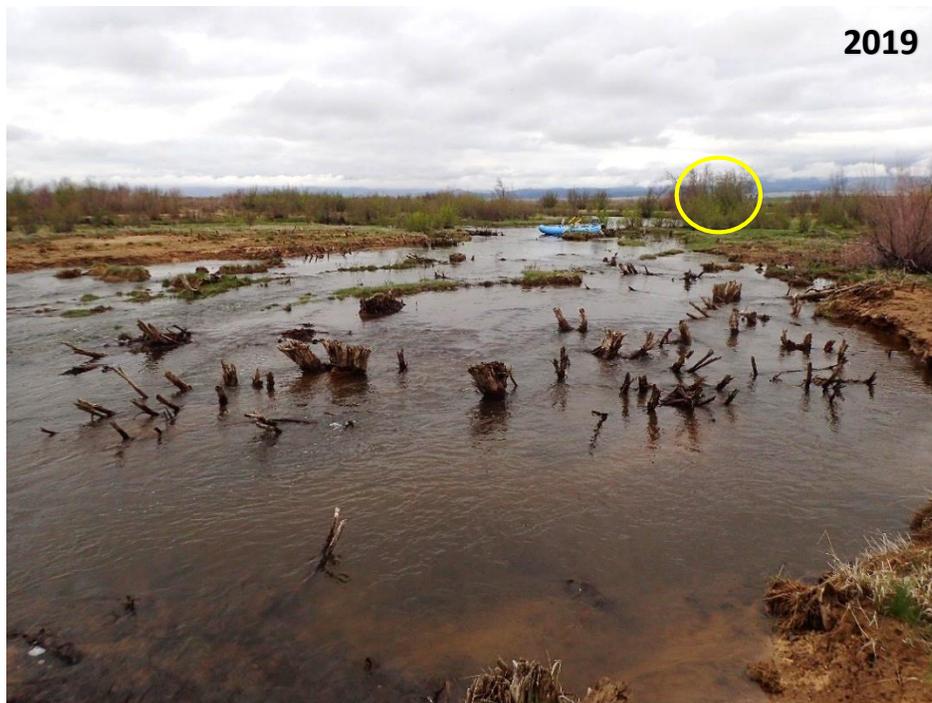
Photo 6- Taken at Point 3. This photo is taken on the downstream portion of the avulsion looking upstream towards Point 2. As evidenced in this photo, the avulsion at this location has likely turned into a permanent side channel and is now connected to the mainstem.

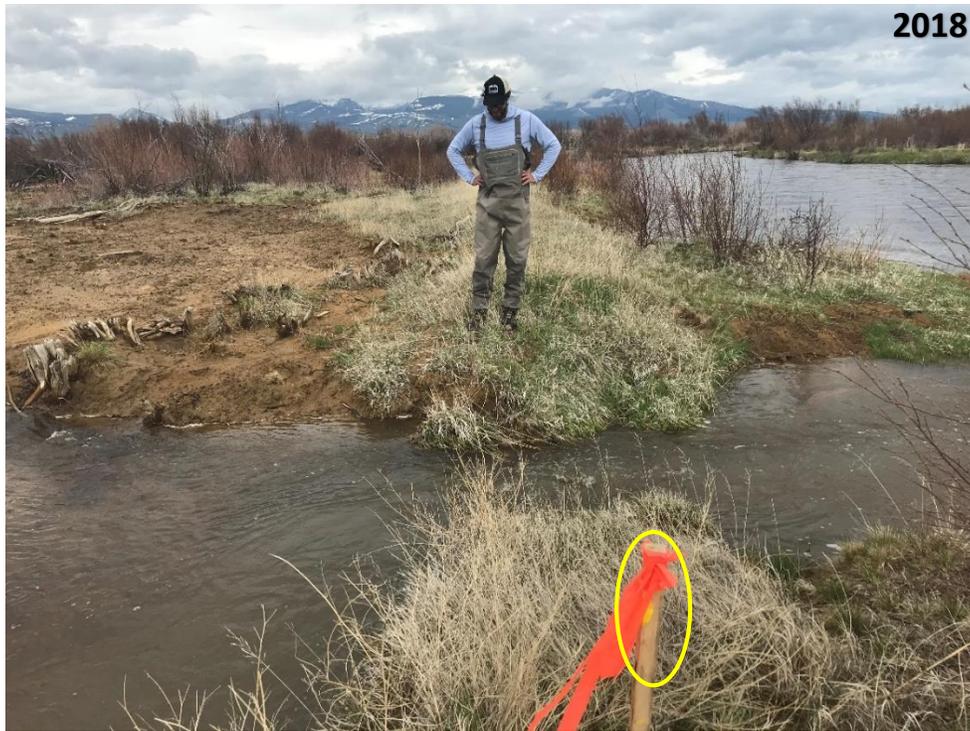
Photo 7- Taken at Point 3. This photo shows the outlet of the avulsion. The berm at this location has been breached and continues to erode.

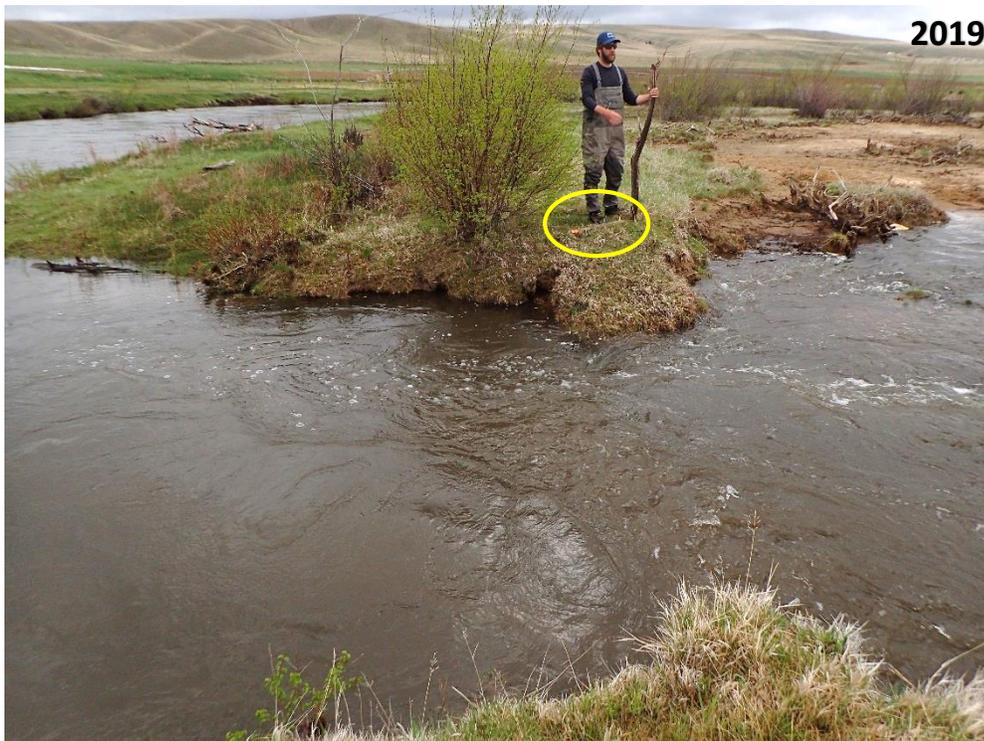
Photo 8- Taken at Point 3. This photo shows the outlet of the avulsion. As clearly evidenced in the photo, the outlet has further eroded since 2018. As evidenced by the stake on the ground near the CFC staff, this photo was taken on the opposite end of the berm from the previous year.

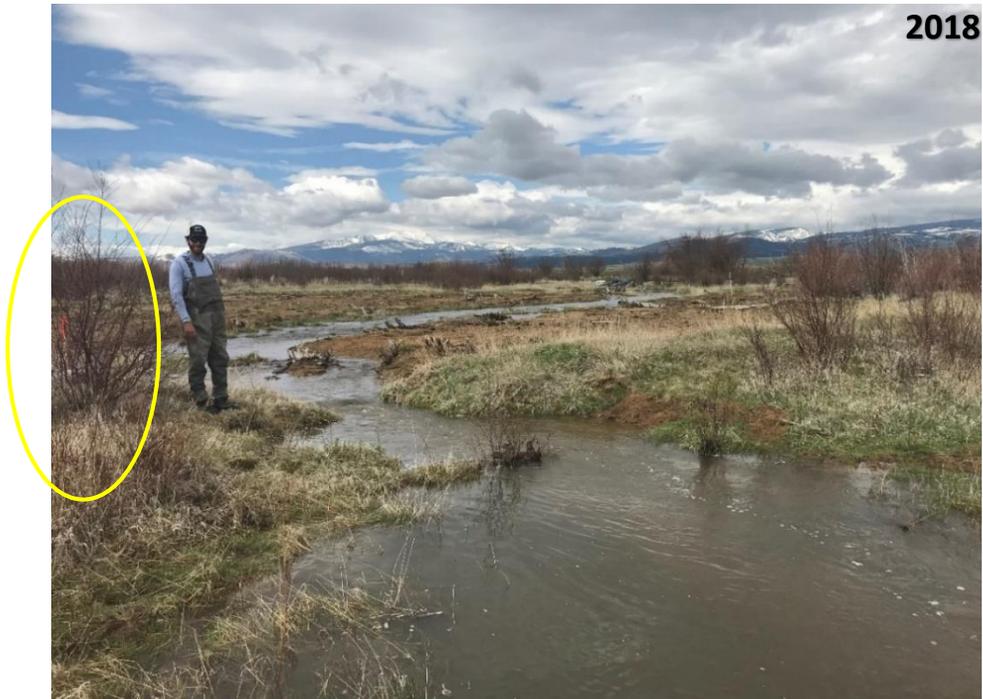
Photo 9- Taken at Point 3. This photo also shows the outlet of the avulsion. It is taken from the banks of the Clark Fork River. The berm is clearly visible next to the CFC staff member. Note the shrub and stake within the yellow circle

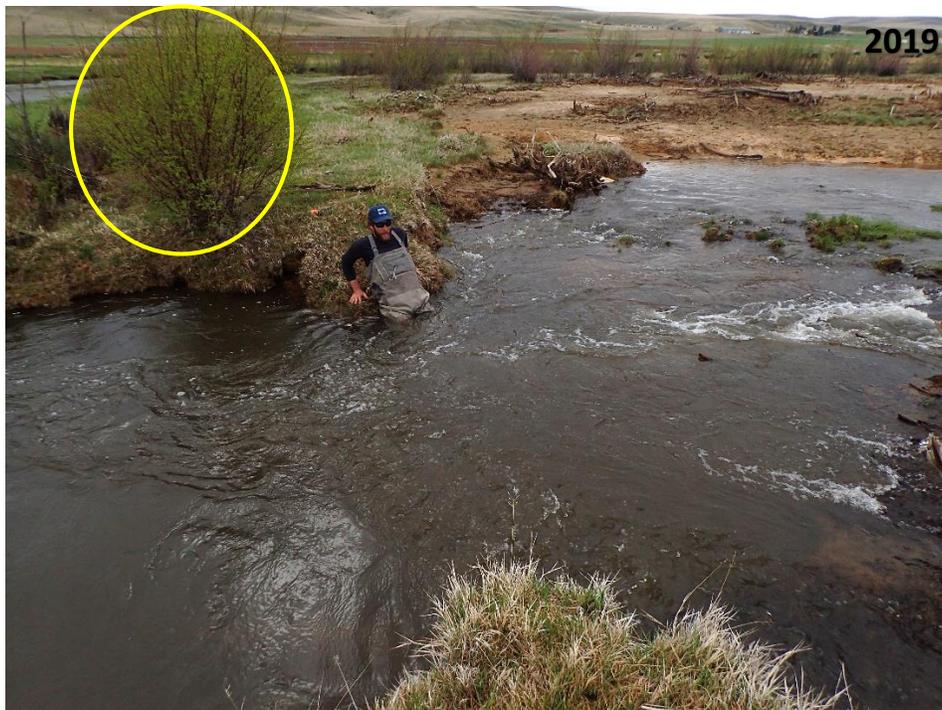
Photo 10- Taken at Point 3. This photo also shows the outlet of the avulsion. As evidence by the depth of the outlet, there has been additional erosion to the berm and downcutting at this location. The outlet at this location into the mainstem of the Clark Fork also contains a clearly visible delta of slicken materials.

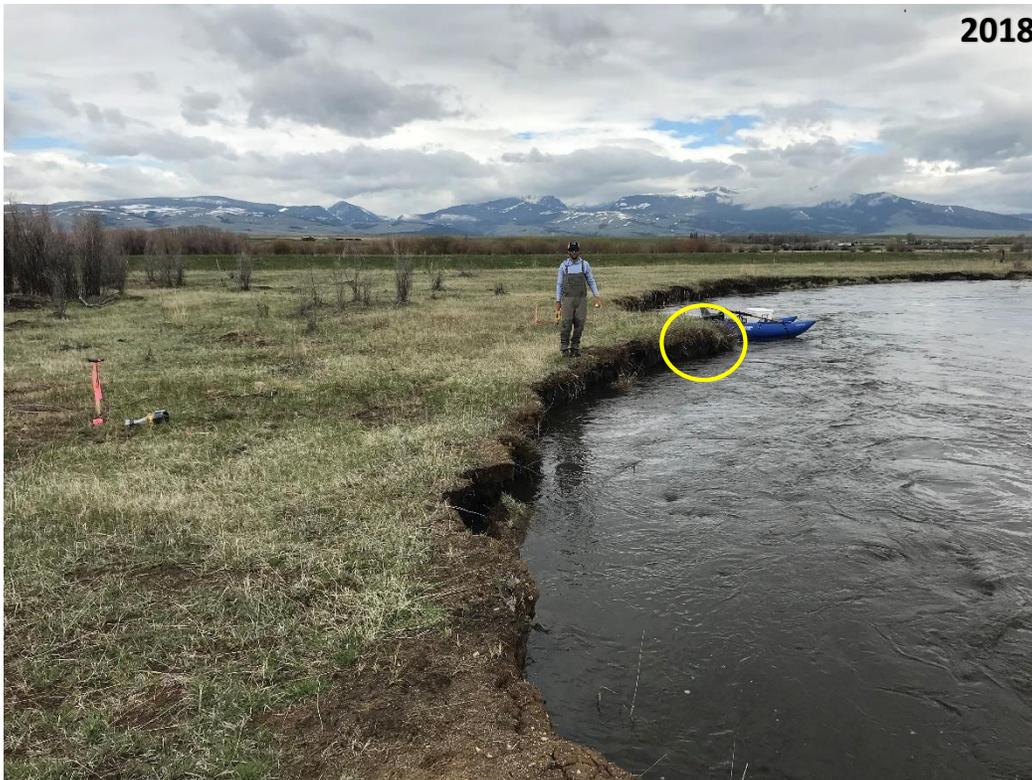
Photo 11- Taken at Point 4 looking downstream. Active bank calving was noted while stopped at this location.

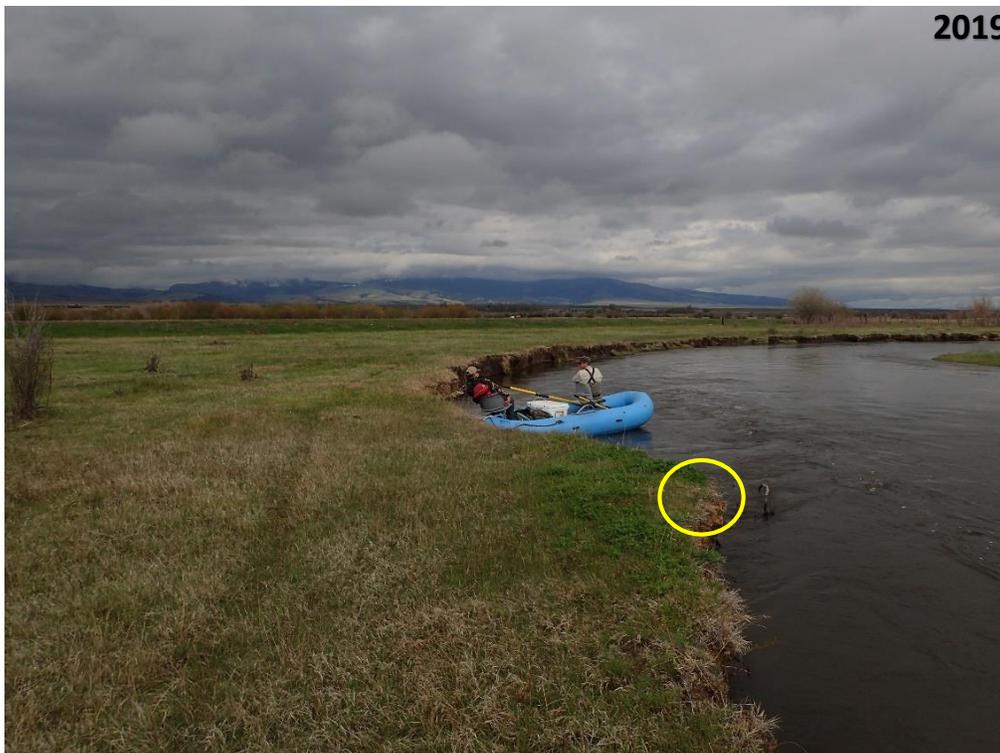
Photo 12- Taken at Point 4 looking downstream. As evidenced in the photo, additional bank calving occurred at this location from 2018 to 2019.

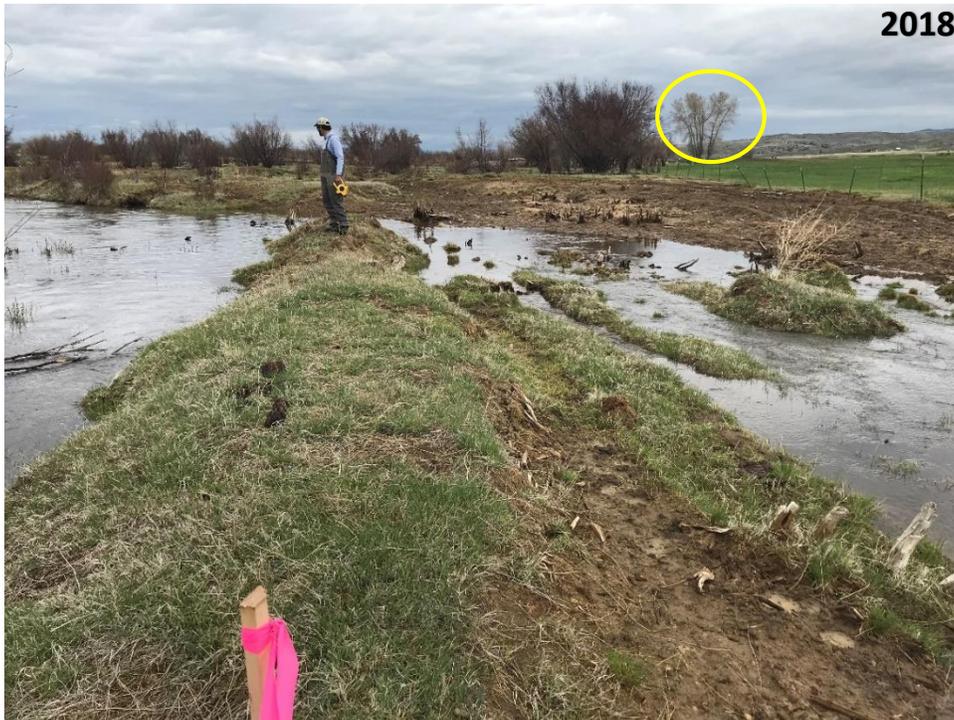
Photo 13- Taken at Point 5. This photo was taken looking downstream towards the outlet of the recently activated channel. The CFC staff member is standing on the downstream end of the breached berm.

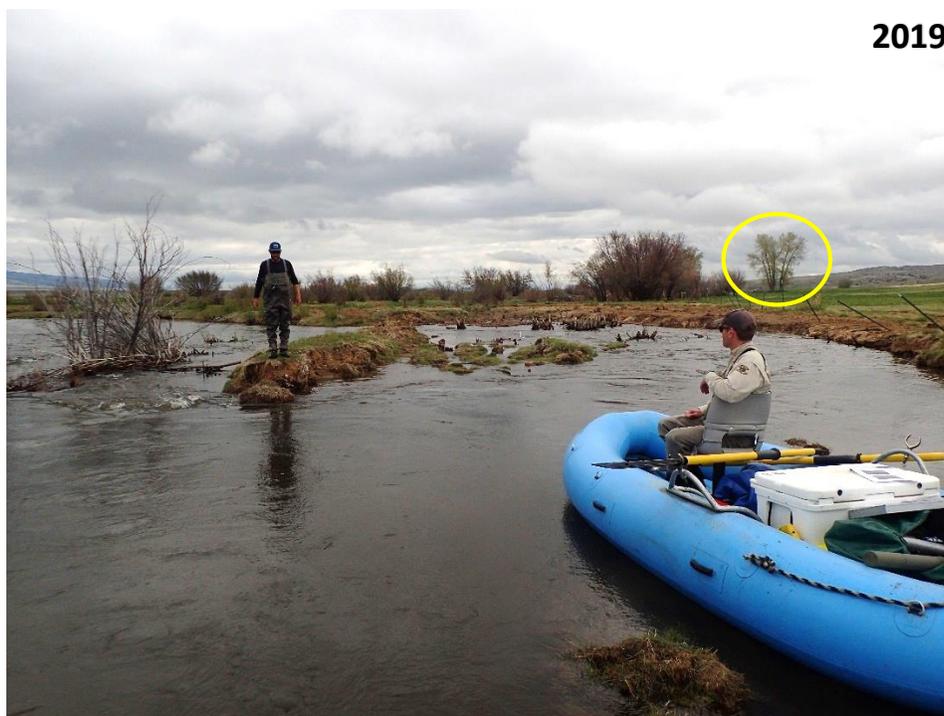
Photo 14- Taken at Point 5. This berm at this location has completely failed and the main channel has absorbed most of the slicken. Note the tree in the background directly above the boat. This photo was taken at the same location as the above photo but the channel has changed significantly.

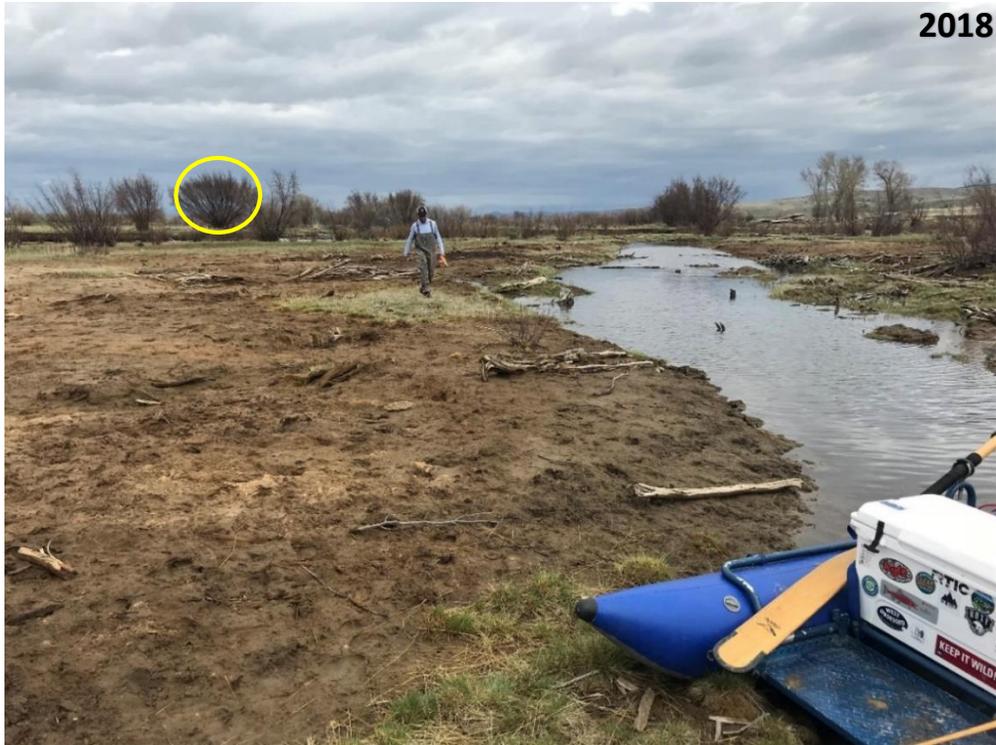
Photo 15- Taken at Point 6. This photo is taken looking downstream from the active high water side channel through a slicken. The side channel was active with approximately 3 cfs of flow.

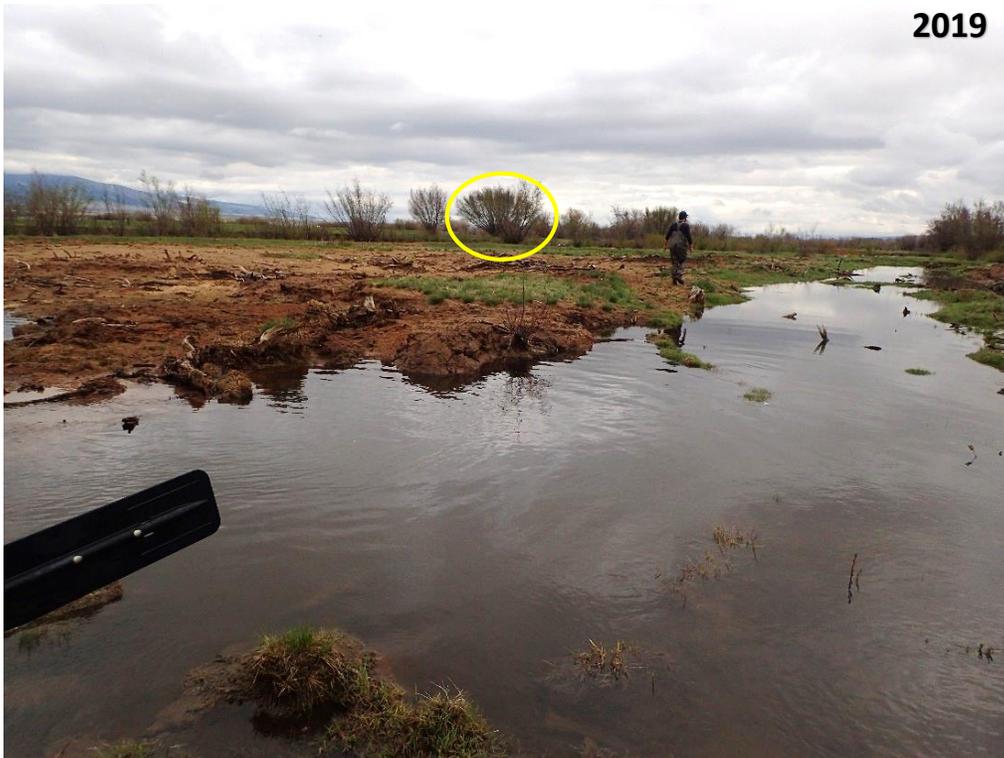
Photo 16- Taken at Point 6. This photo is taken looking downstream from the active high water side channel through a slicken. The channel has expanded significantly at this location as the berm on the upstream side continues to erode.

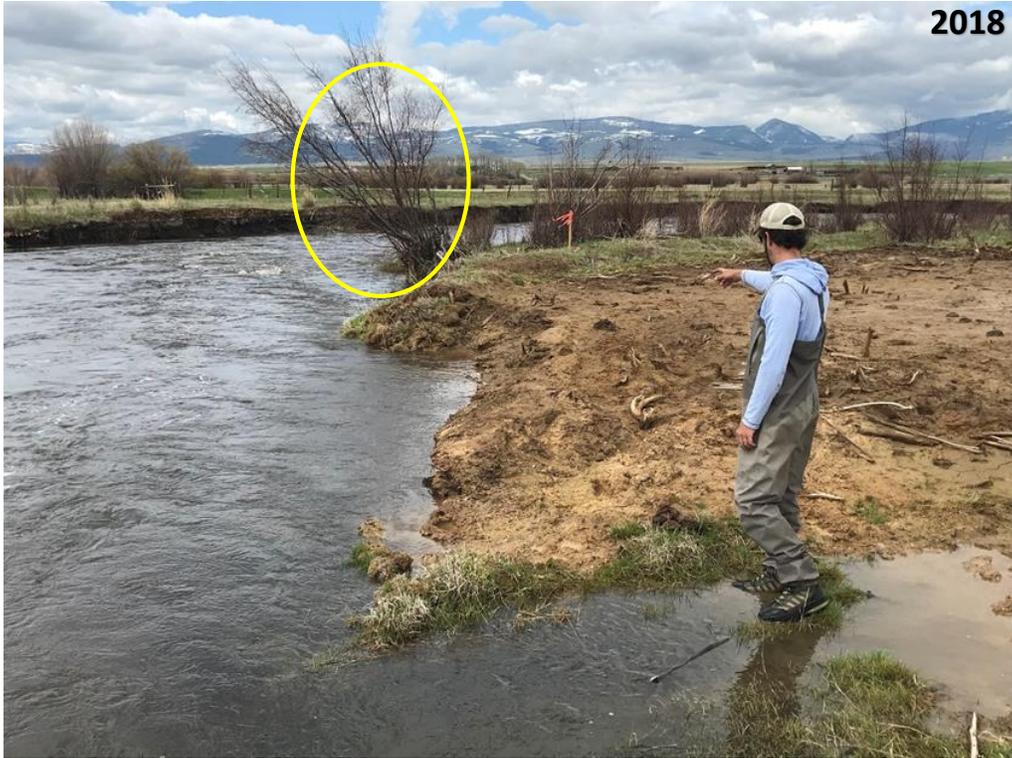
Photo 17- Taken at Point 6. This photo was taken looking downstream on the mainstem of the Clark Fork near the entrance of the high water side channel.

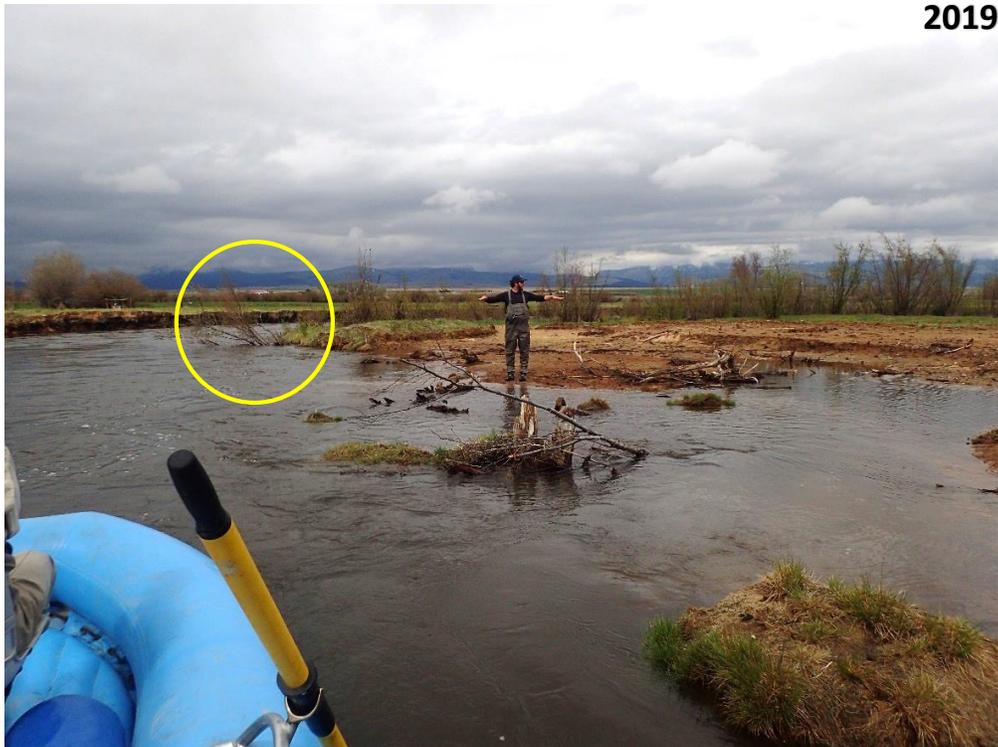
Photo 18- Taken at Point 6. This photo was taken looking downstream on the mainstem of the Clark Fork near the entrance of the high water side channel. Note the cantilevered bush in water to the left of the CFC staff member (that is the same bush from the 2018 photo).

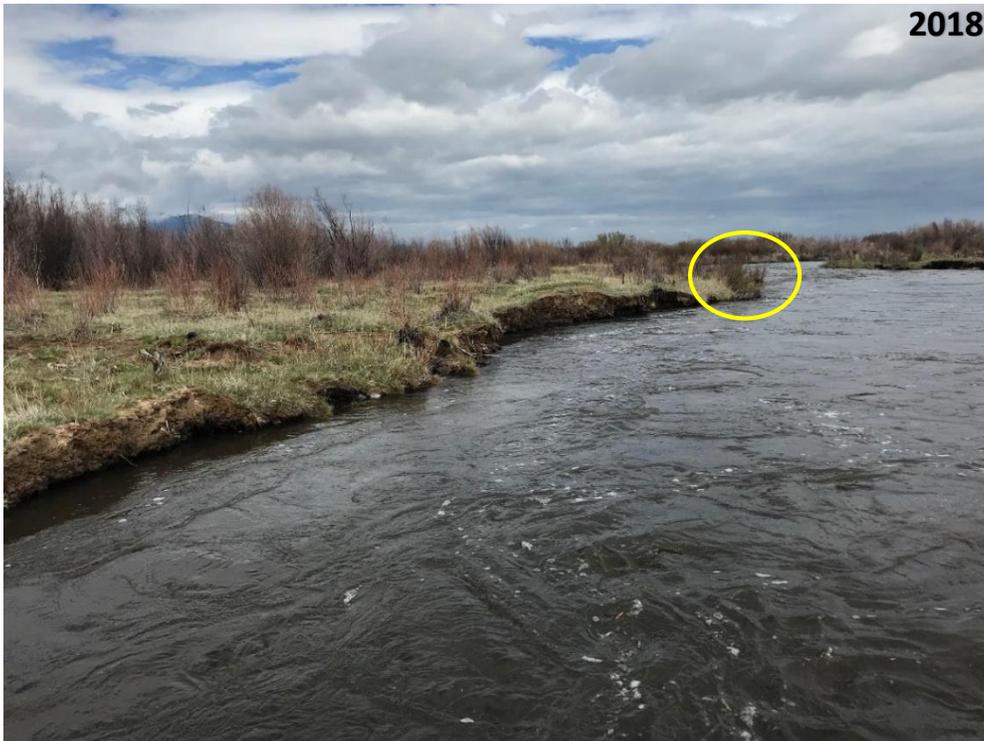
Photo 19- Taken at Point 7. This photo shows a berm that is actively eroding into the river.

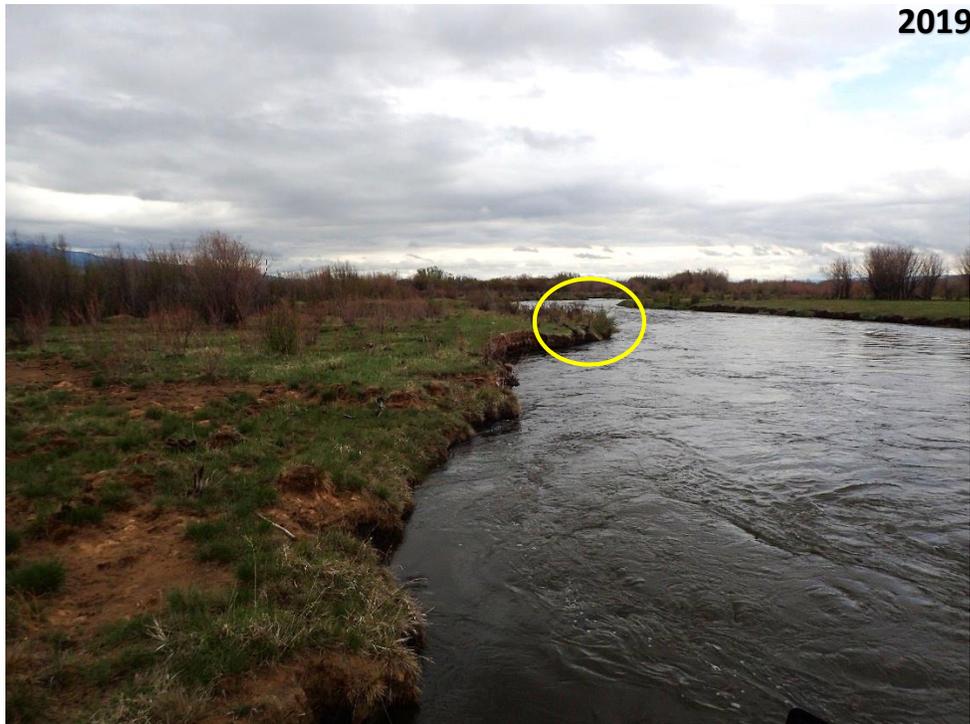
Photo 20- Taken at Point 7. This location has remained relatively stable with only minor bank calving occurring over the last year.

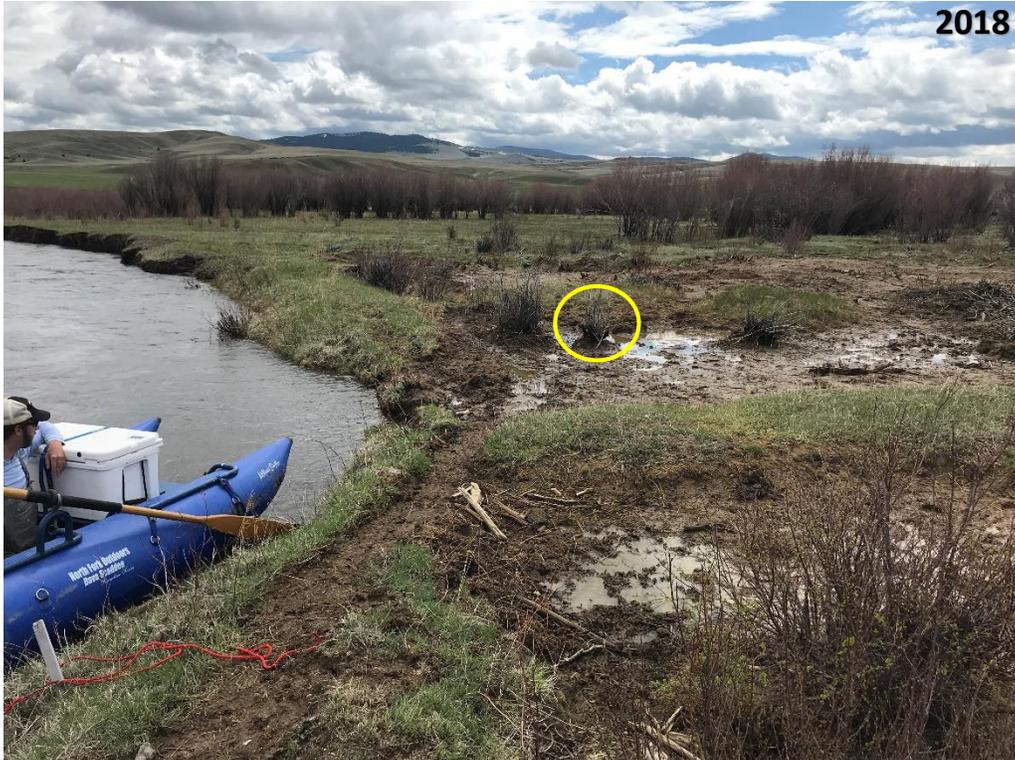
Photo 21- Taken at Point 8. This photo shows a berm that is at risk of erosion. The shallow surface water was colored teal due to the underlying slicken materials.

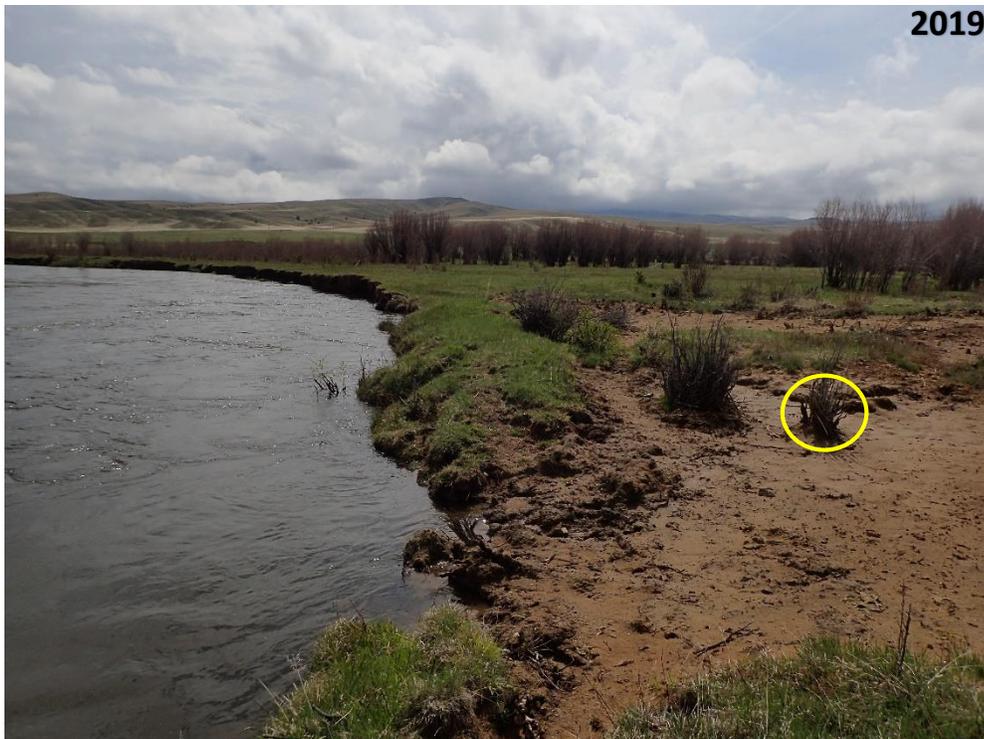
Photo 22- Taken at Point 8. The berm at this location remained stable and there was little additional erosion over the last year.

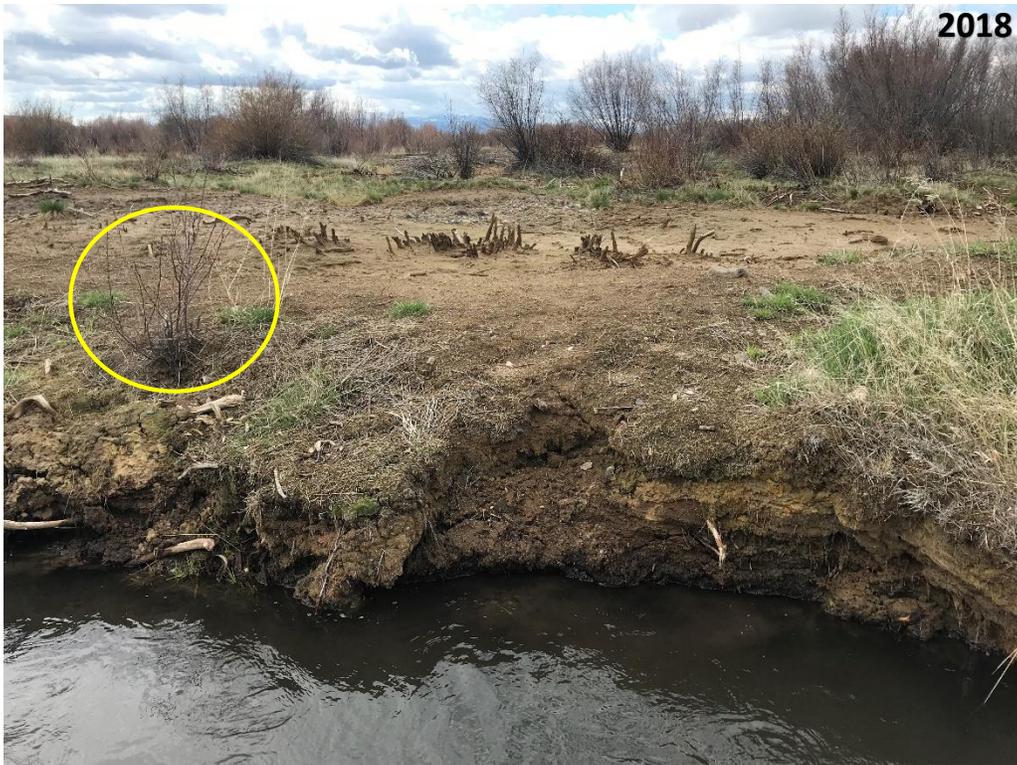
Photo 23-Taken at Point 9. This photo shows a high slicken bank that is at risk of erosion in higher flows.

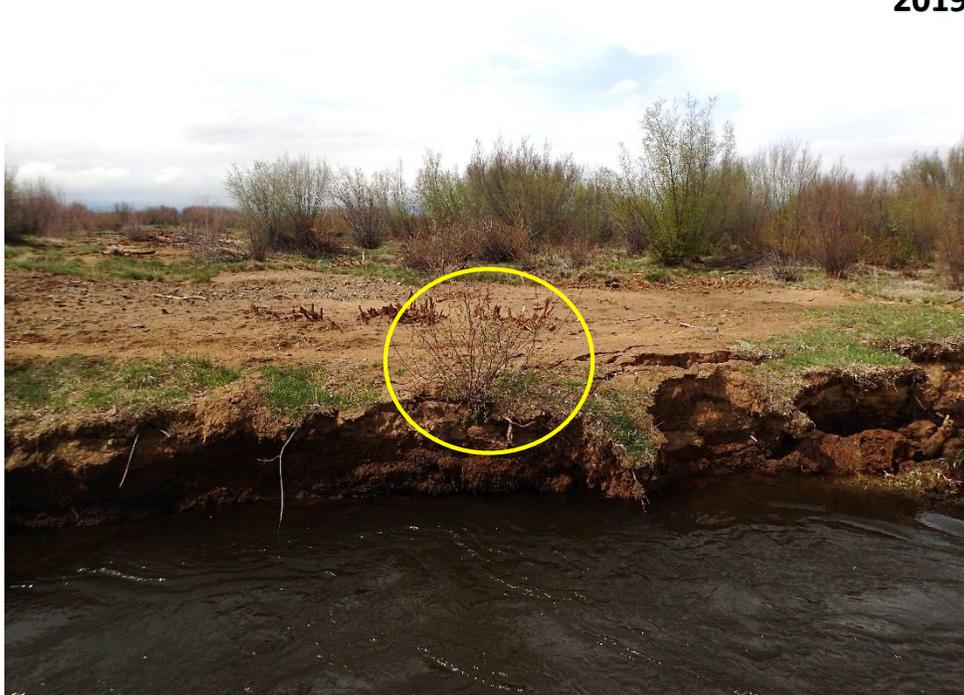
Photo 24-Taken at Point 9. Note the small bush on the edge of the bank in the center of the photo (same bush that is on the left of the photo in the top pane). There has been some minor bank calving at this location over the past year.
