Upper Clark Fork Slicken Assessment Report

July 2020

Slicken Assessment Report

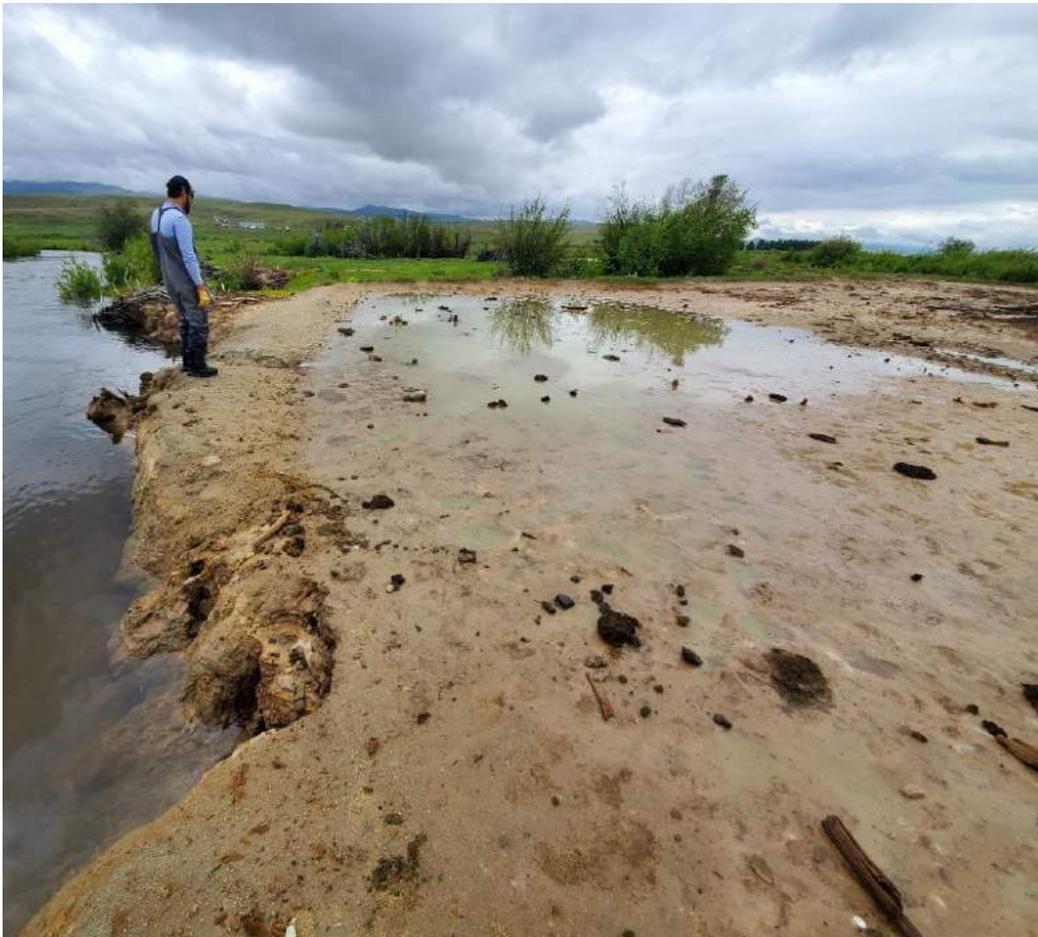
Figure 1. Example of a high-hazard floodplain “slicken” contaminated with high levels of metals including copper and arsenic. The person in the foreground is standing on a crumbling berm that is at risk of complete failure.

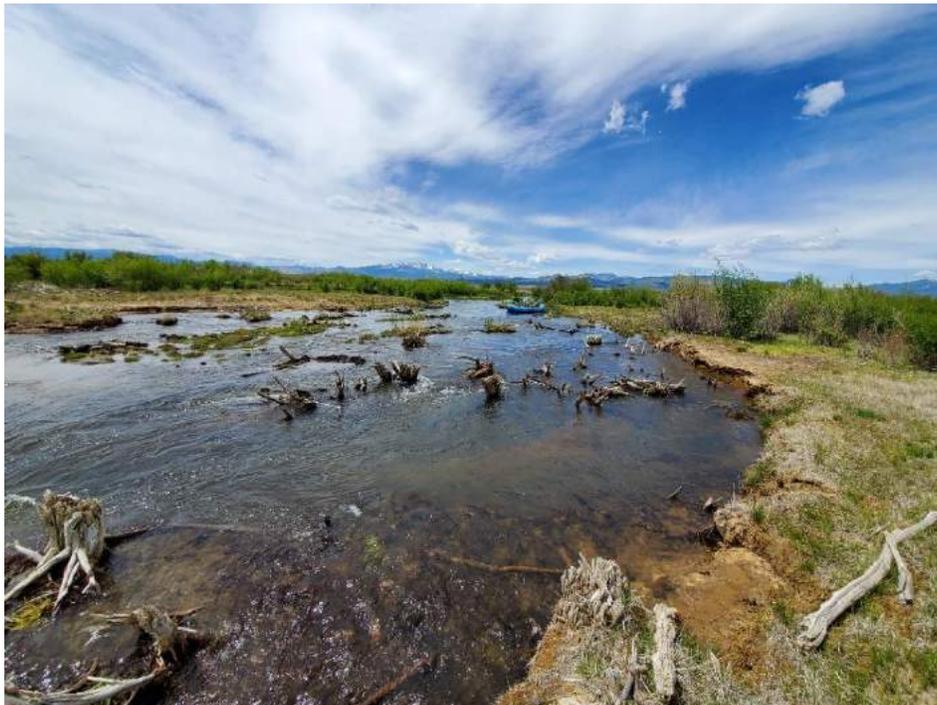
Although the condition of the slickens varied considerably, there were some consistent trends noted, especially in the higher-hazard slickens. Many of the most visibly-contaminated slickens are located on meander tabs that have relatively low elevations (compared to surface water and adjacent floodplain elevation). These meander tab slickens tend to see berm failures at both the top and bottom of the tabs (related to distinct geomorphological forces). In some of the extremely high avulsion hazard slickens head-cutting was noted at the upstream end of the tab with significant down-cutting observed at the lower end. In some instances, these avulsions have matured to the point where much of the exposed contaminated material has been washed downstream (Figure 4).

Figure 4. Newly-formed side channel through a slicken on a meander tab.

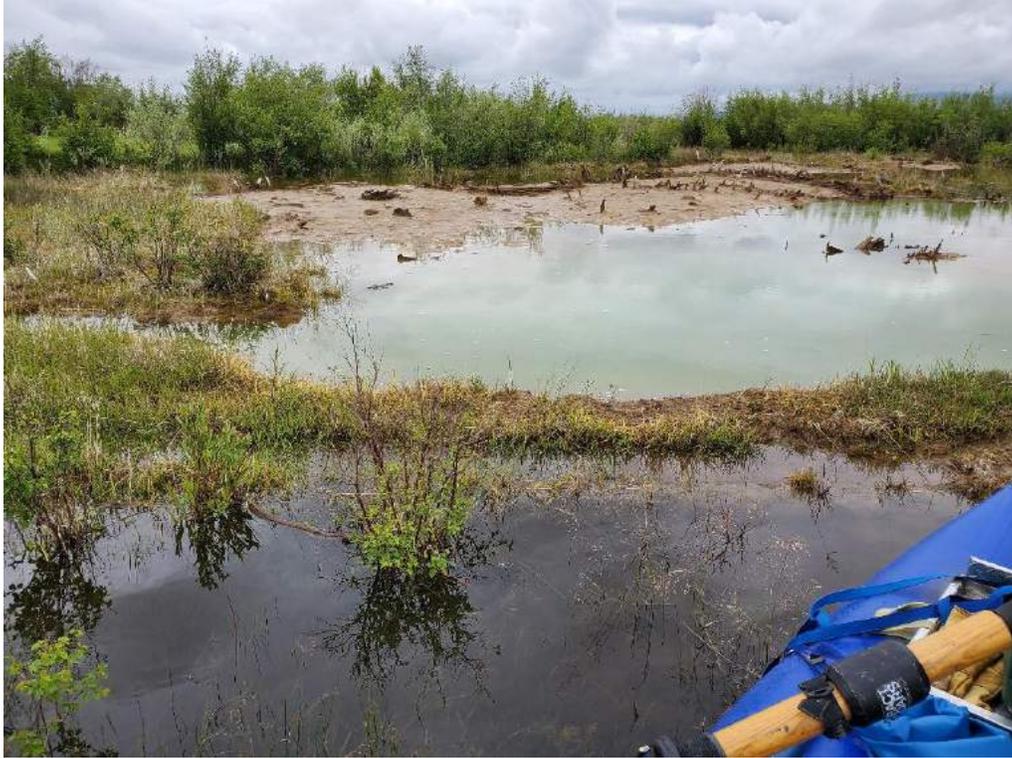
Figure 5. Partially-functioning berm on slicken #4. The berm contains some contaminated water, but is in danger of being overtopped during high river flows.

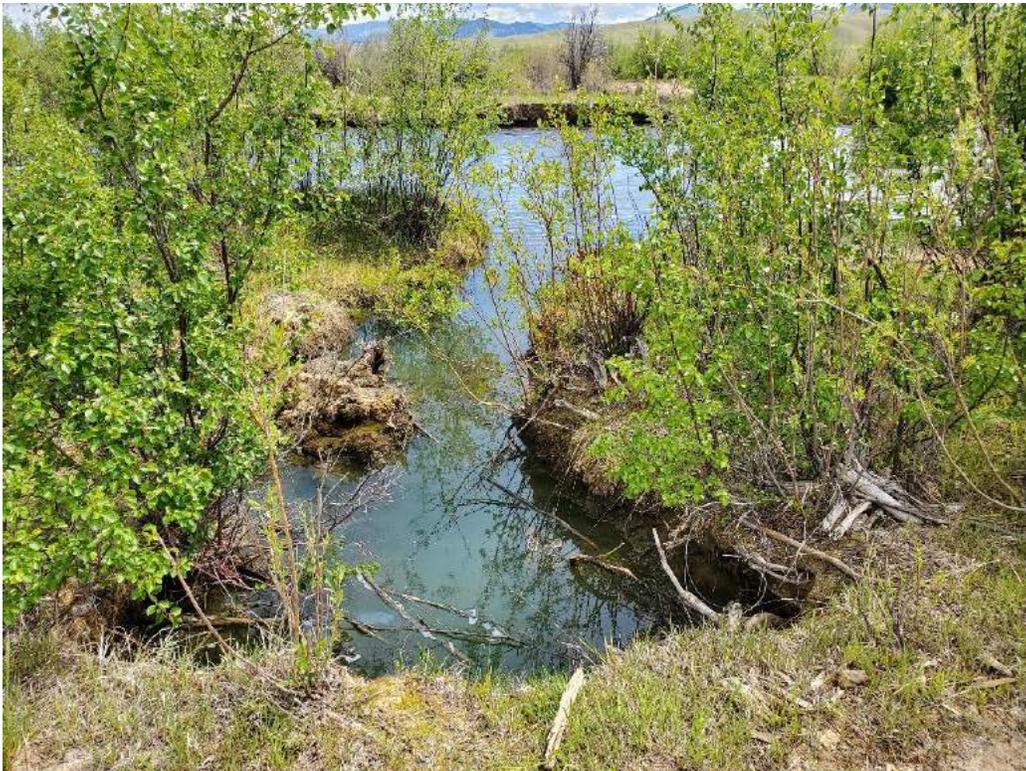
In addition to direct surface connection, there was also clear evidence of contaminated groundwater interaction. At several of the severely contaminated slickens, teal-stained water was noted lingering in slack water areas on the downstream end of the meander tabs (Figure 6). This contaminated water is interacting directly with the Clark Fork River and potentially impacting aquatic resources downstream.

Figure 6. Teal-colored water entering the Clark Fork River at the downstream end of a contaminated meander tab on slicken # 4.

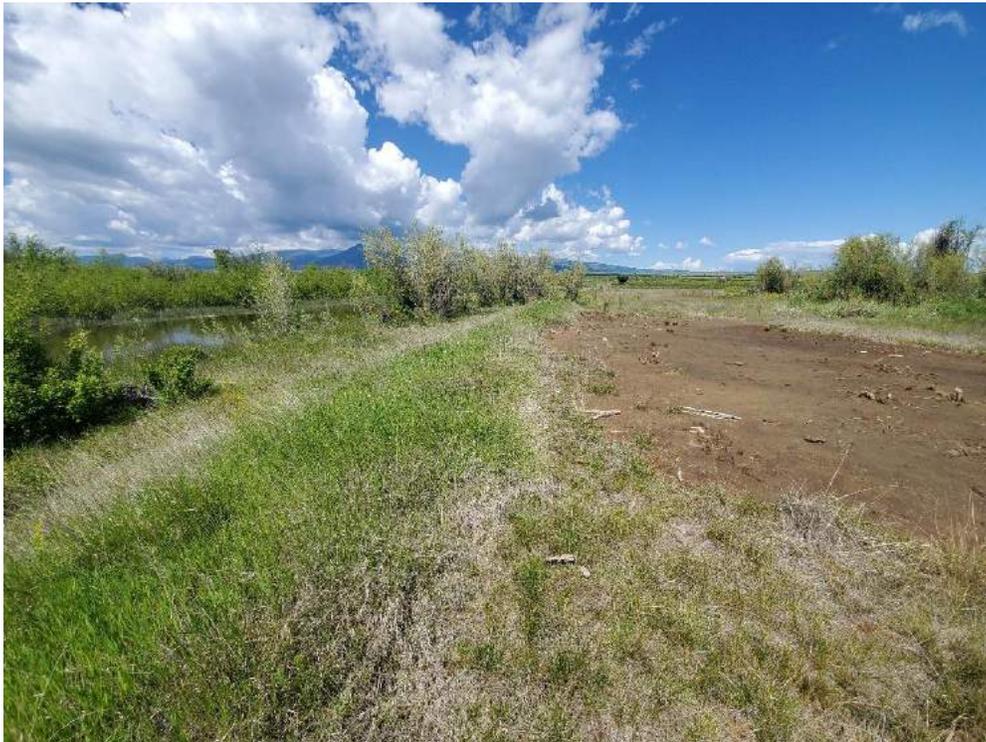
Figure 7. An intact berm on slicken #94. Note that the berm is vegetated and keeps slicken material out of the river (on the left).

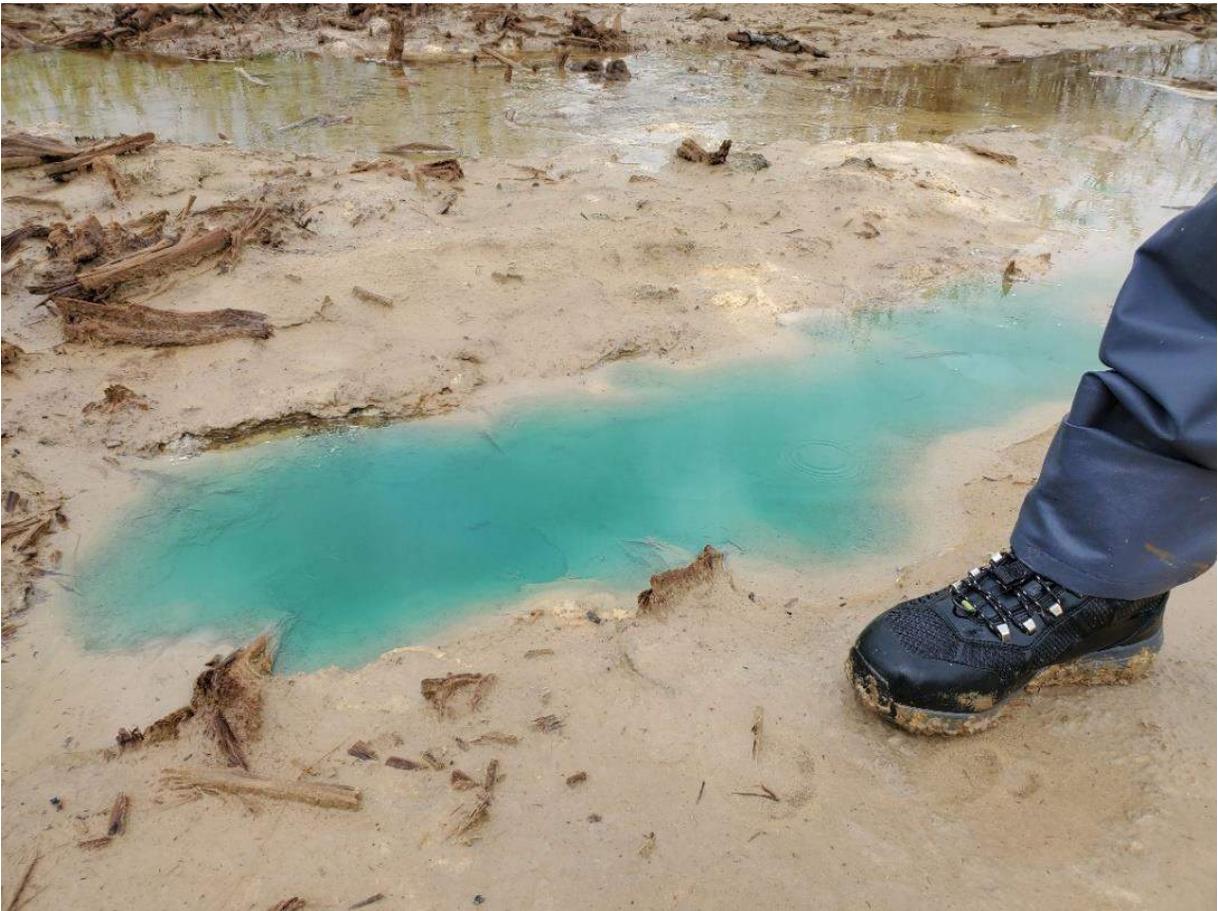
Figure 8. Poned water on sliken #6.

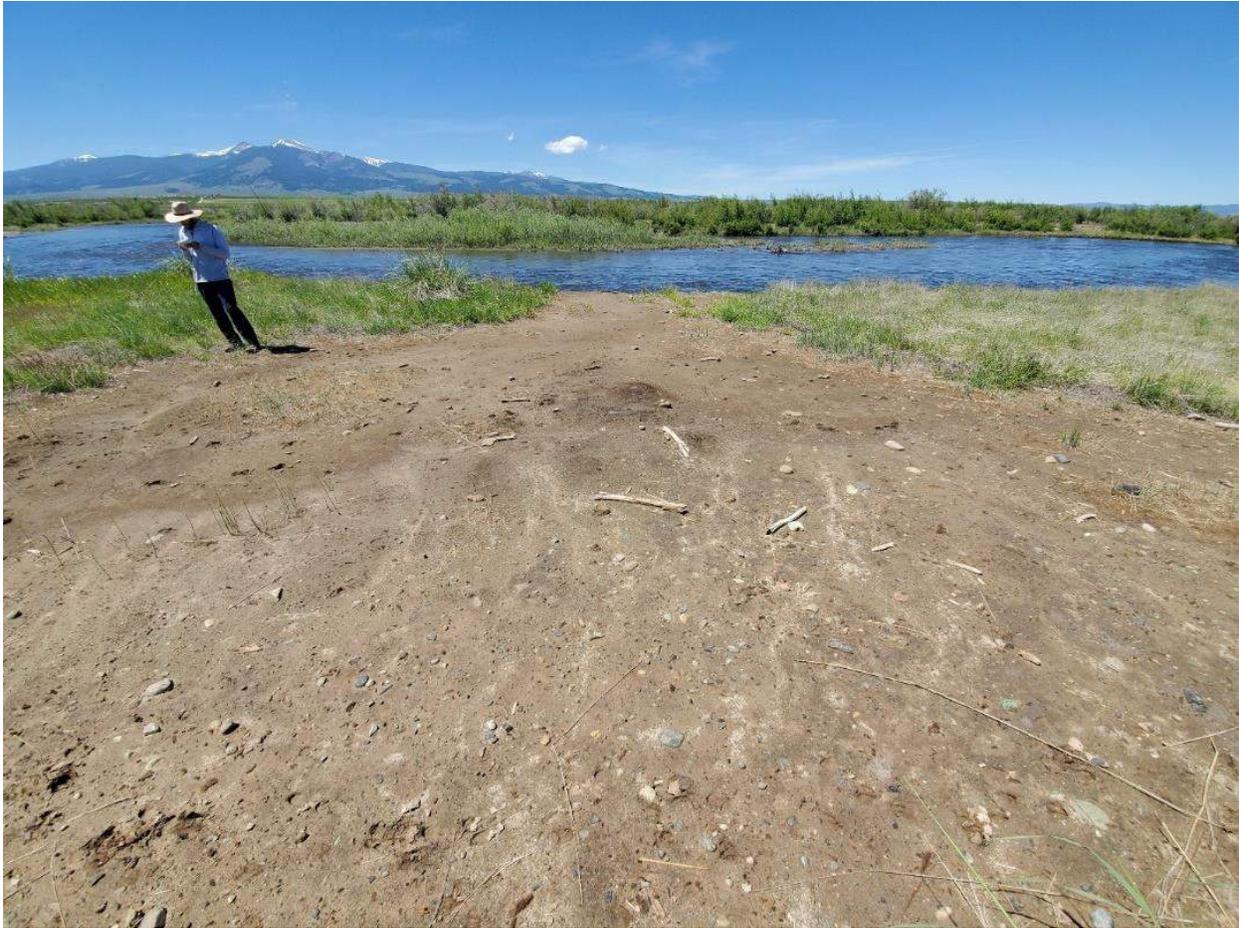
Figure 9. Clear flow path leading from slicken #83 (a small but severe slicken located between Sager Lane and Deer Lodge) to the Clark Fork River.

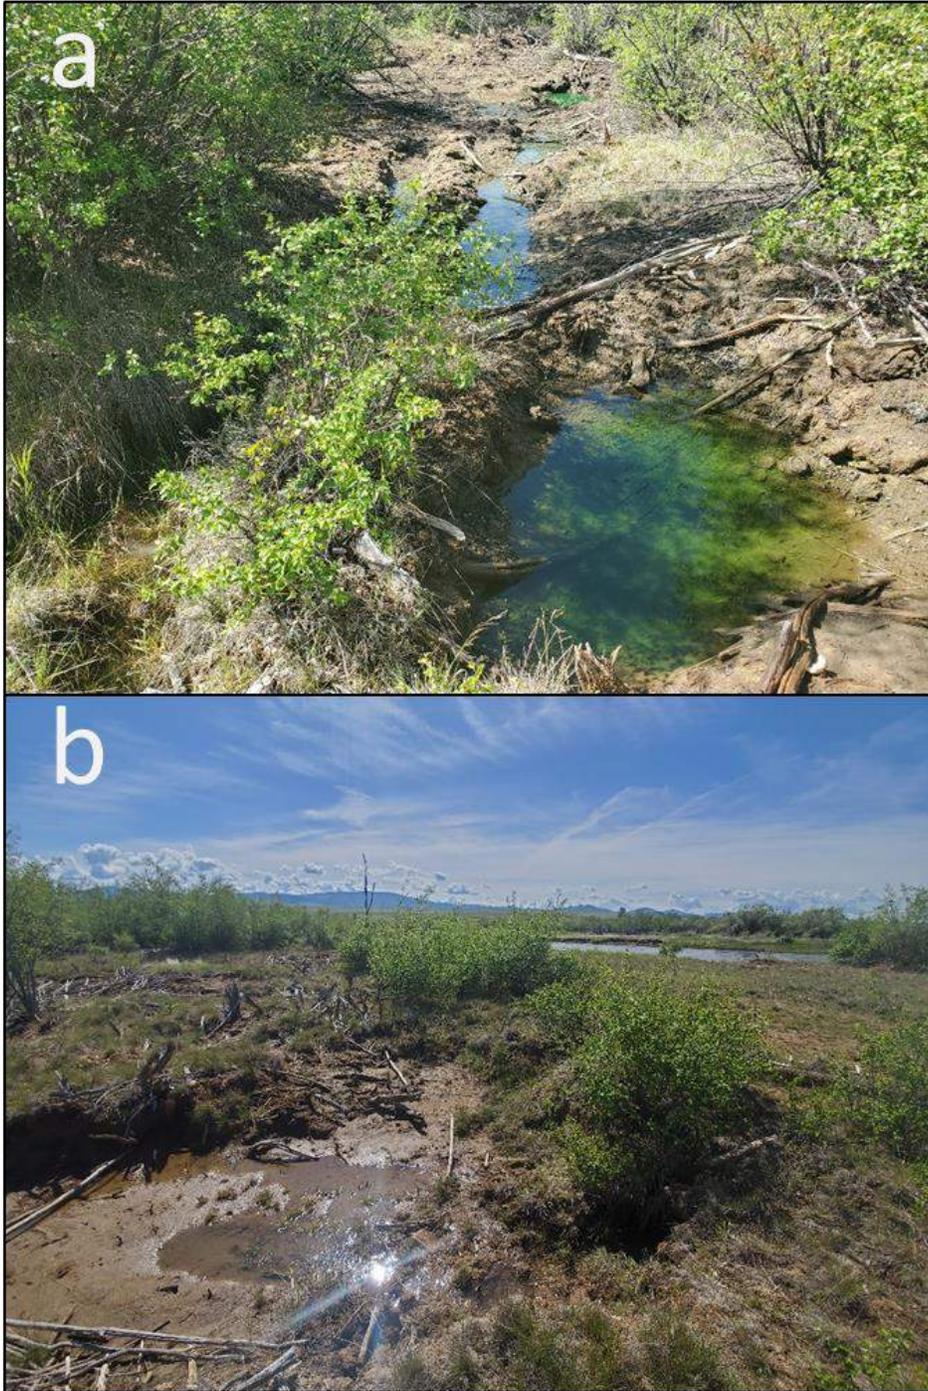
In some cases, slicken avulsions are caused by the direct erosive power of the river. These avulsions are often found on the downstream end of meander tabs where backwaters and eddies form. In other cases, avulsions may form from head-cutting caused by surface runoff over slickens. This surface runoff collects at the lowest point and can form a flow channel and head-cut (Figure 10).

Figure 10. The photos above show an avulsion channel that has formed from surface runoff and erosion of slicken #95 (a large, high risk slicken between Sager Lane and Deer Lodge). Photo “a” is on the lower, downstream portion of the meander tab, photo “b” was taken at the top of the tab. This channel is headcutting toward the upstream end of the meander tab and is within a few meters of causing the river to avulse into the slicken.

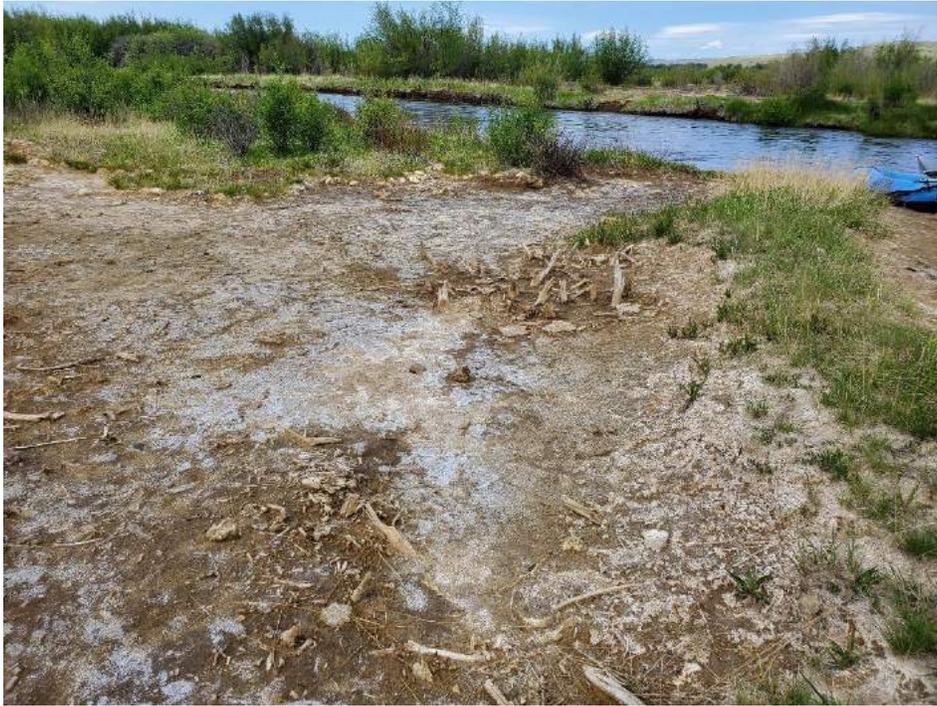
ID#22, SER = 4 (AR=3): Built-up salts on this slicken will flow into the river during a rainfall event.

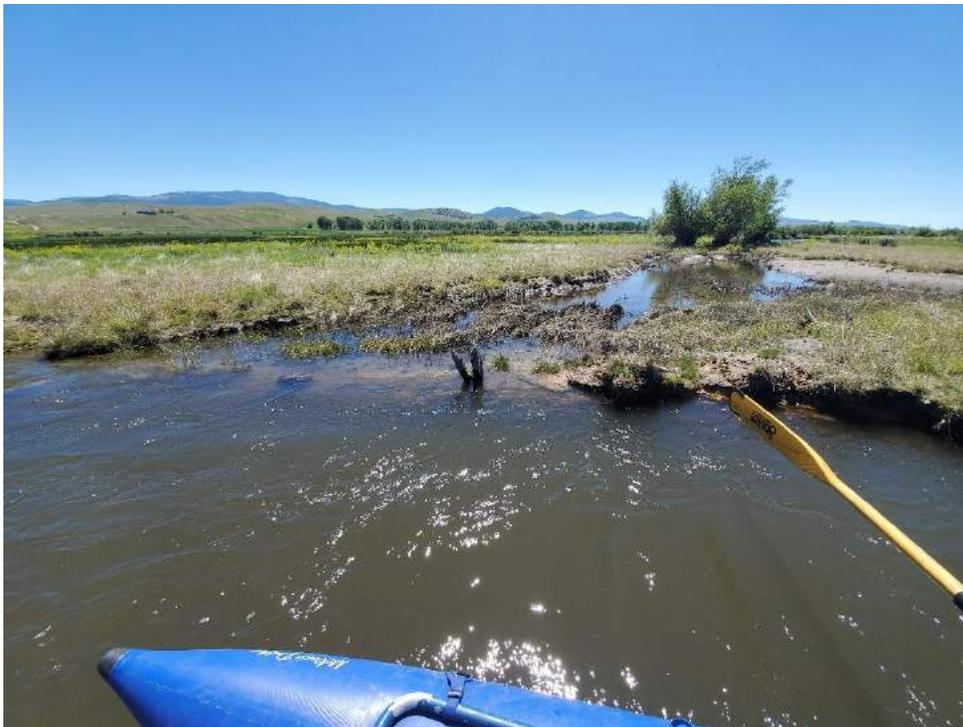
ID#74, AR=4 (SER=3): Slicken is inundated and connected, and channel-forming processes are evident.

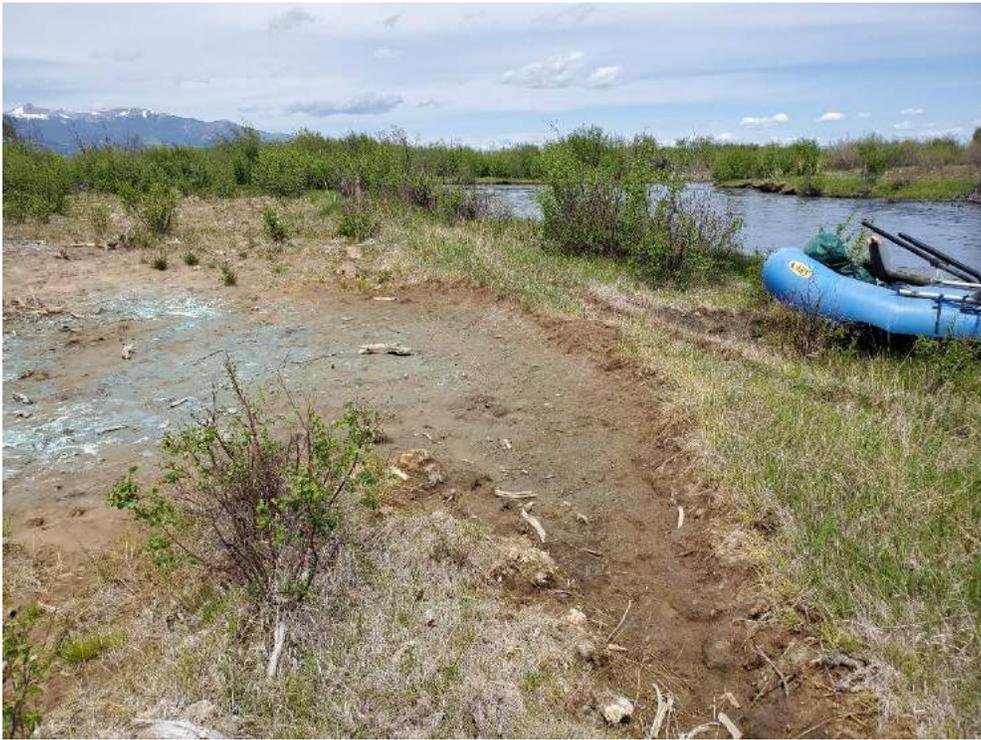
ID#11, **SER=3** (AR=2): Large, severe slicken, but berm is partially intact, reducing SER.

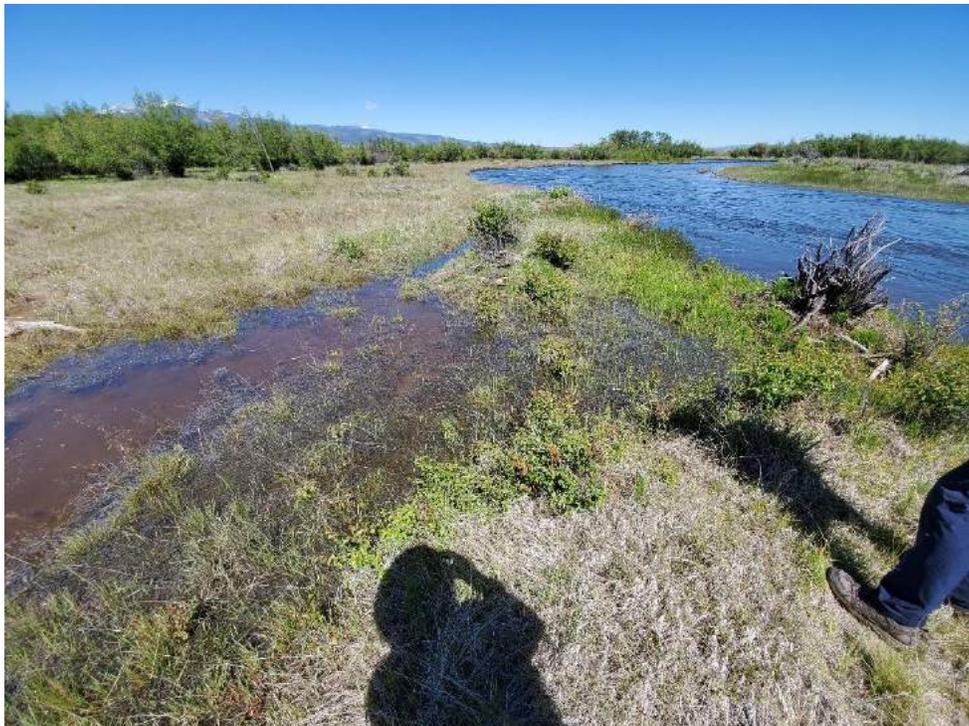
ID#71, **AR=3**, (SER=3): Evidence that river was flowing through slicken, but not at the time of the survey.

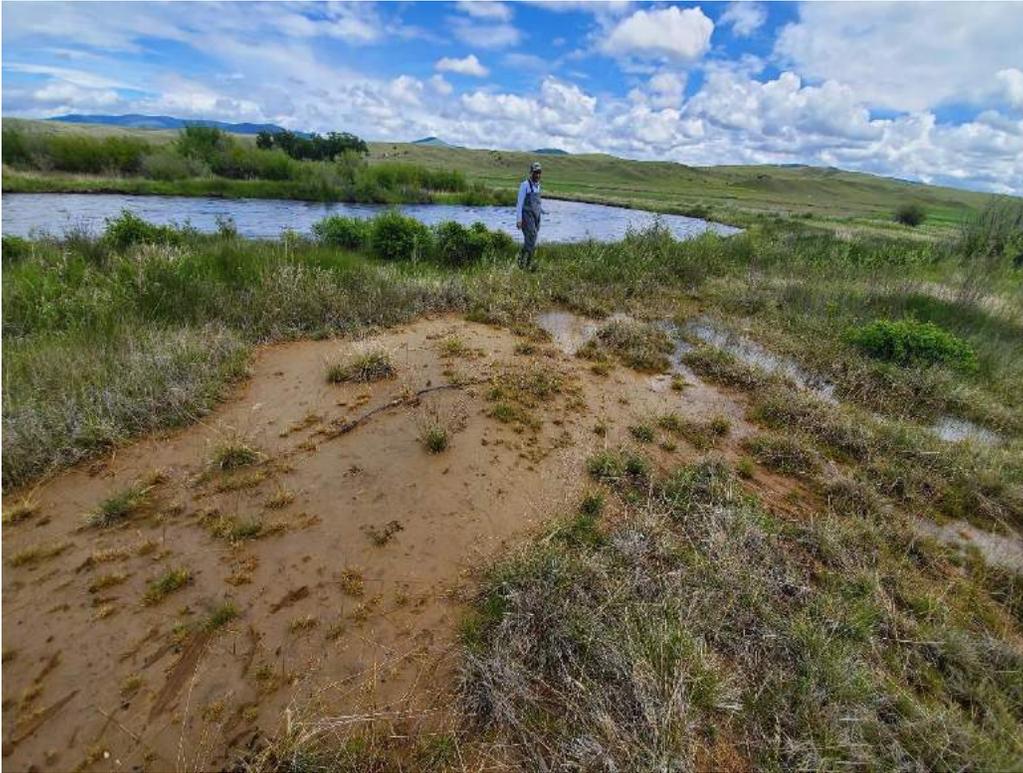
ID#31, SER=2, AR=2: A good example of a berm keeping contamination from contacting the river.

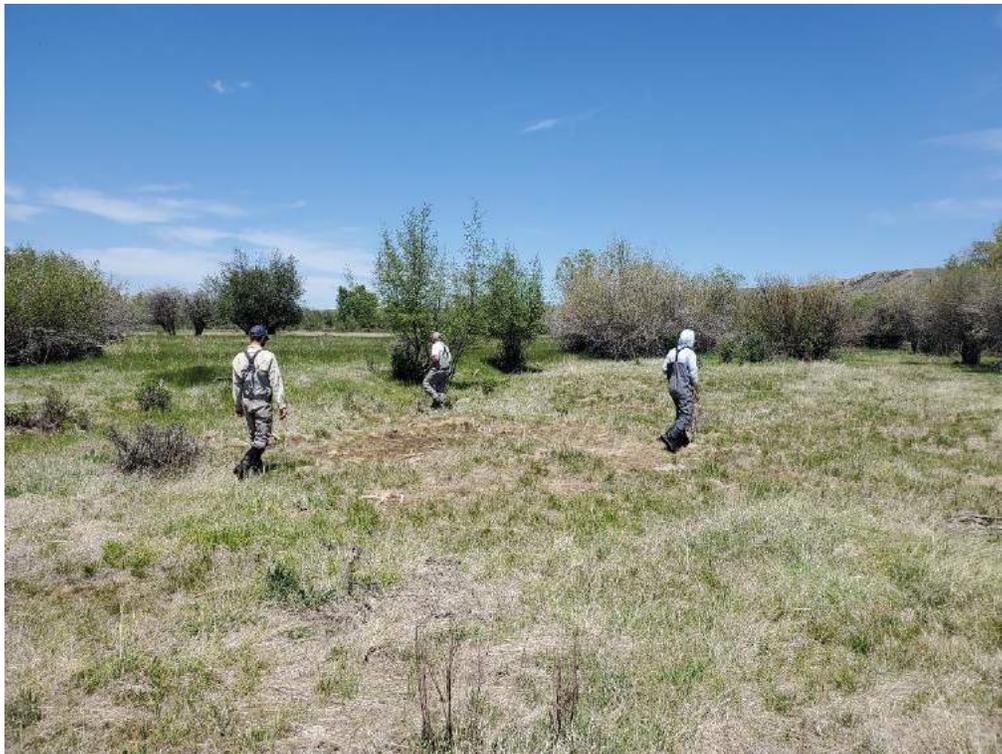
ID#60, SER=1, AR=1: A spotty and mostly-vegetated slicken located away from the river.
