Clark Fork and Bitterroot Rivers Channel Migration Mapping Missoula County

Excerpt from:
Clark Fork and Bitterroot Rivers Channel Migration Mapping
Missoula County

6.2 Smurfit Stone (p. 99)

6.2.1 Berm Failure Mechanisms

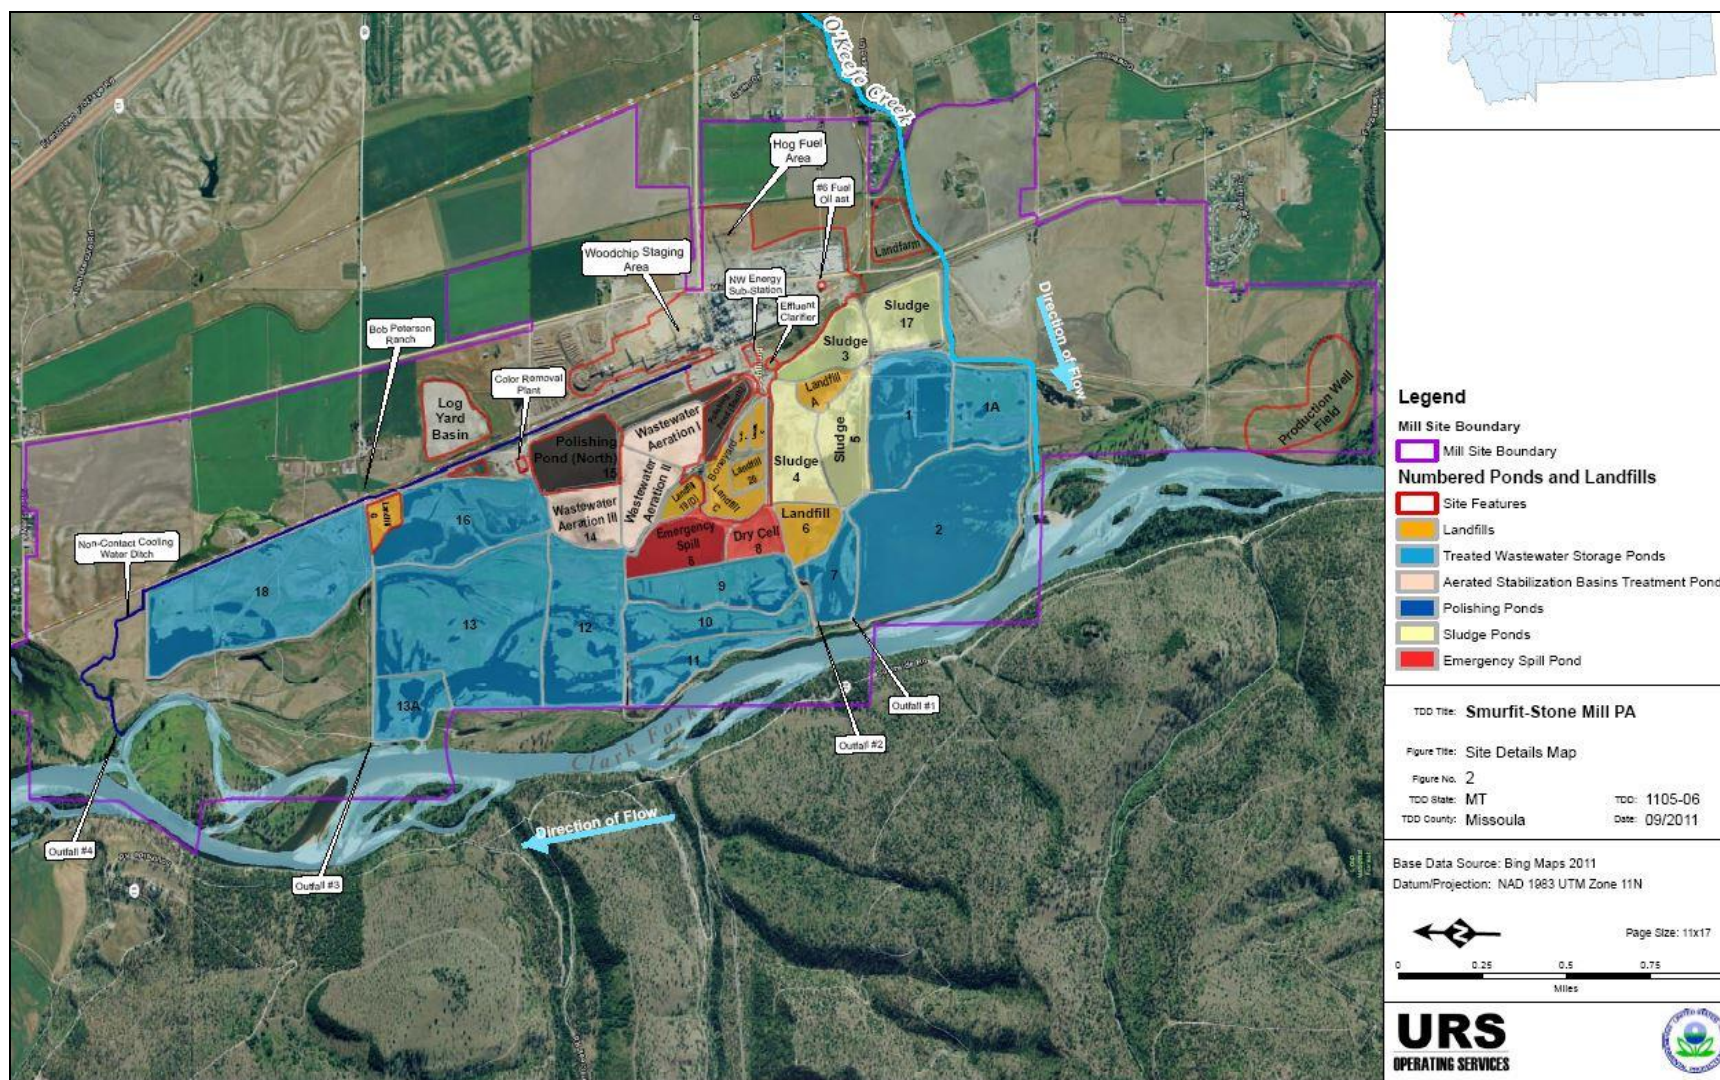
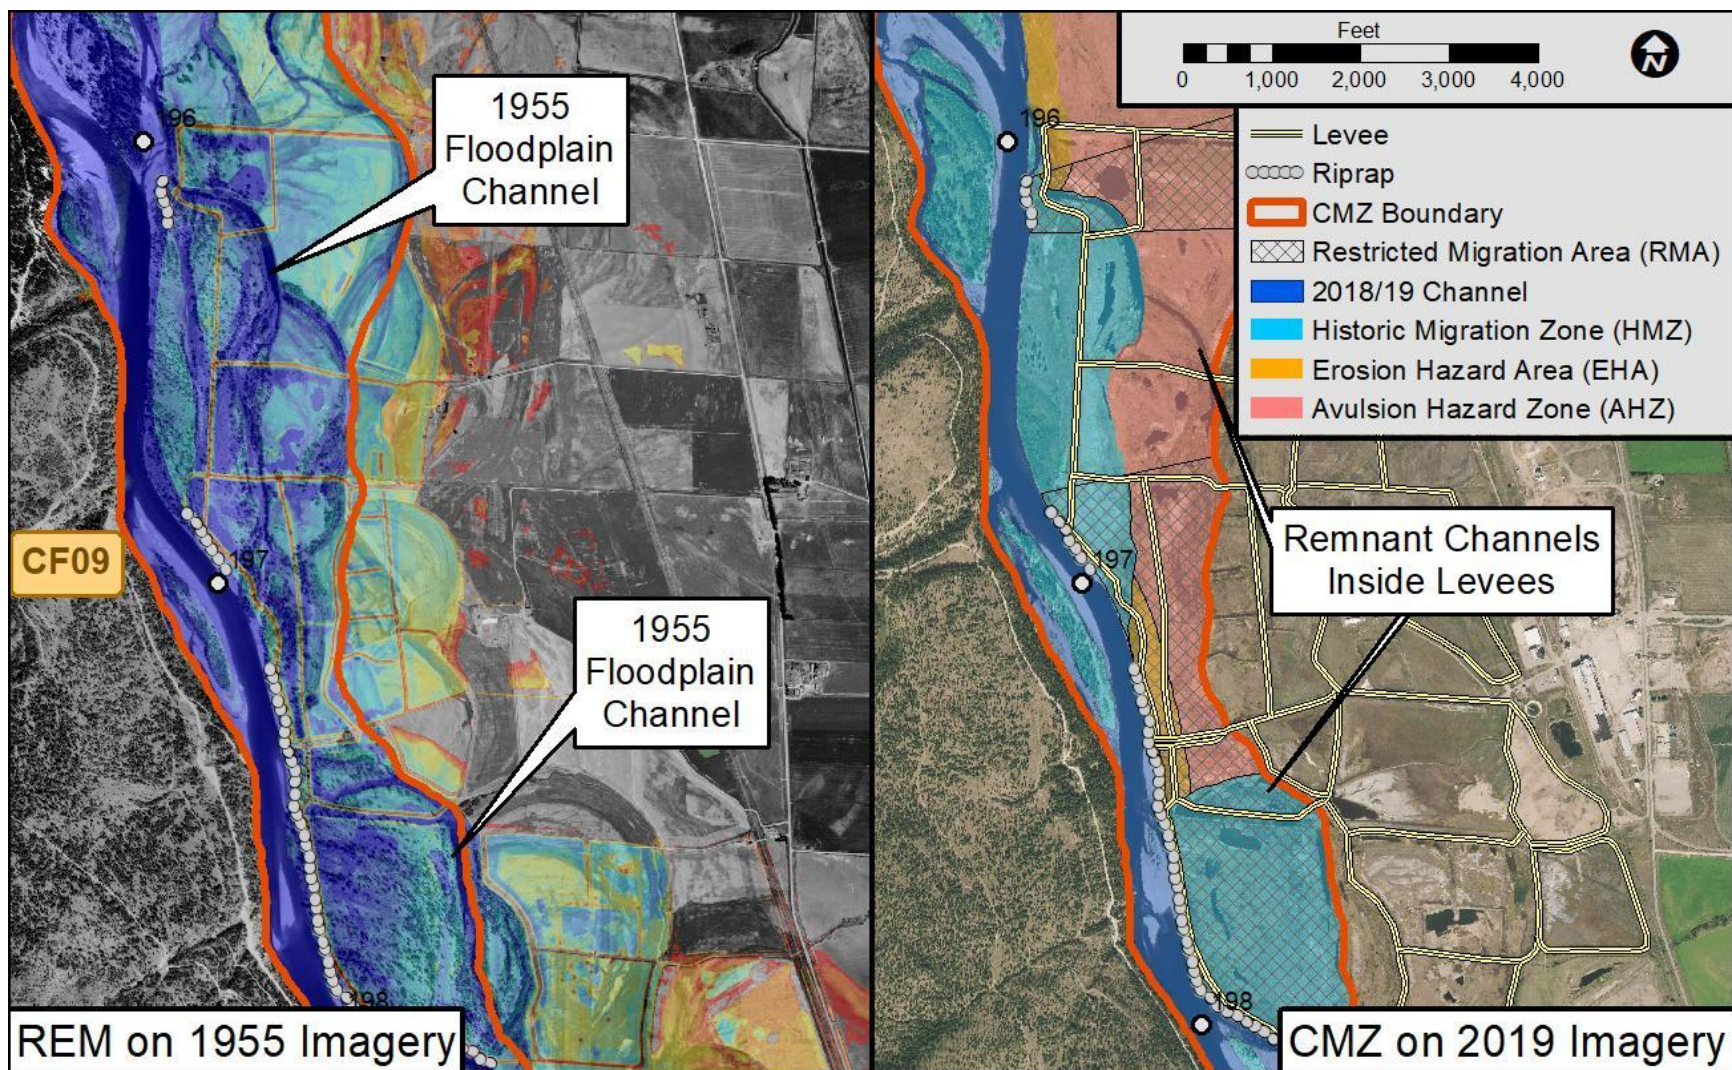
Figure 109. REM (left) and CMZ (right) maps for Smurfit Stone.

Figure 109 shows the Relative Elevation Modeling (REM) results as well as the CMZ map for the Smurfit Stone site. Much of the mill site occupies the Historic Migration Zone where, in the 1950s, floodplain channels were continuous and active. These older channels are still visible as swales in the treatment ponds in the REM, and they stand out due to ponding in the 2018 flood photo (Figure 110).

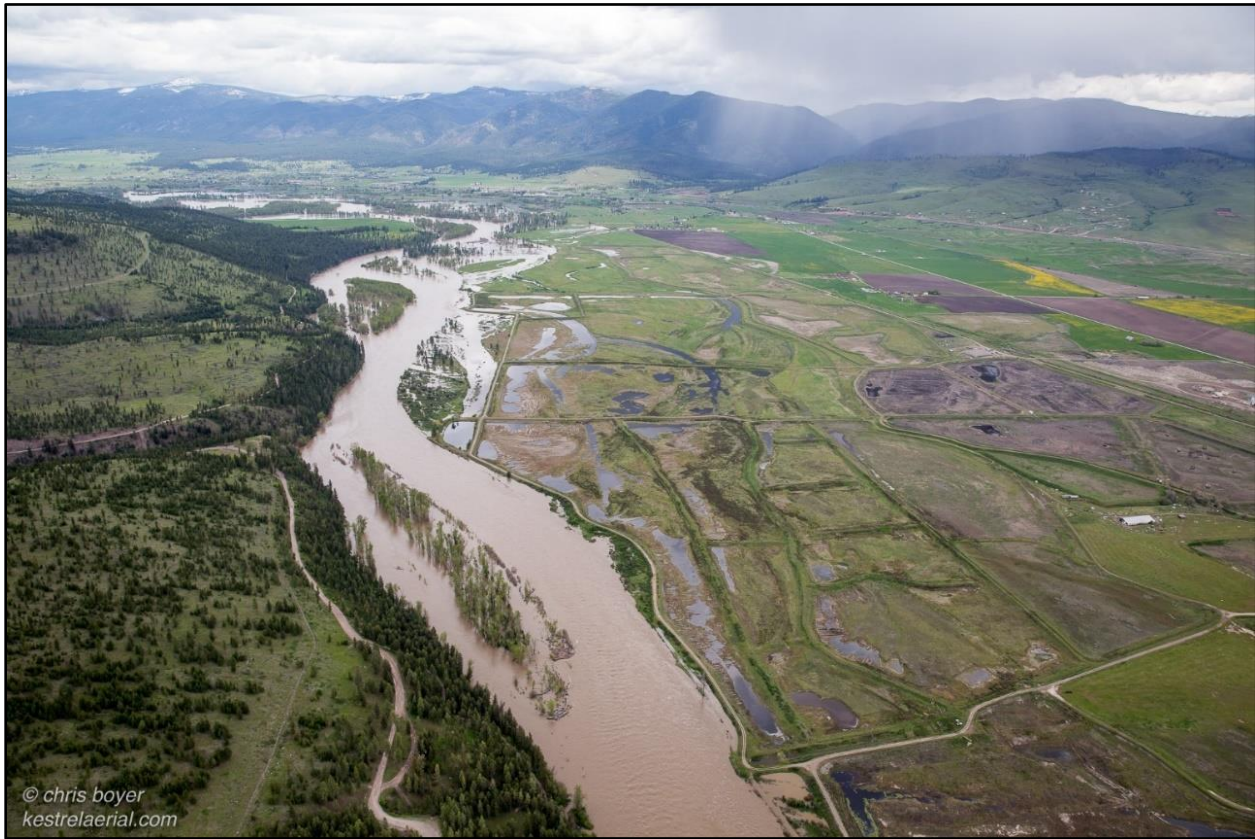
Figure 110. View downstream of Clark Fork River at Smurfit Stone during May 2018 flood.

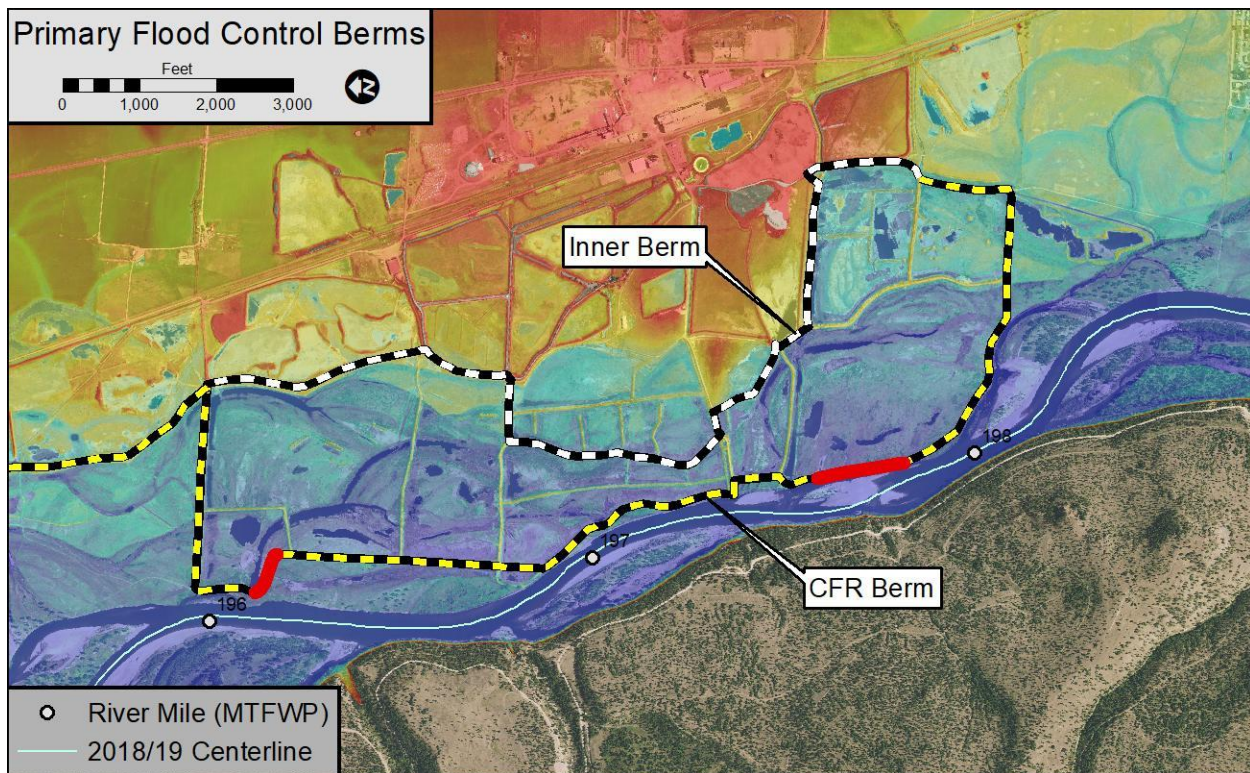
According to a draft Clark Fork River Berm Surveillance and Contingency Plan (Newfields, 2019), there are two berms at the site forming continuous physical barriers to flooding events. These two berms are referred to as the “CFR Berm” and “Inner Berm” (Figure 111). The CFR berm is about 4.4 miles long and separates the site from the Clark Fork River, constructed as a man-made barrier between treated wastewater and the active river corridor (Newfields, 2019). It ranges in height from 8 to 15 feet above surrounding ground with an average top width of 15 to 25 feet. Two segments of the CFR berm were identified by EPA as “Special Concern Areas” after the 2018 flood (Newfields, 2019, Figure 111). The berms were constructed with native materials and underlain primarily by alluvial sands and gravels. The Inner Berm shown in Figure 111 was not addressed in the plan since flood evaluations indicated that the CFR berm would not be overtopped during a 100-year flood (Newfields, 2019).

Figure 111. Primary flood controls berms at Smurfit Stone; red lines denote EPA “Special Attention Areas” following 2018 flood review (Newfields, 2019).

The risk of bank armor failing and causing a berm breach will be an ongoing issue at the old mill site. As a result, bank protection maintenance is a critical aspect of long-term infrastructure protection. Newfields (2019) reported on a “Visual Berm Surveillance Plan” for high water events at Smurfit Stone. This includes either weekly or daily inspections of the berm during high water, depending on stage. The two EPA-designated “Special Attention Areas” will be “paid particular attention” during monitoring events (Figure 111).

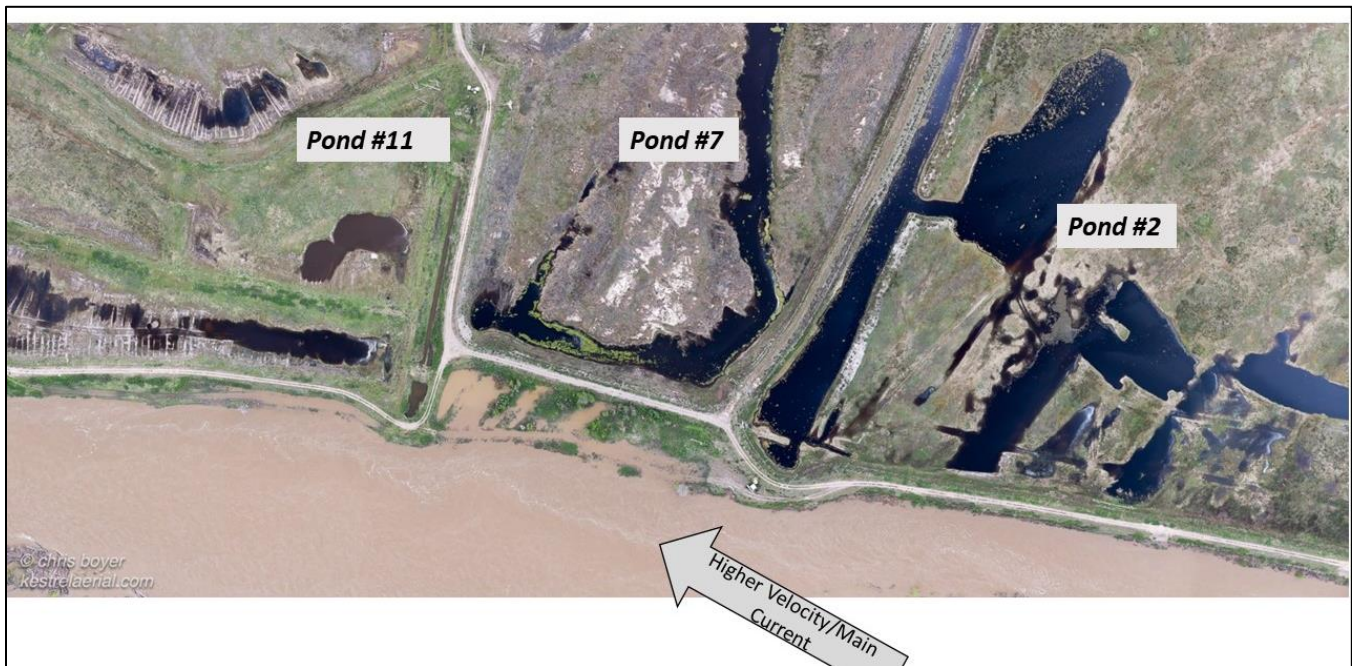
The construction and maintenance history of the bank armor on the CFR berm provides some context as to the risk of berm erosion. In many places the main current of the river flows directly against the armored berm toe. In addition, the berms locally project into the active channel, which amplifies erosive energy along the riprap toe. Figure 112, which is a 2018 flood image along the berm edge, exemplifies this situation at the upstream end of Pond #11.

Figure 112. 2018 photo of floodwaters against Smurfit Stone berms (Ponds #2, #7, and #11 from right to left).

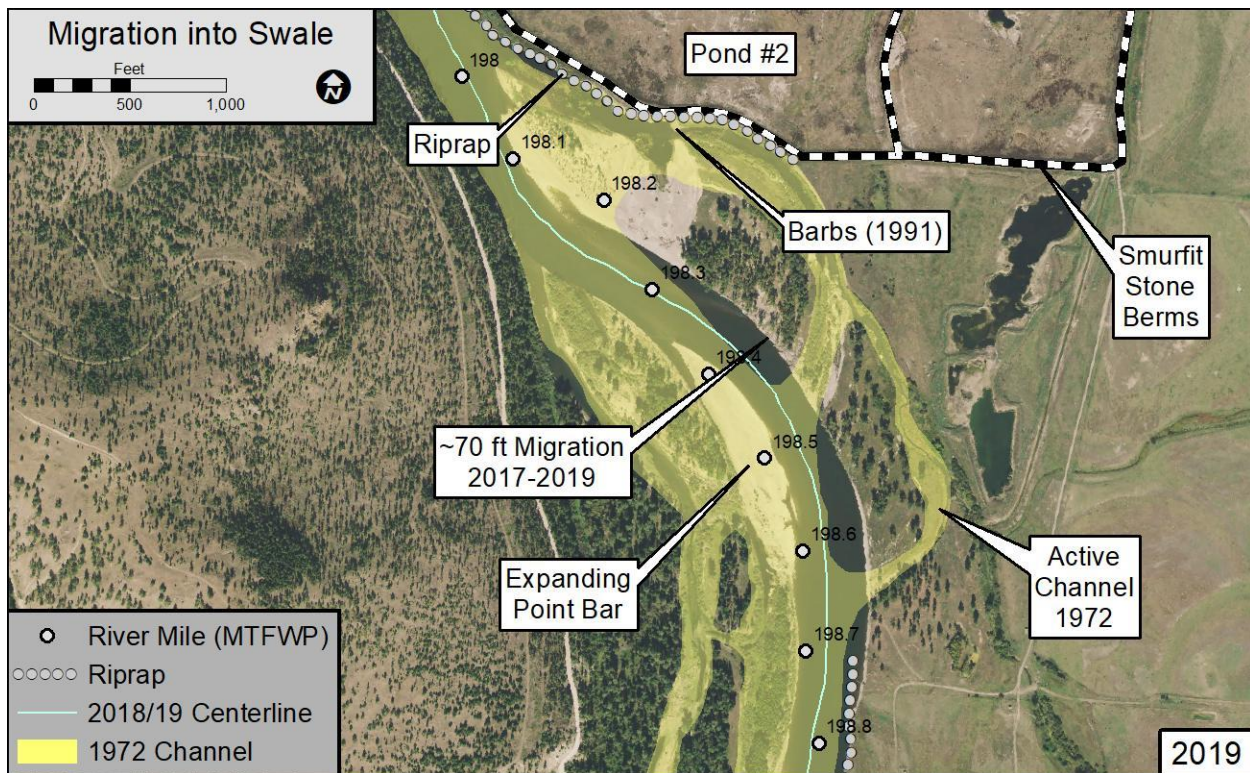
On the upstream end of the Smurfit Stone Mill Site at RM 198, The river has been migrating to the northeast towards the Pond #2 Berm (Figure 113 and Figure 114). About 1,000 feet upstream of the berm, the river has migrated about 70 feet since 2017 towards a swale that was a primary thread in the 1970s (Figure 113). A growing point bar on the left bank of the river will continue to drive right bank erosion and bend development at this location. As a result, increased activation of this meander should be expected, along with the erosion potential that comes with a higher frequency, duration, and magnitude of flow.

Figure 113. Bank migration just upstream of Smurfit Stone showing 2018 migration towards abandoned meander that flows against Berm along Pond #2.

The 300 feet of riprap was probably deemed necessary when the bendway cutoff and re-oriented the river to the west, which would have increased erosive pressure on the right bank near RM 198 (Figure 113). The 2,200 feet of additional rock appears to have been placed on the right bank of the older channel on the south side of Pond #2.

The 1995 imagery shows barbs at the location labeled in Figure 113. At that time, a primary channel was hitting this bank at a right angle.

Another lesson from the Pond #2 armoring history is that maintenance permits have been repeatedly requested in addition to permits for armor extension. The maintenance requirements do not necessarily originate from a single major flood but can develop from constant pressure on a given segment of armor, even at low to moderate flows or from non-hydrologic processes such as animal burrows. There is currently an EPA designated “area of special concern” against Pond #2, this site should be monitored frequently for both loss of berm integrity as well as protective armor decay.

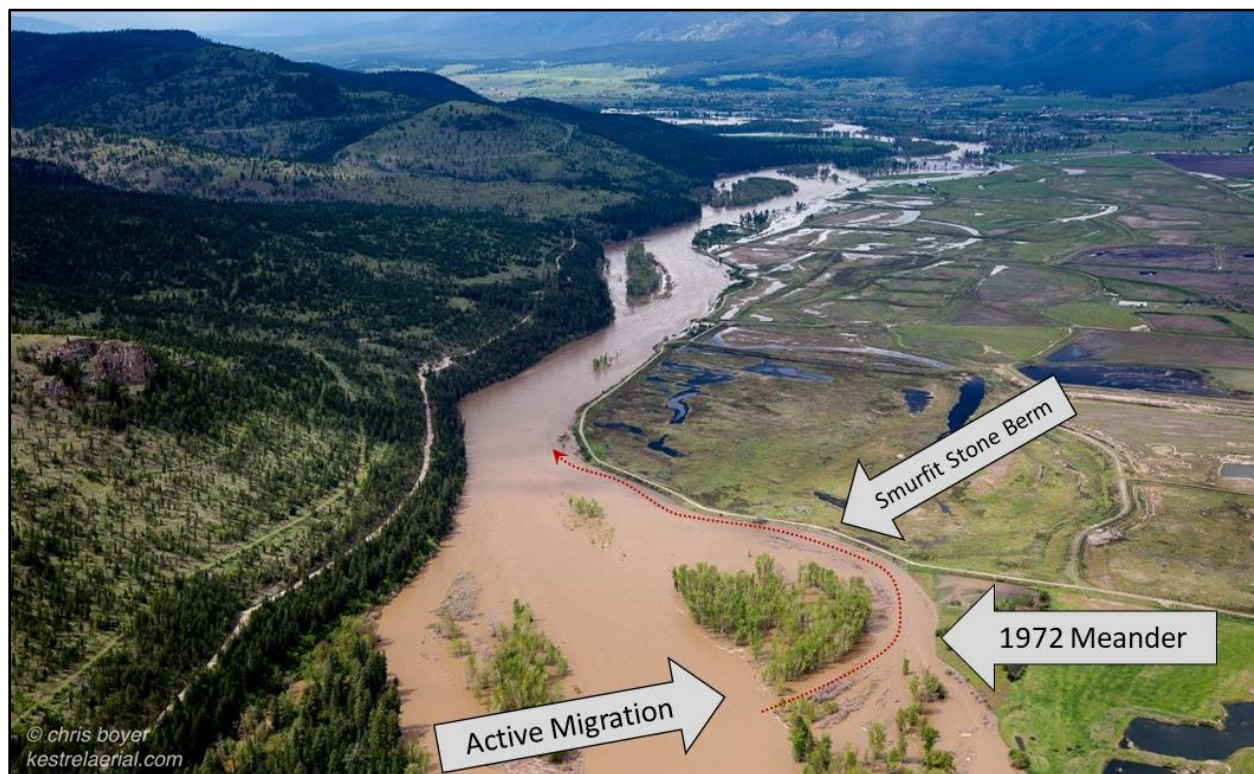
Figure 114. 2018 flood photo showing high flow activation of meander swale that flows against Smurfit Stone berm at upper end of mill site (May 10, 2018).

Figure 114 shows that this area around Pond #2 is marked by a substantial narrowing of the river’s Channel Migration Zone as it approaches the Smurfit Mill Site. This can create problems regarding sediment continuity, as abrupt artificial narrowing of stream corridors commonly results in deposition upstream (such as at bridges). Any increased rate of sediment storage in the area shown in Figure 113 will drive additional channel movement and create new stressors on the existing berm/armor system.

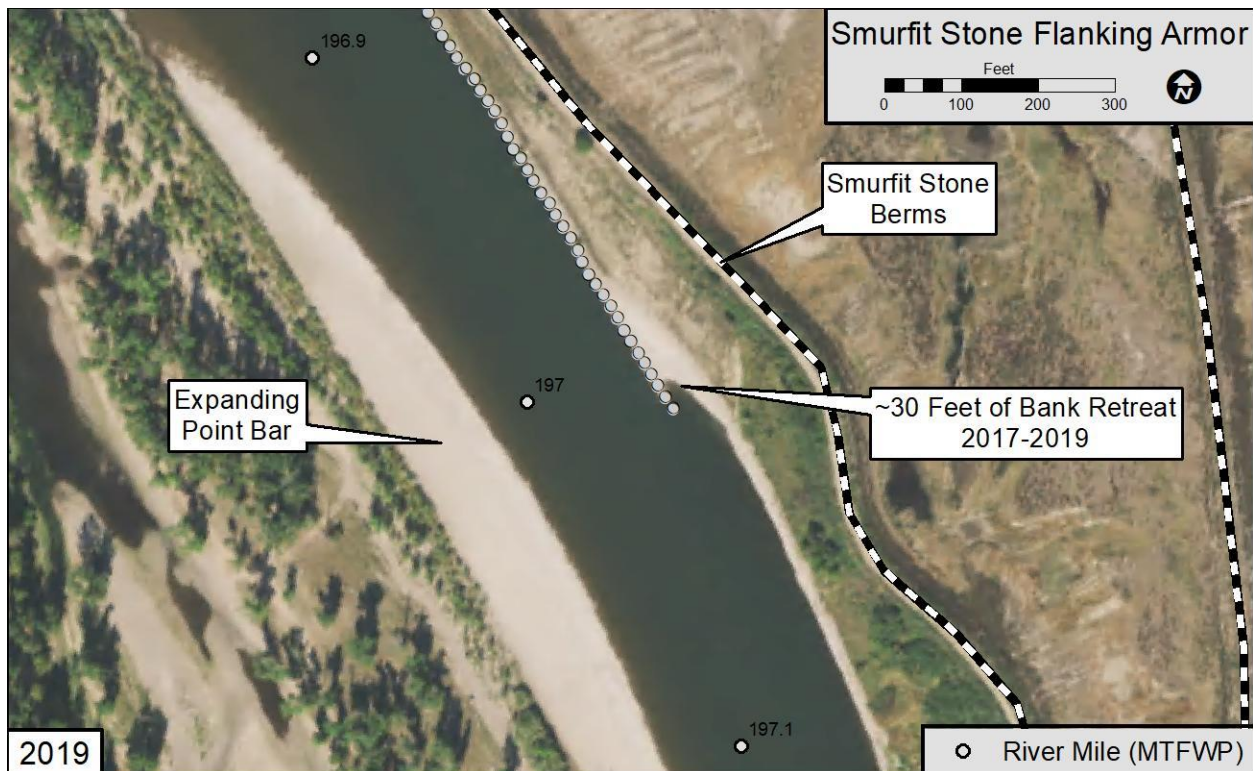
Although the CFR berm continuously forms a physical boundary between the river and the mill site, the armor is discontinuous. This is apparently because the berm is locally set back from the active river channel and thus is not imminently threatened by bank erosion. This creates some risk however in that a primary mode of armor failure is unraveling on its upstream end due to local scour behind the rock. There is a good example of this developing risk against Pond #11 (Figure 115).

Figure 115. 2019 image showing local scour behind bank armor at RM 197 at Pond #11.

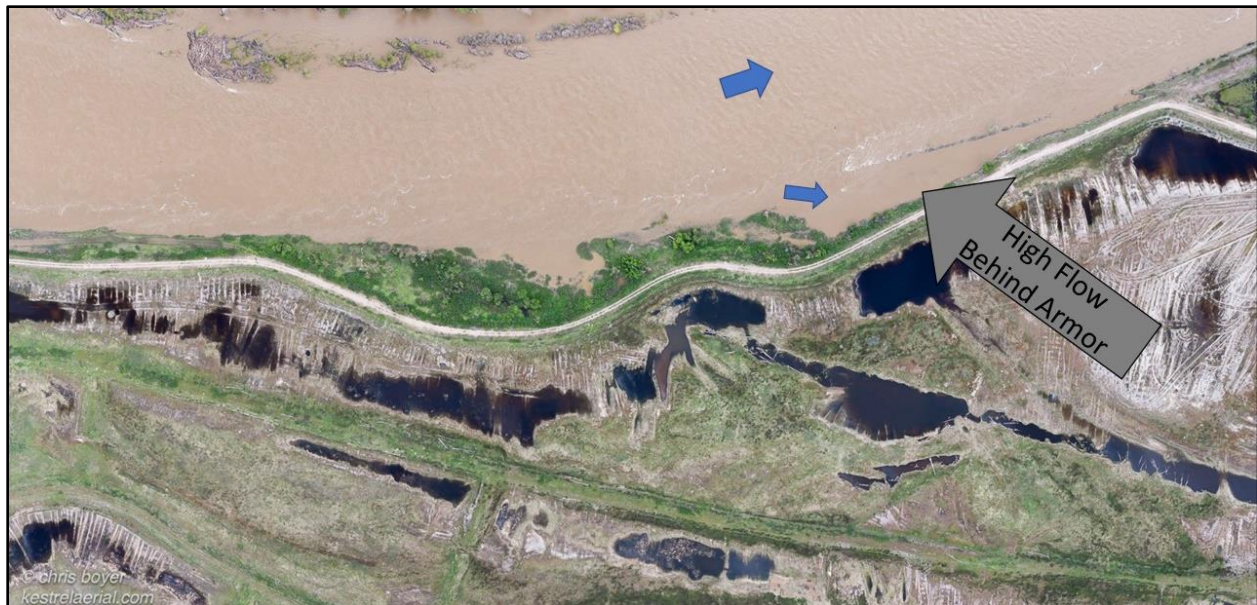
Figure 116 shows water flowing behind the bank armor during the 2018 flood. And Figure 117 shows an oblique Google Earth image of the same site. This flow concentration on the back side of a bank treatment can cause rapid erosion between the armor and berm, and this should be carefully monitored.

Figure 116. 2018 flood photo of bank armor at RM 197 (Pond #11) showing linear rock treatment largely submerged; note high flow velocities visible on upper end of treatment.

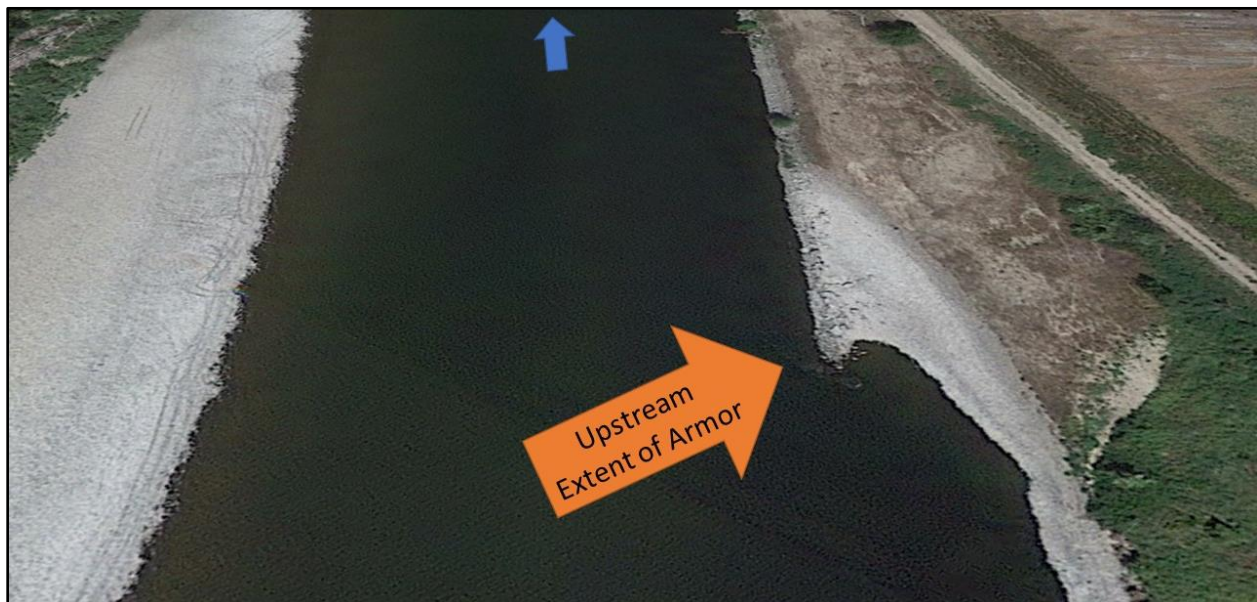
Figure 117. Google Earth image showing scour behind armor at RM 197.

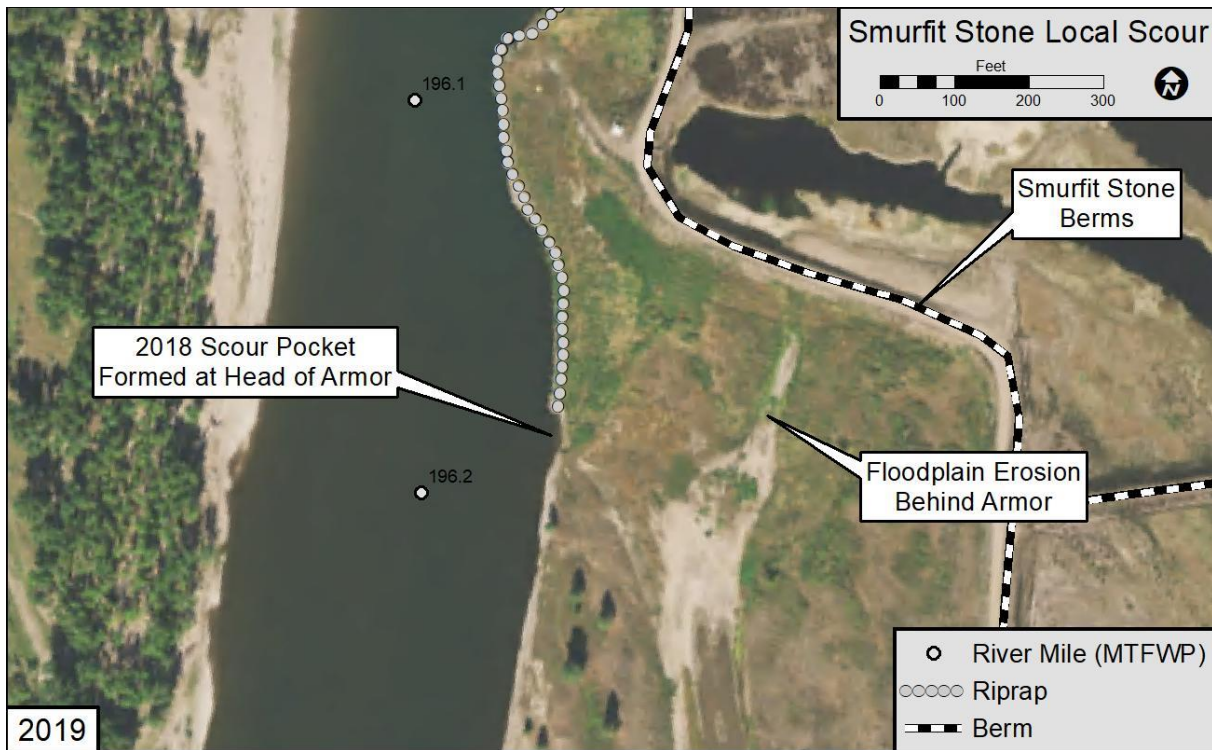
Another example of potential armor damage is shown in Figure 118. This is located at the downstream (northern) end of the mill site. In 2018, a scour pocket formed at the head of the armor which will increase its risk of failure in coming years. East of the armor, floodwaters have scoured out floodplain area between the armor and the Smurfit Stone Berm. Figure 119 shows that at high flow the water flowing behind the armor hits the berm at a right angle, increasing the potential for local scour at the toe of the berm. This section of berm, which runs at a high angle to the Clark Fork River corridor axis, should be monitored and maintained as necessary. This section of the CFR berm was identified as an “area of special concern” by the EPA following the 2018 flood (Newfields, 2016).

Figure 118. Local scour pocket formed during 2018 flood at head of riprap bank treatment, RM 196.15 (Pond #13a).

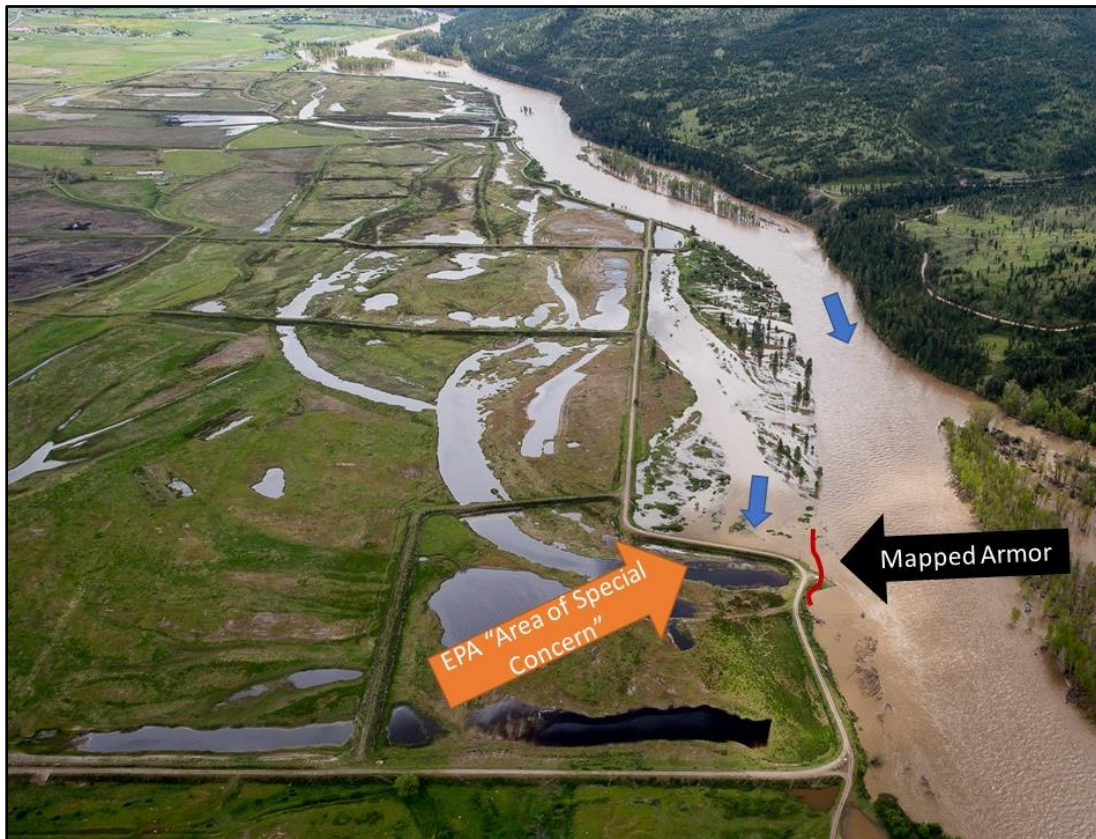
Figure 119. View upstream of armor at RM 196.15 showing flow behind treatment hitting Smurfit Stone berm at right angle.

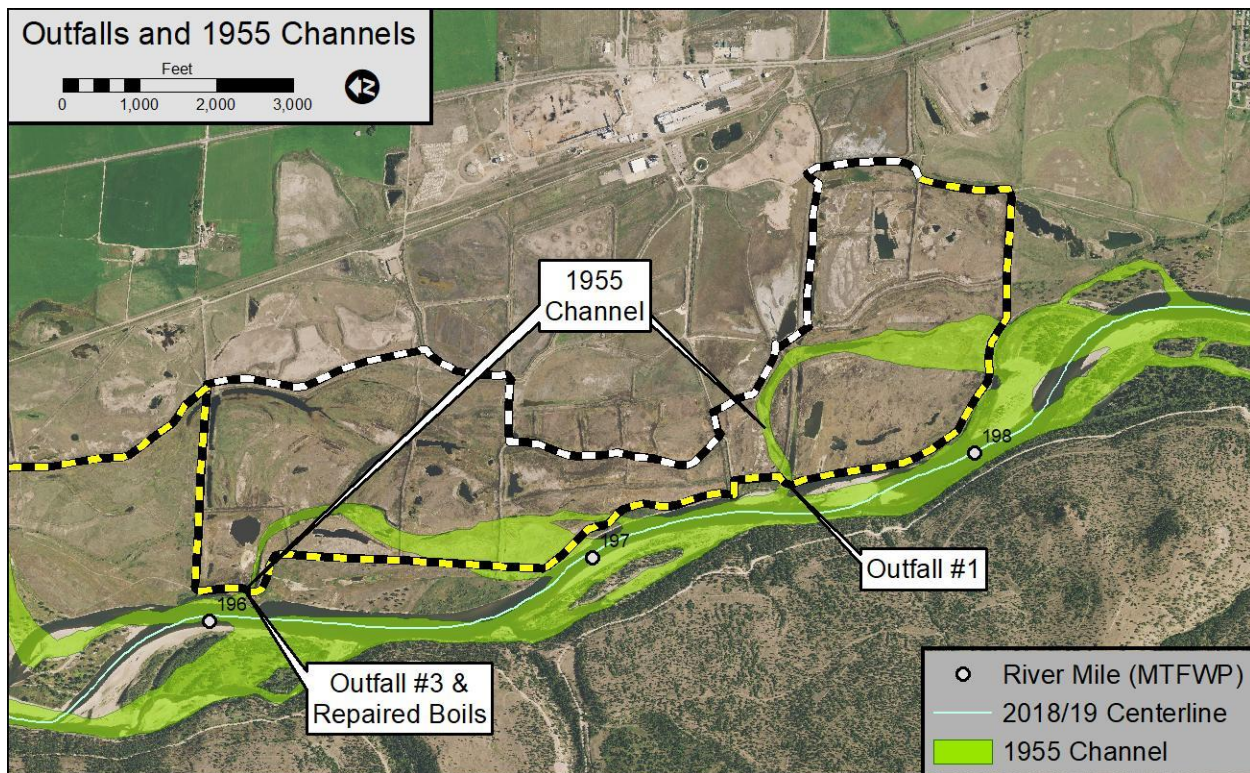
One thing to consider in monitoring these areas is their location in the Clark Fork River Channel Migration Zone. Figure 120 shows the locations of these outfalls on a 1955 image, with the active 1955 channels mapped. Both outfalls are located on recent channels mapped as active in 1955. This could have strong implications for berm stability, as there have been other situations where levees have breached in such settings.

Figure 120. 1955 image of Smurfit Stone showing Outfall #1 and #3 locations on 1955 channel threads.

Stratigraphic conditions on the Clark Fork River floodplain are somewhat different than that of the Yuba, because there is no expansive fine grained mining-derived silt layer on top of old channels. As a result, heightened groundwater pressures that result in ultimate breaching of the cap and creation of geysers may be unlikely at the Smurfit Stone Mill site. It is interesting, however that the outfalls were built on historic channel threads, and that there has been concern regarding their stability, with reports of boils forming on the landward side of Outfall #3.
