Upper Clark Fork Slicken Assessment Report

March 2022

Slicken Assessment Report

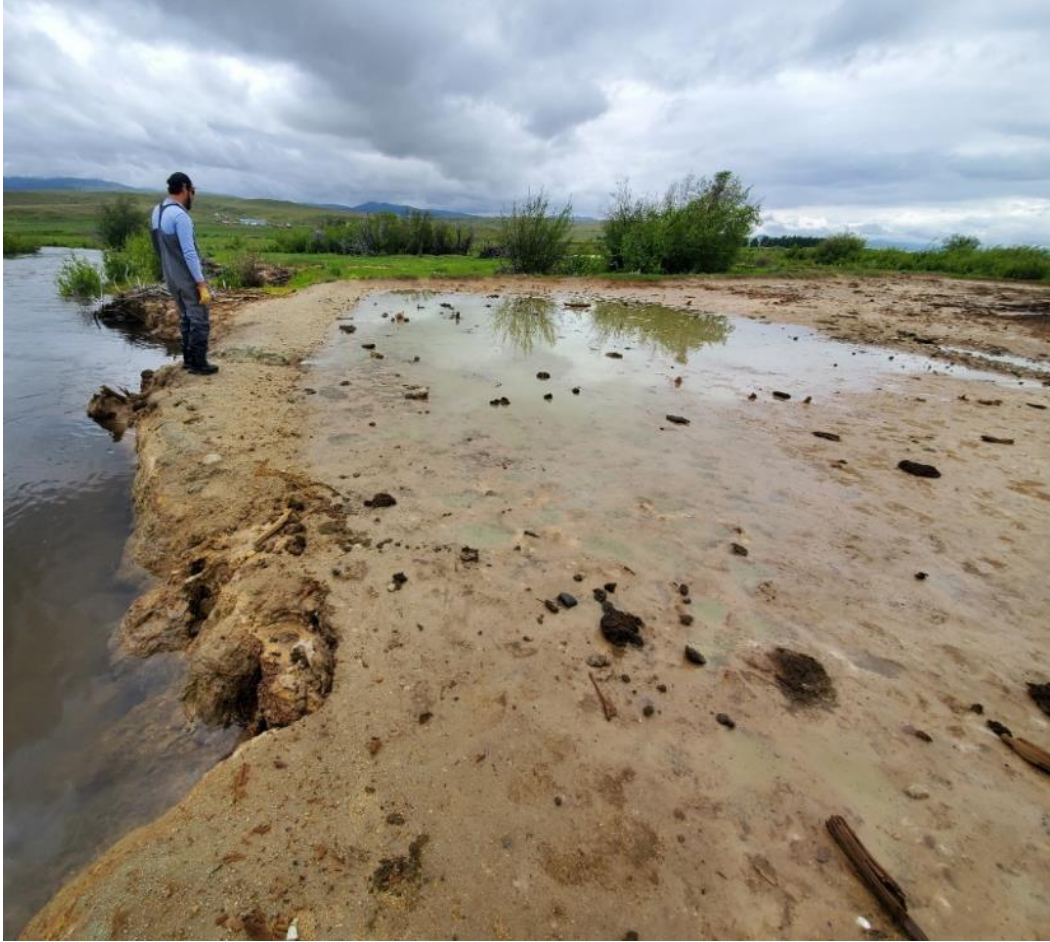
Figure 1. Example of a high-hazard floodplain “slicken” contaminated with high levels of metals including copper and arsenic. The person in the foreground is standing on a crumbling berm that is at risk of complete failure.

There are still several lateral miles of berm complexes that persist in the UCFR (in varying conditions). Most of the remaining berms are approximately 2-3 feet in height above the existing bankfull floodplain elevation. Although some berm complexes remain intact and functioning, many of the berms are experiencing significant sloughing and continue to erode and fail (Figure 1).

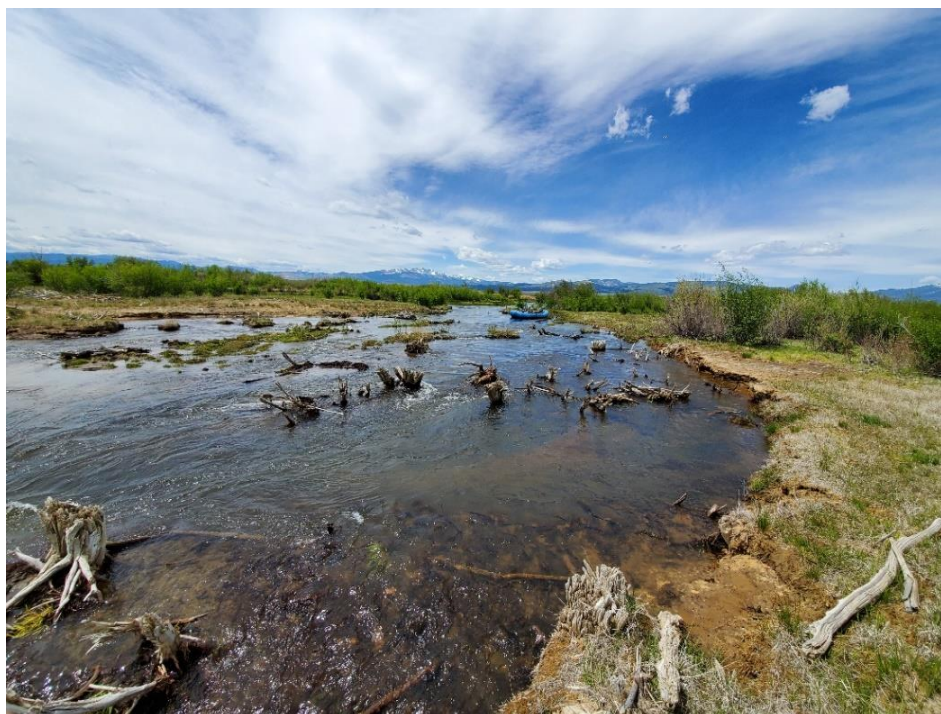
Although the condition of the slickens varied considerably, we noted some consistent trends, especially in the higher-hazard slickens. Many of the most visibly-contaminated slickens are located on meander tabs that have relatively low elevations (compared to surface water and adjacent floodplain elevation). These meander tab slickens tend to see berm failures at both the top and bottom of the tabs (related to distinct geomorphological forces). In some of the extremely high avulsion hazard slickens we noted head-cutting at the upstream end of the tab and significant down-cutting at the lower end. In some instances, these avulsions have matured to the point where much of the exposed contaminated material has been washed downstream (Figure 4).

Figure 4. Newly-formed side channel through a slicken on a meander tab.

A prime example is slicken #10 in Phase 3B. CFC first documented major berm failure at this slicken in 2017. Since that initial failure (which started as a 1-2 foot breach), a mature side channel has formed through the slicken that, as of summer 2021, is more than 30 feet wide (Figure 4).

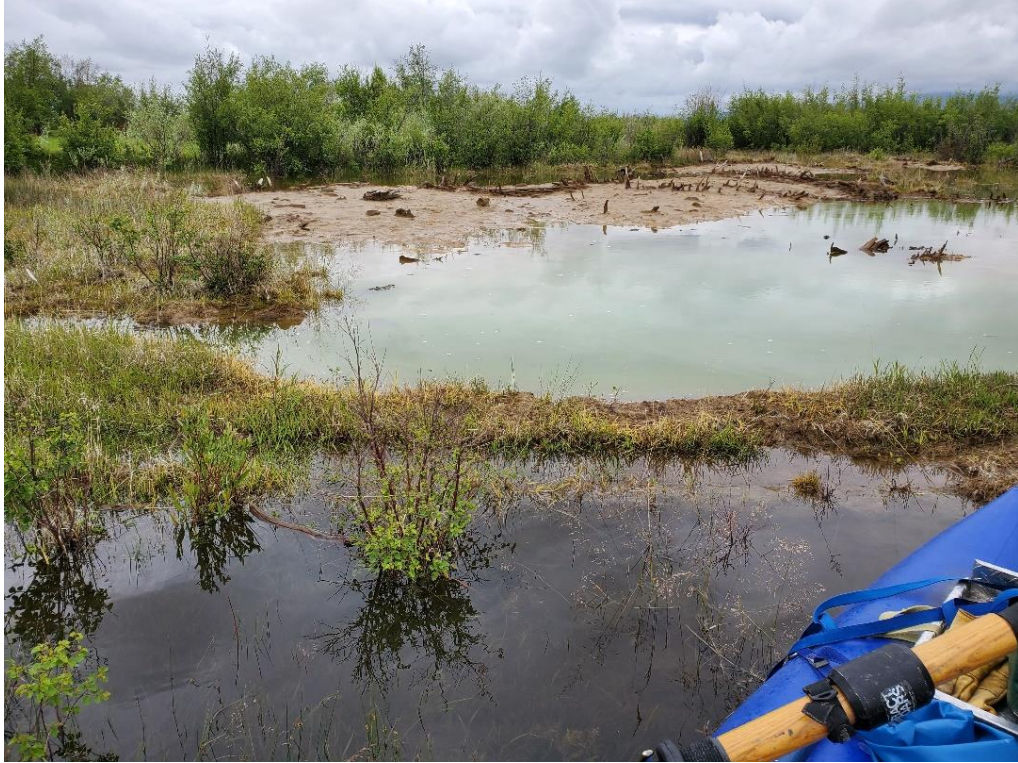
Figure 5. Partially-functioning berm on slicken #4 in Phase 3A. The berm contains some contaminated water, but is in danger of being overtopped during high river flows.

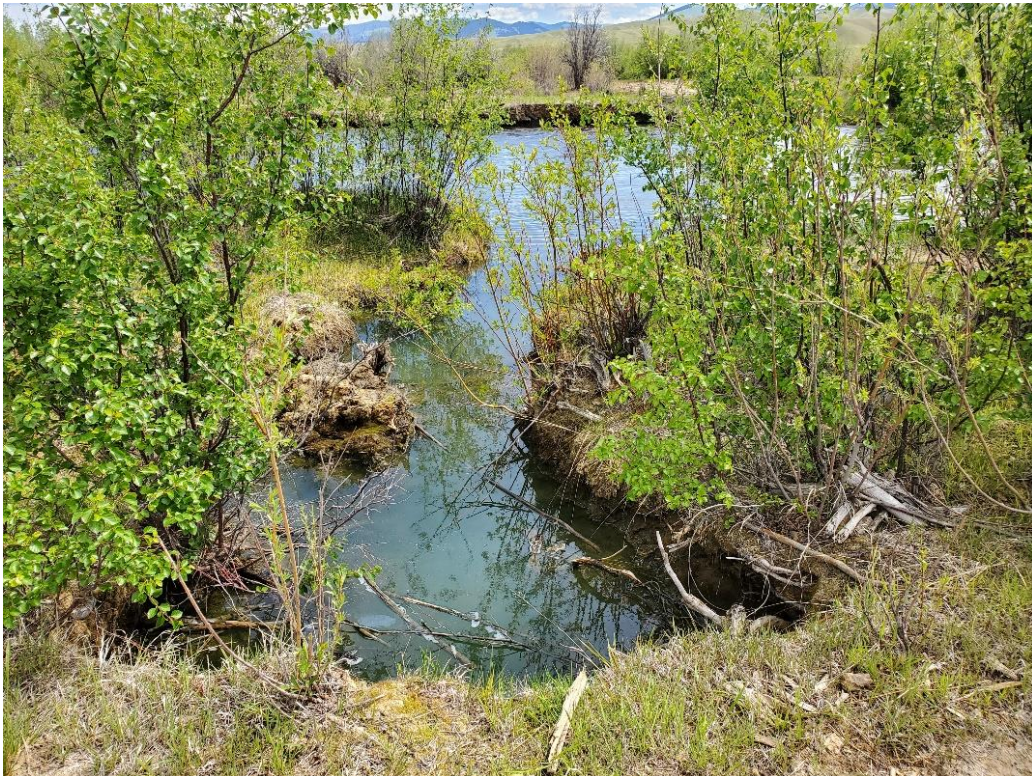
In addition to direct surface connection, we also found clear evidence of contaminated groundwater interaction. At several of the severely contaminated slickens, we noted teal-stained water lingering in slack water areas on the downstream end of the meander tabs (Figure 6). This contaminated water is interacting directly with the Clark Fork River and potentially impacting aquatic resources downstream.

Figure 6. Teal-colored water entering the Clark Fork River at the downstream end of a contaminated meander tab on slicken # 4 in Phase 3A.

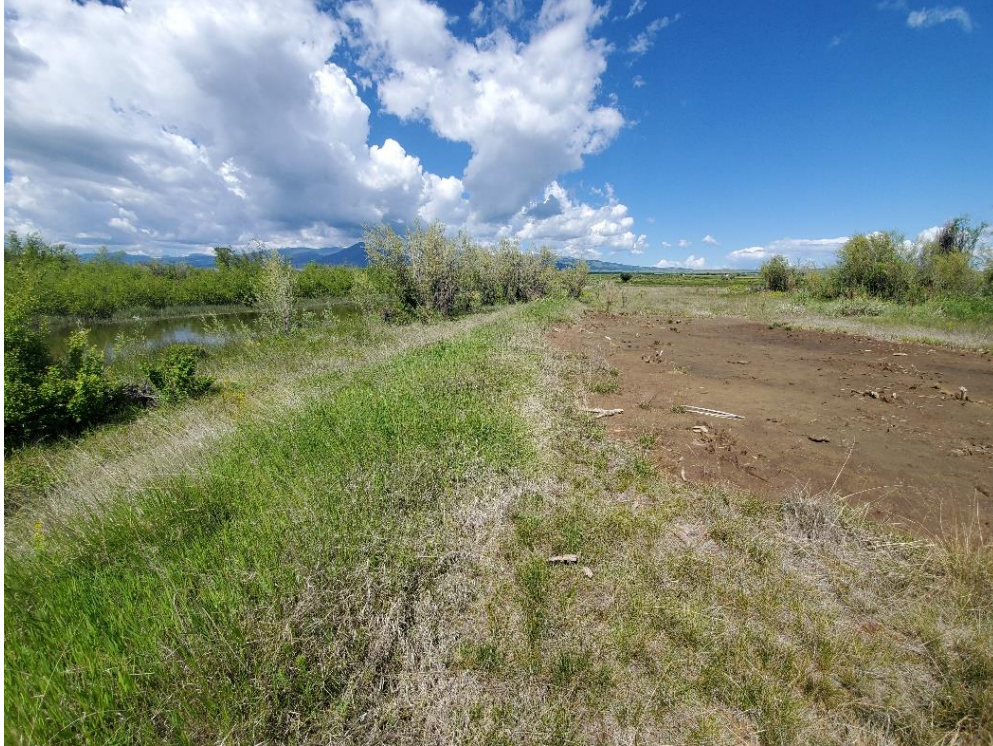
Figure 7. An intact berm on slicken #94 in Phase 12. Note that the berm is vegetated and keeps slicken material out of the river (on the left).

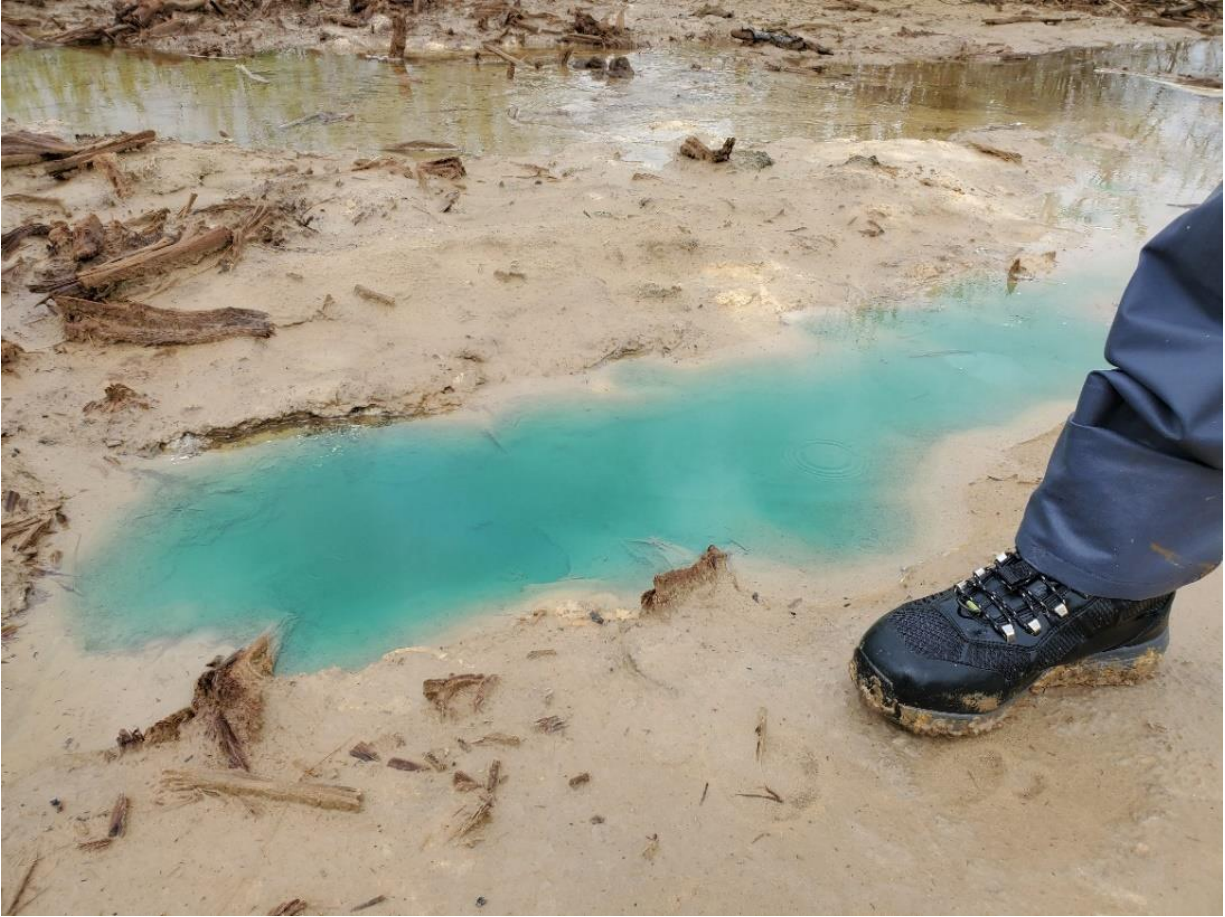
Figure 8. Ponded water likely contaminated with high levels of copper and other heavy metals on slicken #6 (Phase3A).

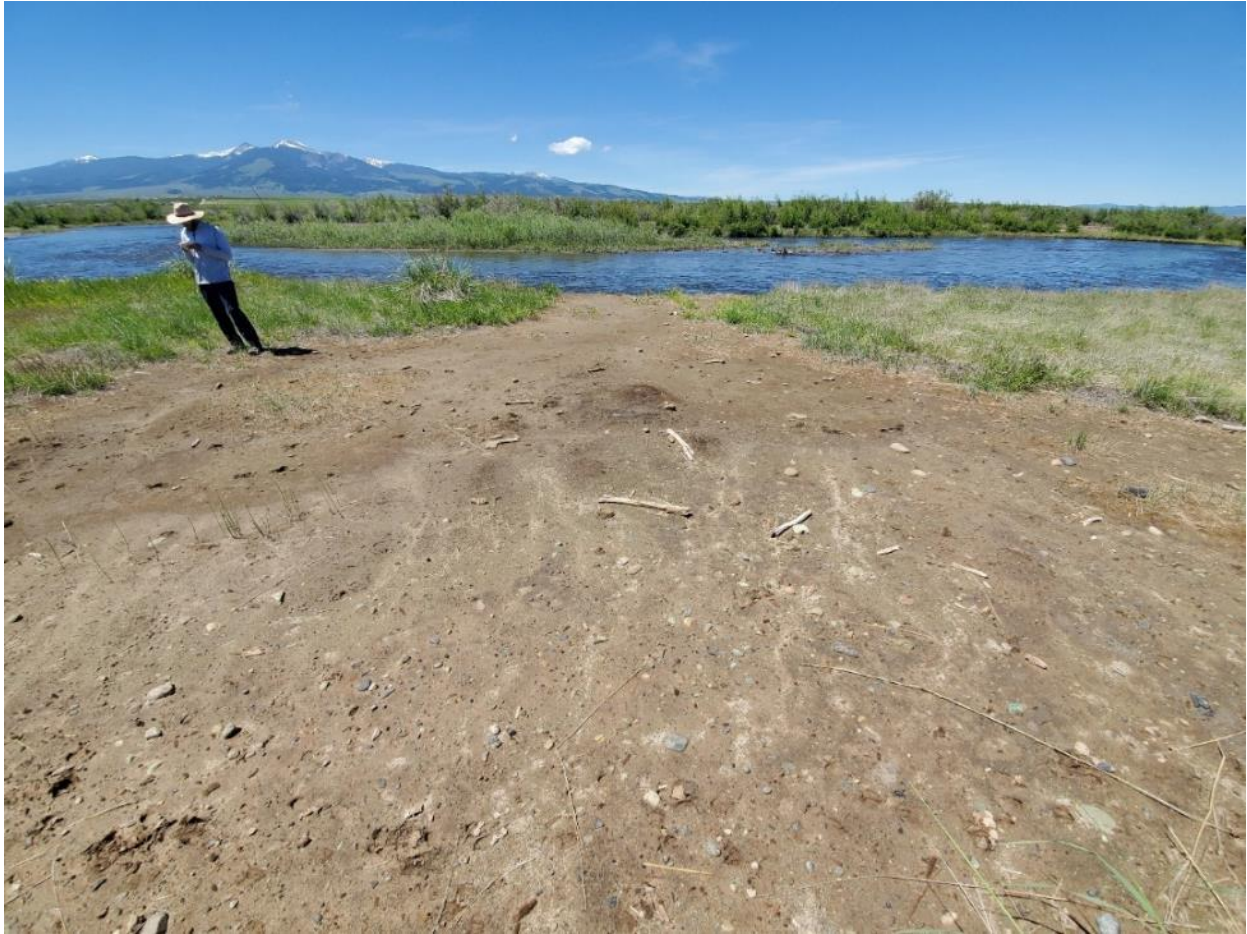
Figure 9. Clear flow path leading from slicken #83 (a small but severe slicken located in Phase 11 between Sager Lane and Deer Lodge) to the Clark Fork River.

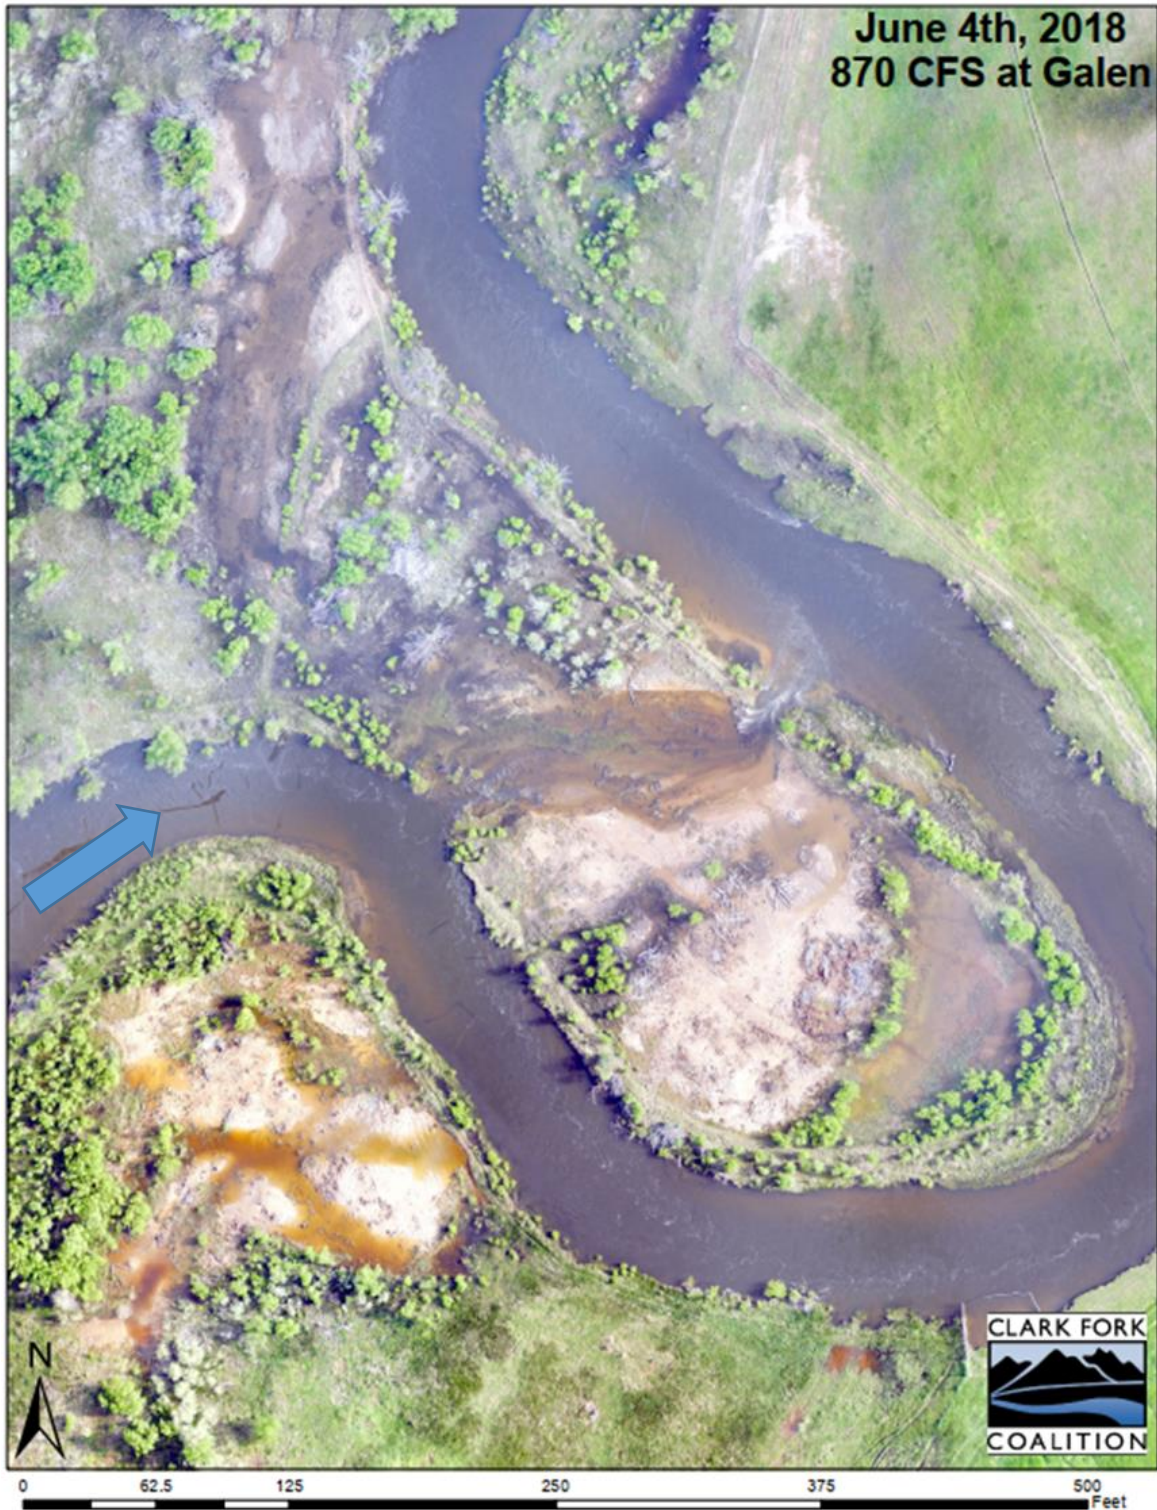
In some cases, slicken avulsions are caused by the direct erosive power of the river. These avulsions are often found on the downstream end of meander tabs where backwaters and eddies form. In other cases, avulsions may form from head-cutting caused by surface runoff over slickens. This surface runoff collects at the lowest point and can form a flow channel and head-cut (Figure 10 & 11).

Figure 10- Aerial imagery of a contaminated meander tab in in Phase 3A. Active avulsion pathways are clearly noted with deltaic slicken sediments clearly present at the outlet of the avulsion.

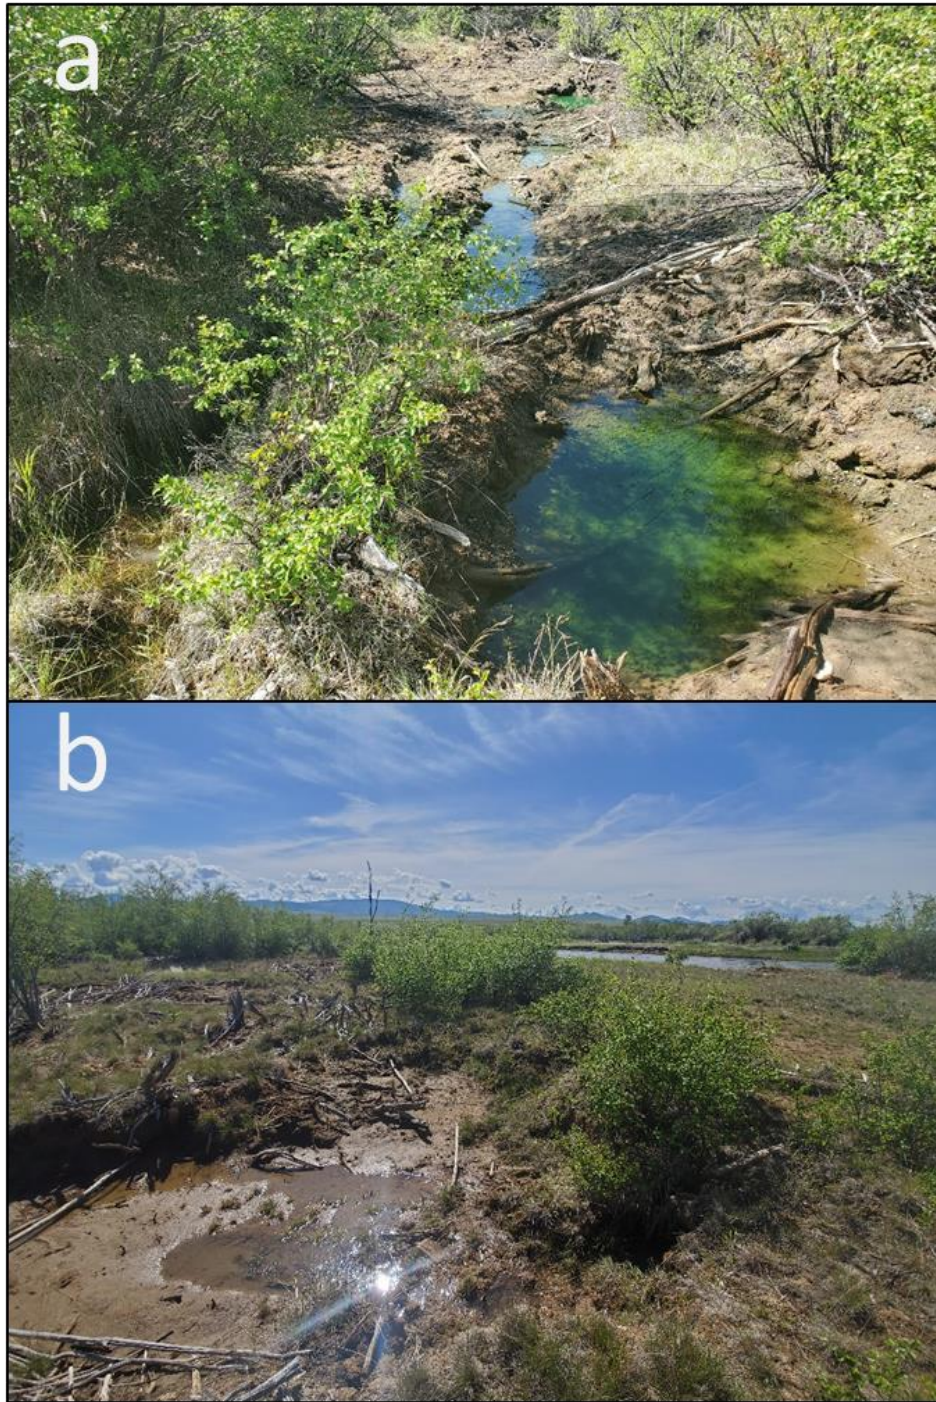
Figure 11. The photos above show an avulsion channel that has formed from surface runoff and erosion of slicken #95 (a large, high risk slicken in Phase 12 between Sager Lane and Deer Lodge). Photo “a” is on the lower, downstream portion of the meander tab, photo “b” was taken at the top of the tab. This channel is headcutting toward the upstream end of the meander tab and is within a few meters of causing the river to avulse into the slicken.

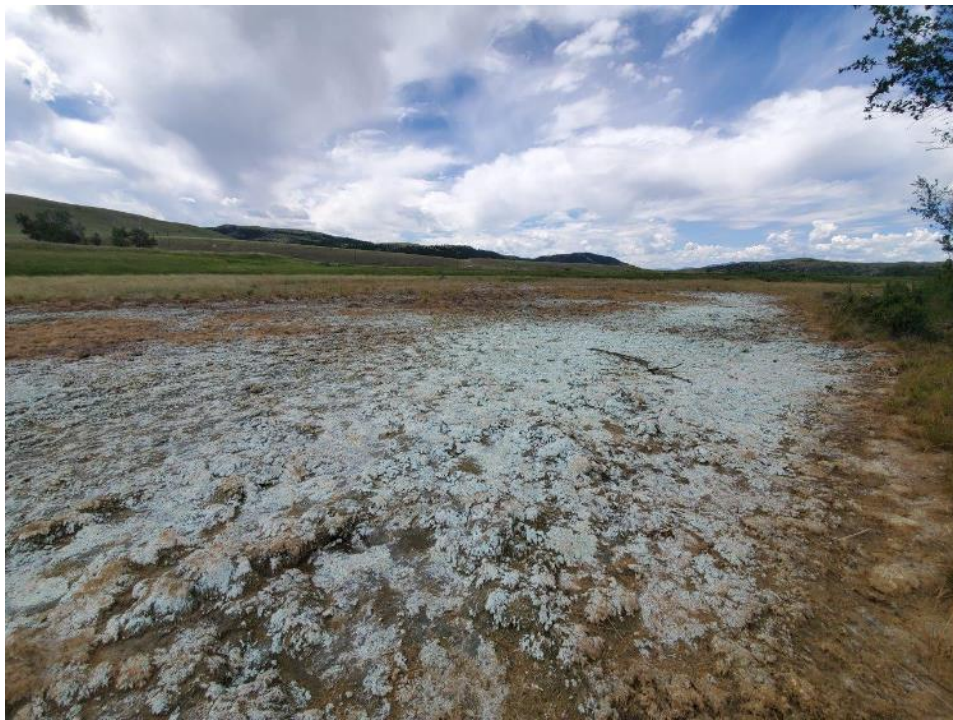
ID #151 (Phase 22 near Garrison): This abandoned oxbow slicken is expansive, covering approximately 12 acres.

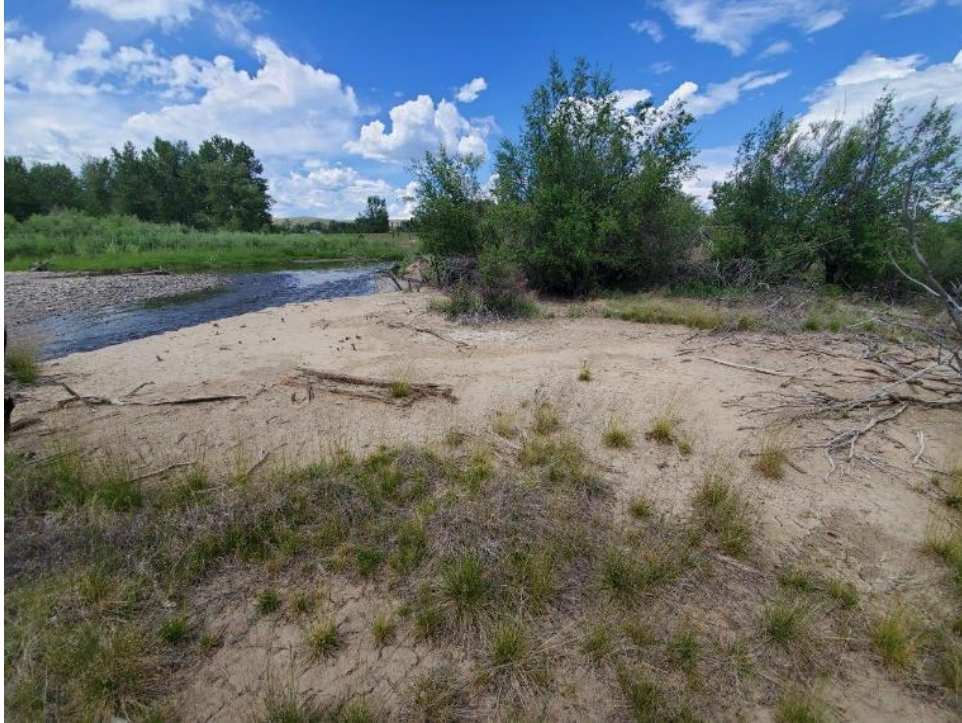
ID #154 (Phase 22 near Garrison): Located at the confluence of the Little Blackfoot, this slicken is a potential fish killer.

The extent and severity of the floodplain contamination in Phase 22 (reach of River near Garrison) was somewhat unexpected. Slicken #154, located at confluence of the Little Blackfoot River, is exceptionally hazardous. This slicken should receive high priority for removal. If timely removal is not feasible, then erosion control measures should be implemented as soon as possible.

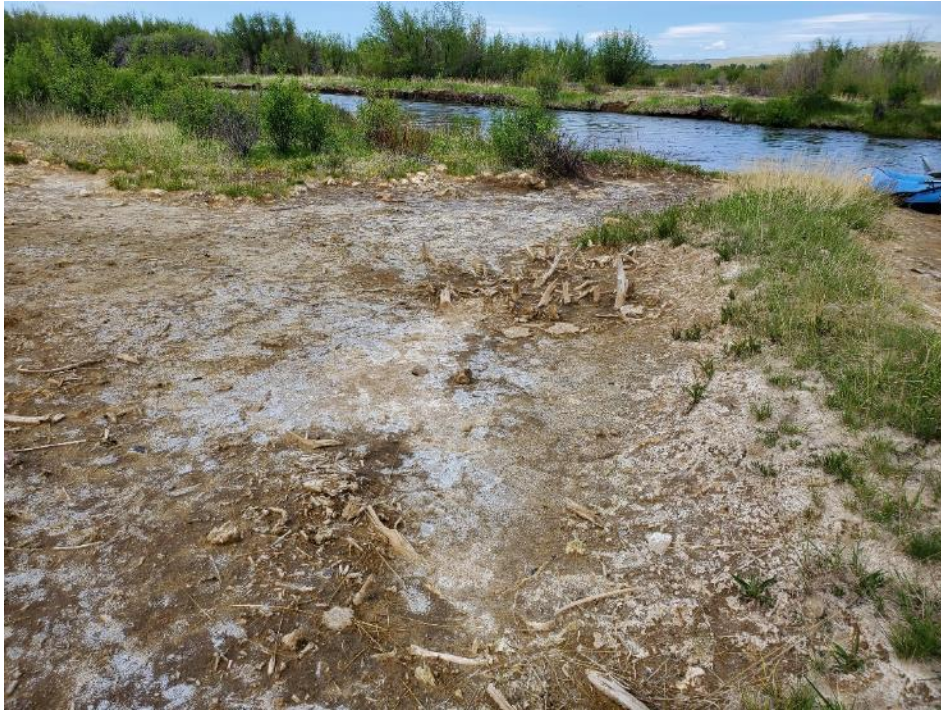
ID#22, **SER = 4** (AR=3): Built-up salts on this slicken will flow into the river during a rainfall event.

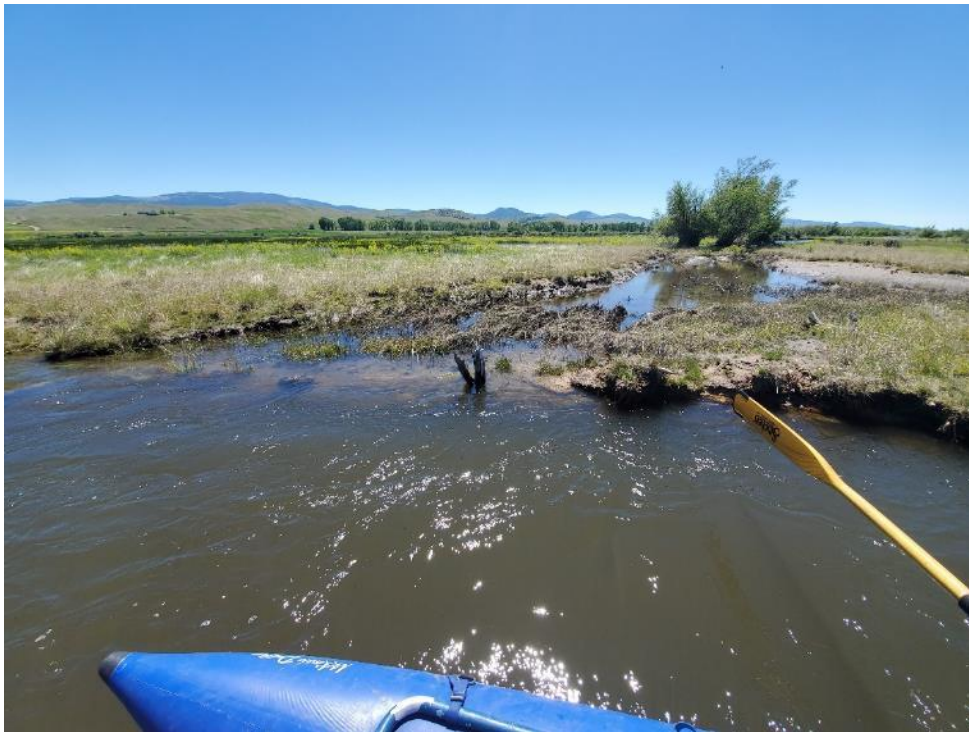
ID#74, **AR=4** (SER=3): Slicken is inundated and connected, and channel-forming processes are evident.

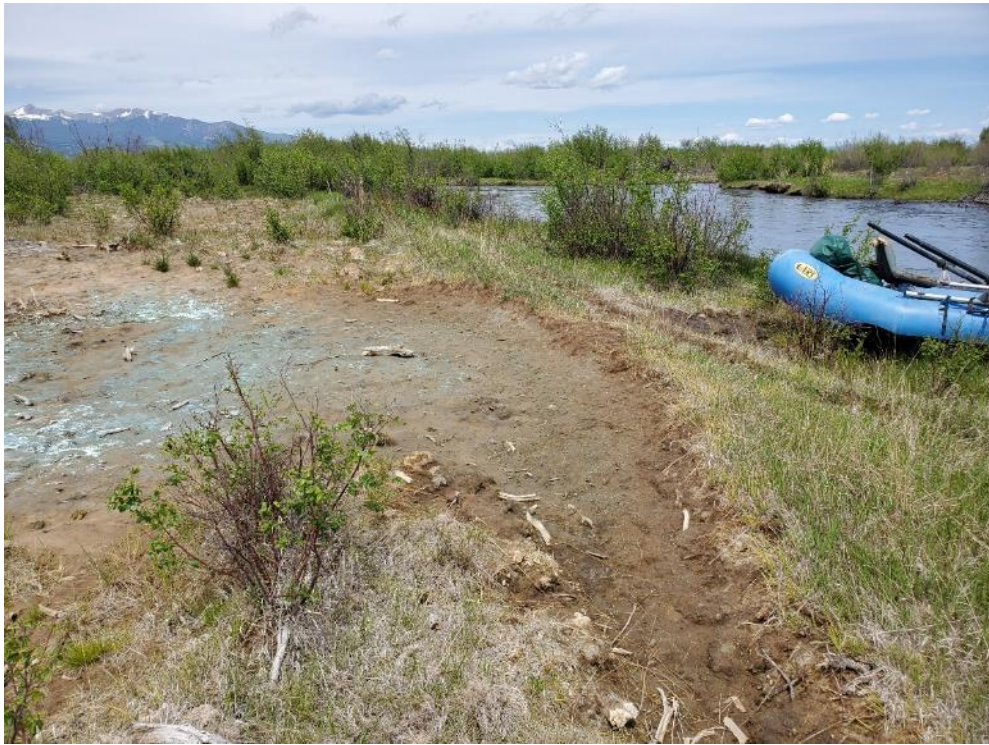
ID#11, **SER=3** (AR=2): Large, severe slicken, but berm is partially intact, reducing SER.

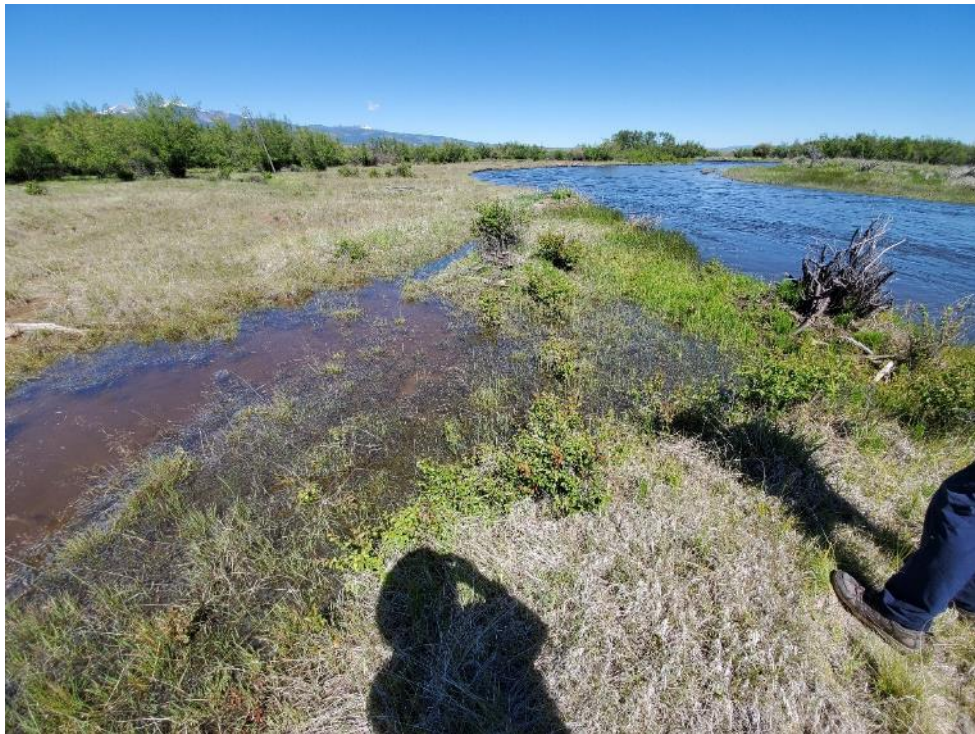
ID#71, **AR=3**, (SER=3): Evidence that river was flowing through slicken, but not at the time of the survey.

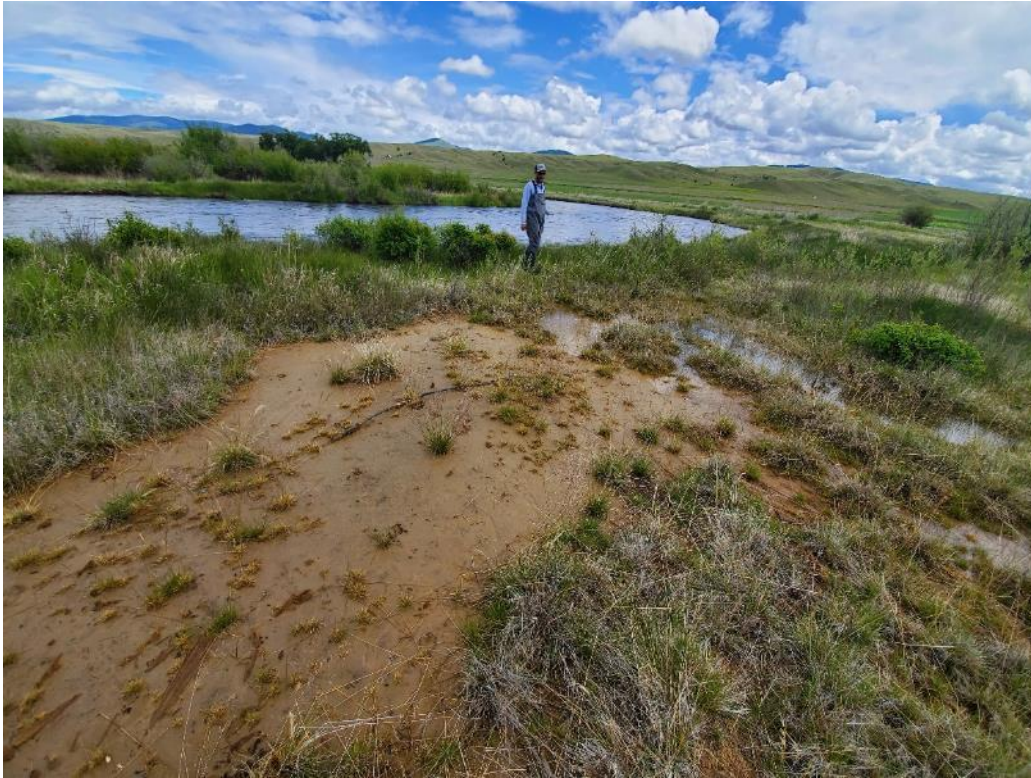
ID#31, **SER=2, AR=2**: A good example of a berm keeping contamination from contacting the river.

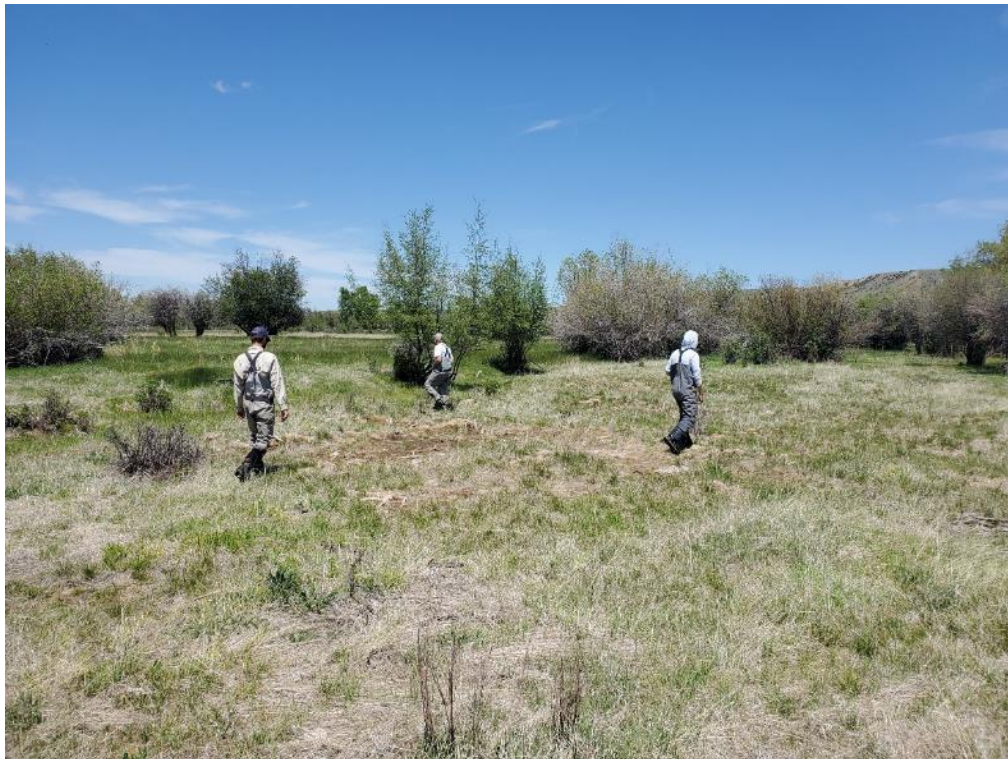
ID#60, **SER=1, AR=1**: A spotty and mostly-vegetated slicken located away from the river.
