Grant Creek Riparian Assessment

SUMMARY OF FIELD WORK CONDUCTED, SUMMER 2021

BY: Seamus Land • Masters Candidate • University of Montana
Will McDowell • Restoration Director • Clark Fork Coalition
John DeArment • Science Director • Clark Fork Coalition

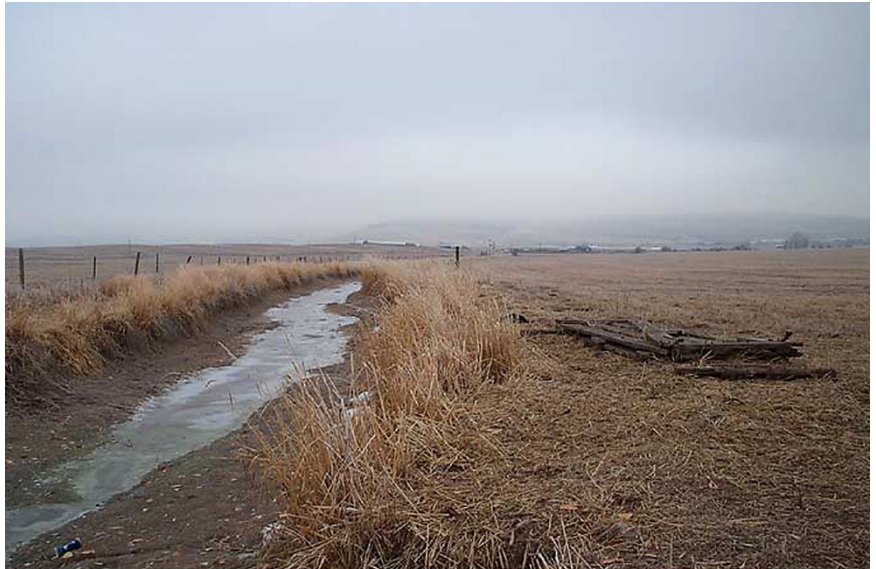
Grazing and dewatering impacts

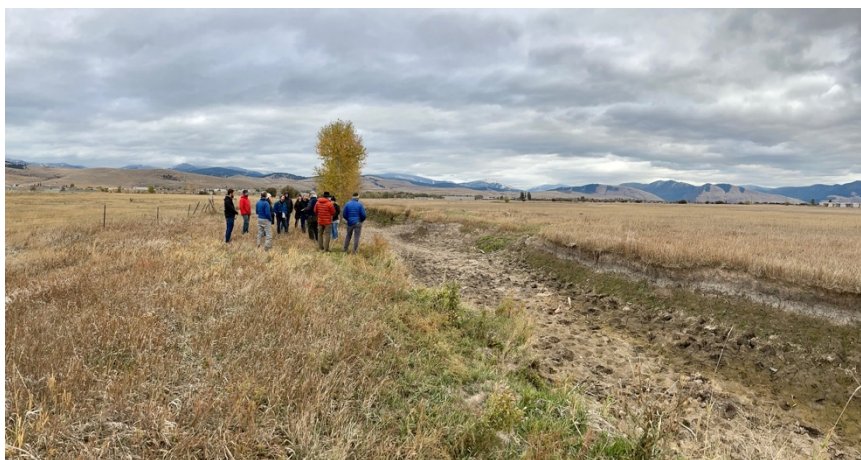
Late fall CFC 2021 tour of Grant Creek – a dewatered reach near the airport

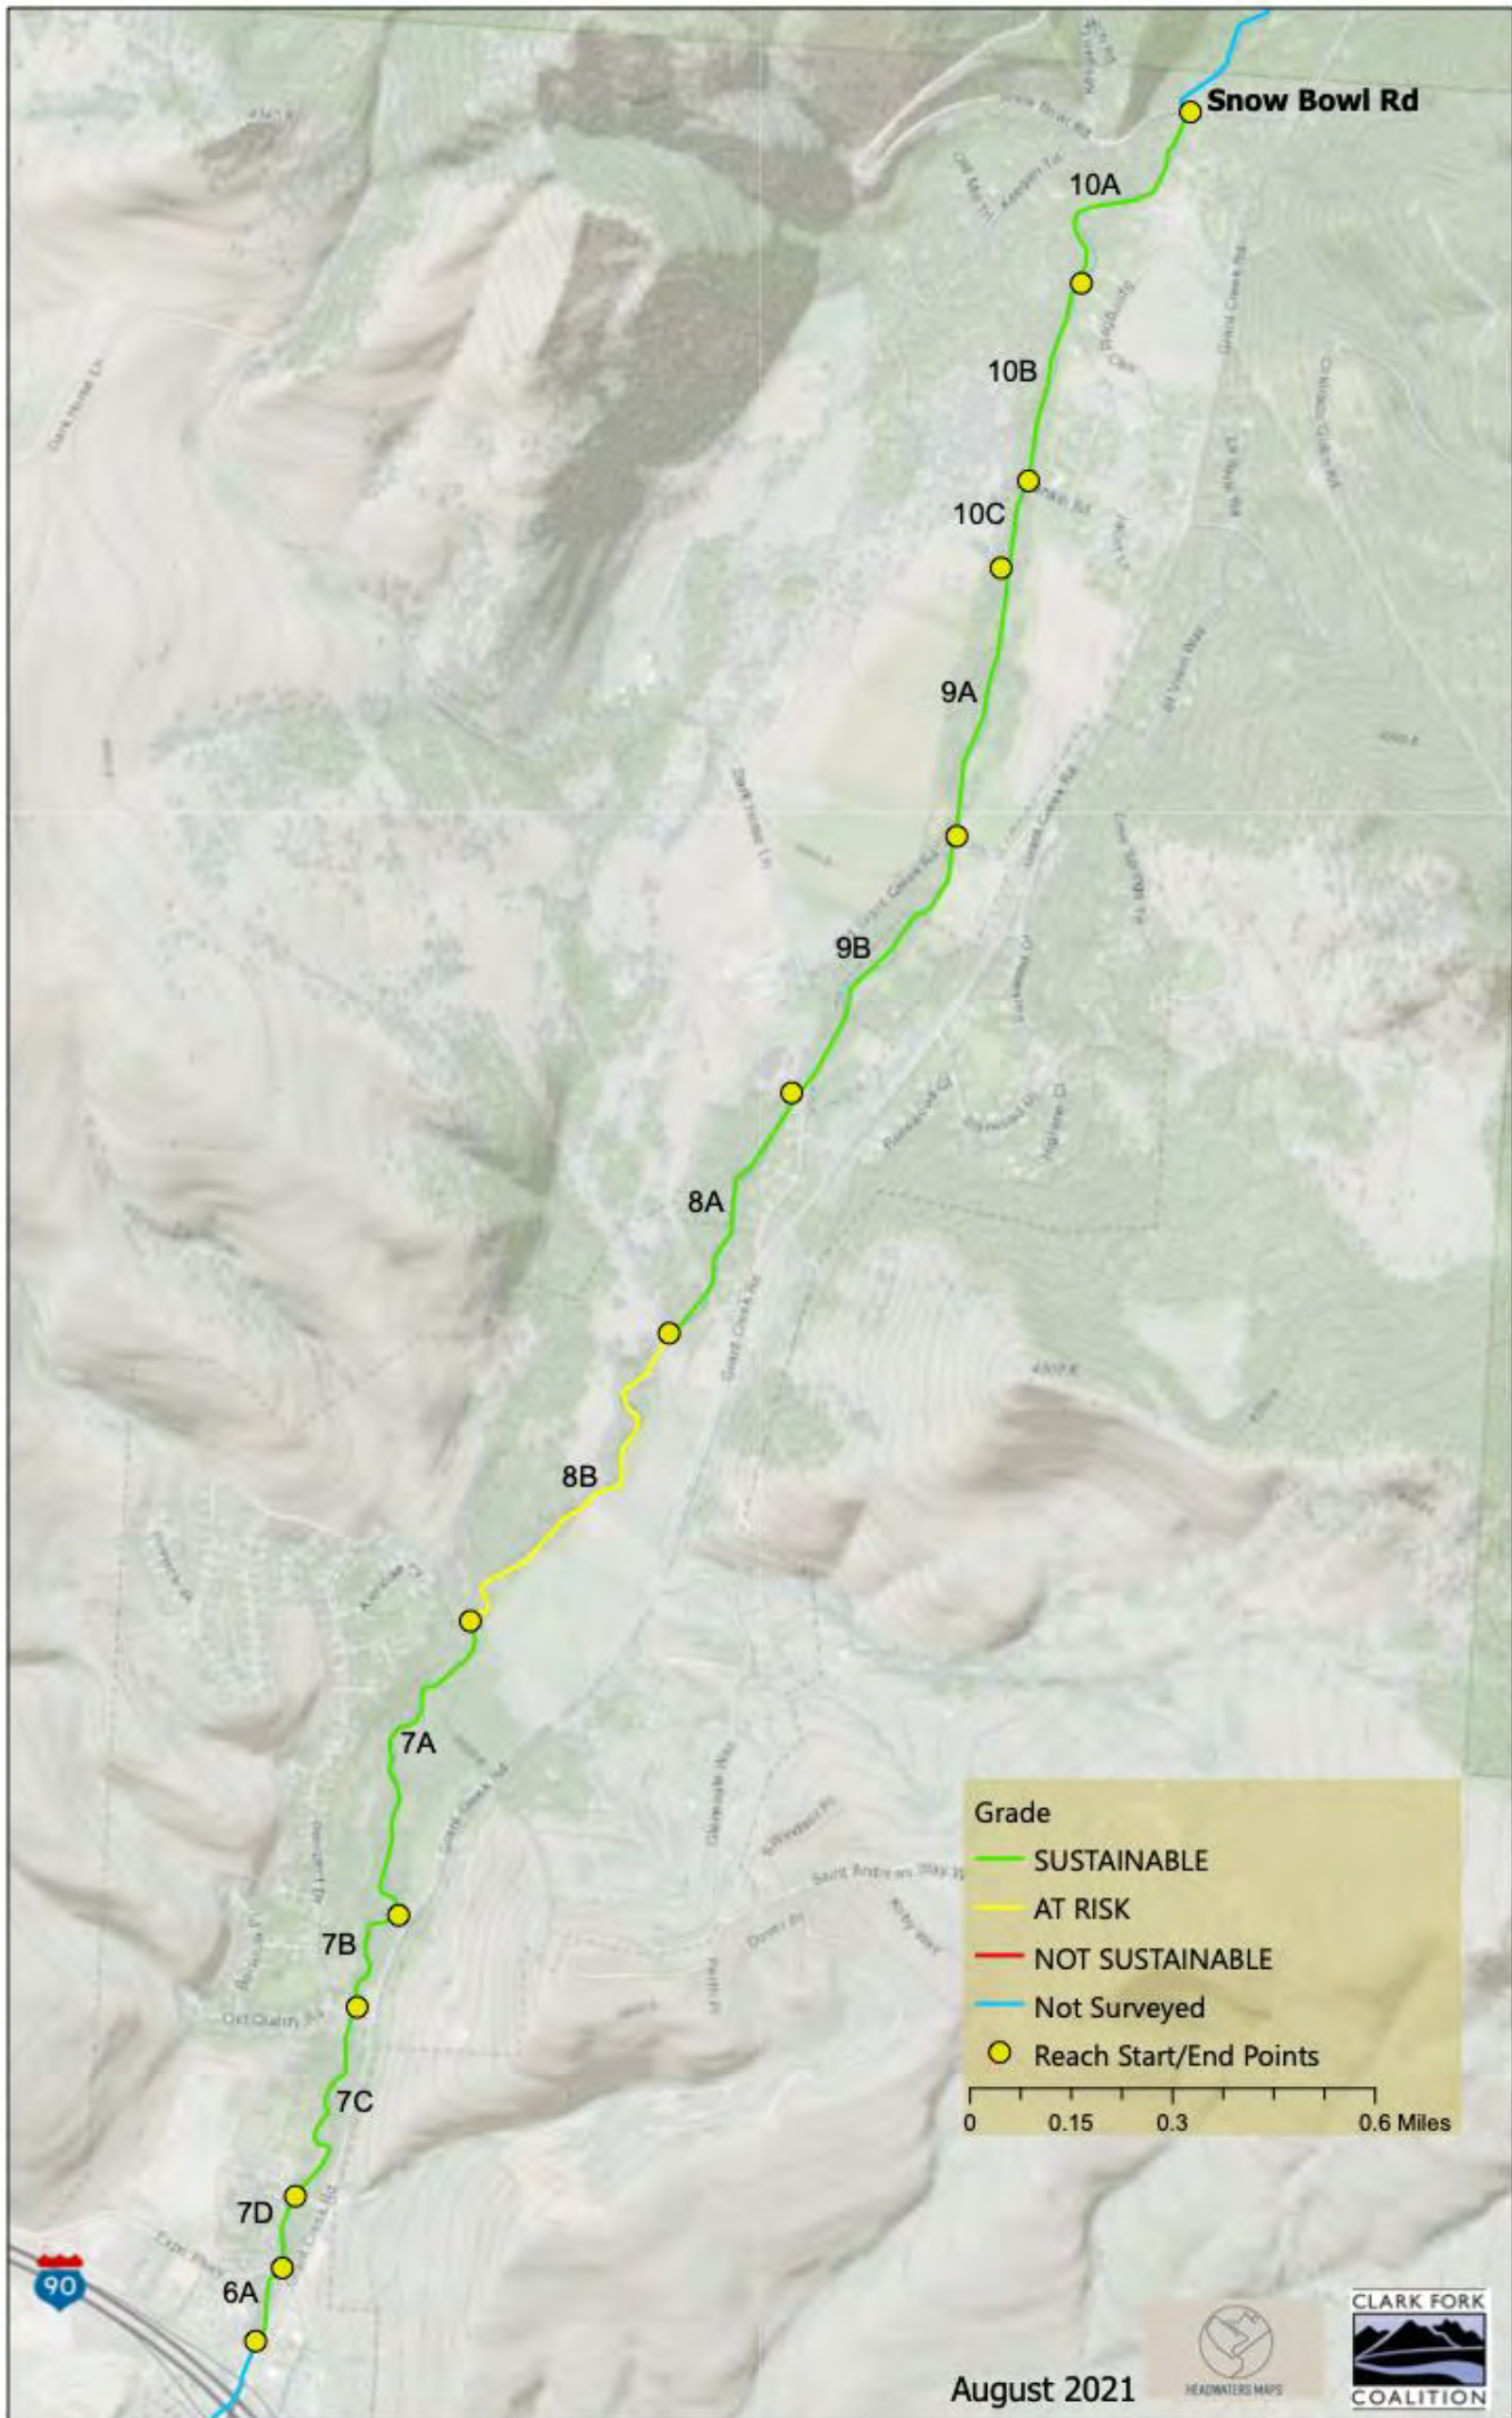
Figure 4.2 NRCS riparian assessment sustainability ratings results for Segment 1: Snowbowl Road to Interstate 90

reaches (**Figure 4.2, Table 4-2**). Ten active irrigation withdrawals exist, and dewatering began to affect the stream in the lower part of this segment later in the summer.

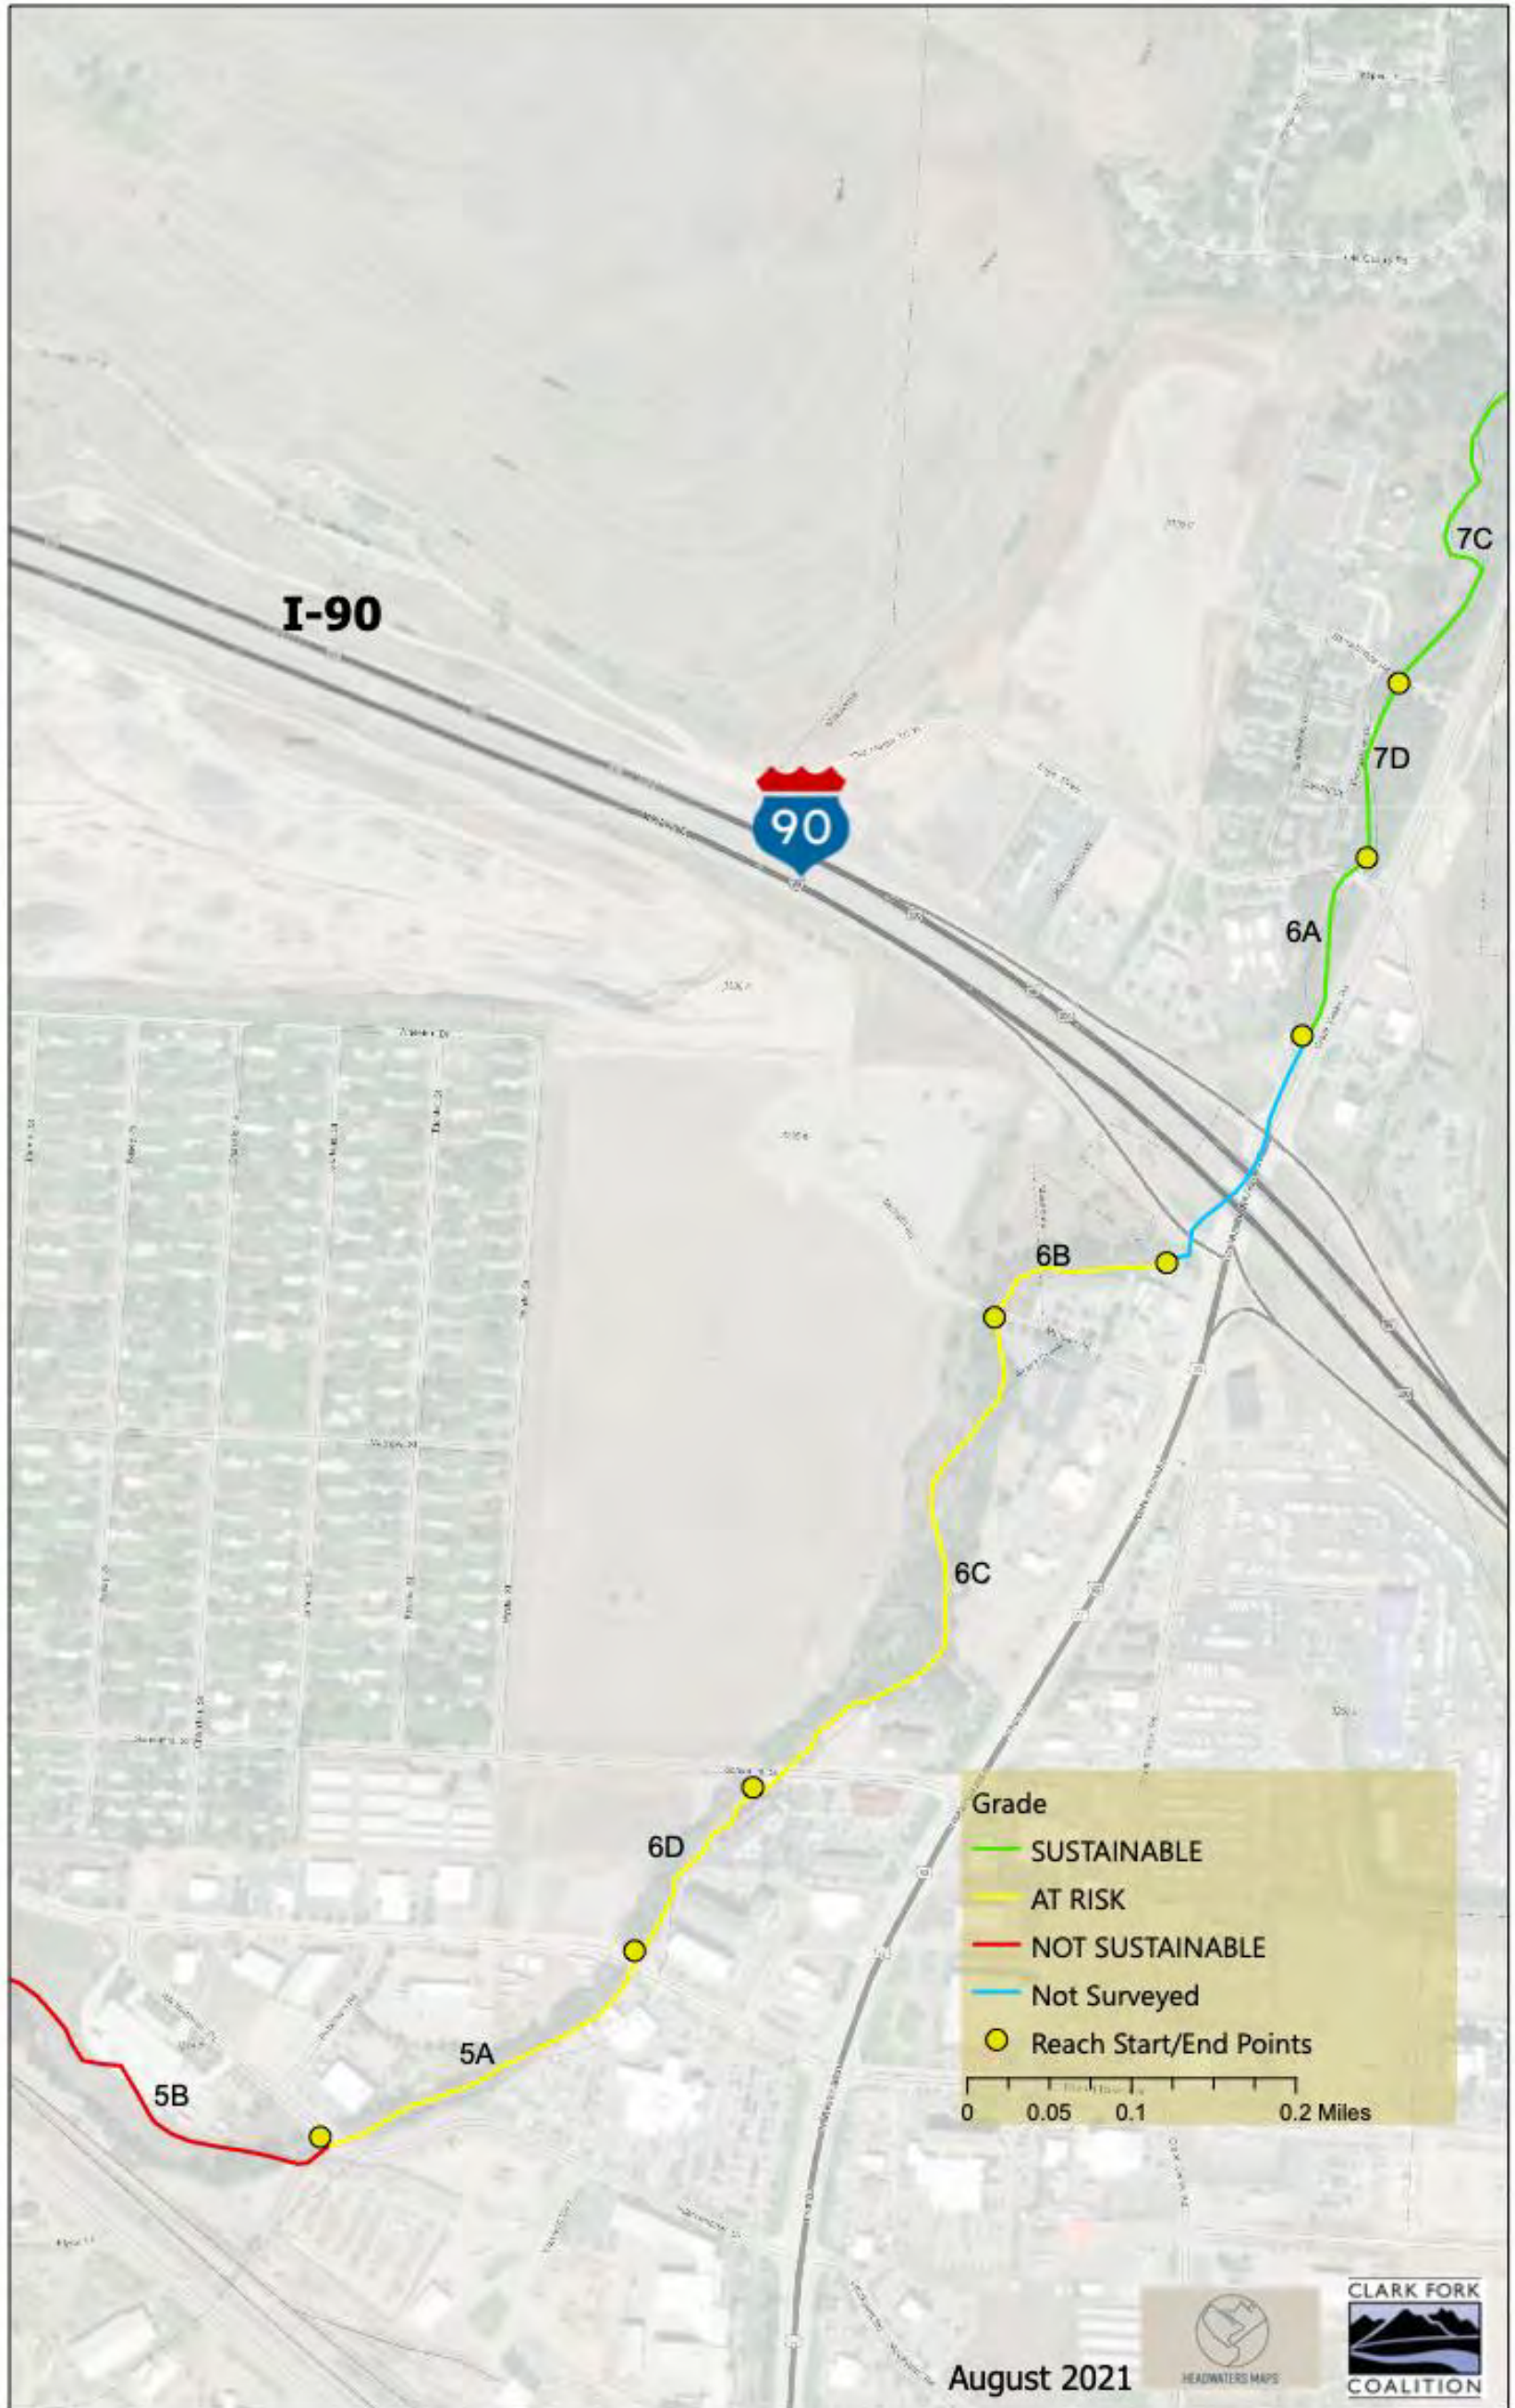
Figure 4.3 NRCS riparian assessment sustainability ratings results for Segment 2: Interstate 90 to Broadway

The 6 sub-reaches surveyed in this segment had many common characteristics. Throughout much of the segment there is very little available floodplain to dissipate energy. The channel is constricted by terraces made of gravel fill and sometimes topped with pavement. The lowest riparian score was 38%, or Not Sustainable (5B), while the rest of the sub-reaches were classified as At Risk, with a high score of 68% (**Figure 4.3, Table 4-2**).

When it was surveyed in late July of 2021, Grant Creek went dry just below a large irrigation diversion (Grant Creek Ditch) about 130 feet below International Drive. This diversion uses a 36-inch diameter concrete culvert, and at lower flows (below 5 CFS) takes nearly all the remaining water in the creek. Below this point the fish habitat scores dropped to Poor, due to dewatering. The constructed, entrenched channel flows west/northwest (5B,5C) along the railroad tracks for nearly three-quarters of a mile before passing under a railroad trestle, and then under Broadway in a triple barrel CMP culvert. Historically, the channel of Grant Creek apparently flowed southwest directly across the Broadway alignment near upper end of sub-reach 5B, closer to where the Grant Creek Ditch flows today. The constructed channel along the railroad posed risks to the banks and some infrastructure, and created significant lateral erosion.

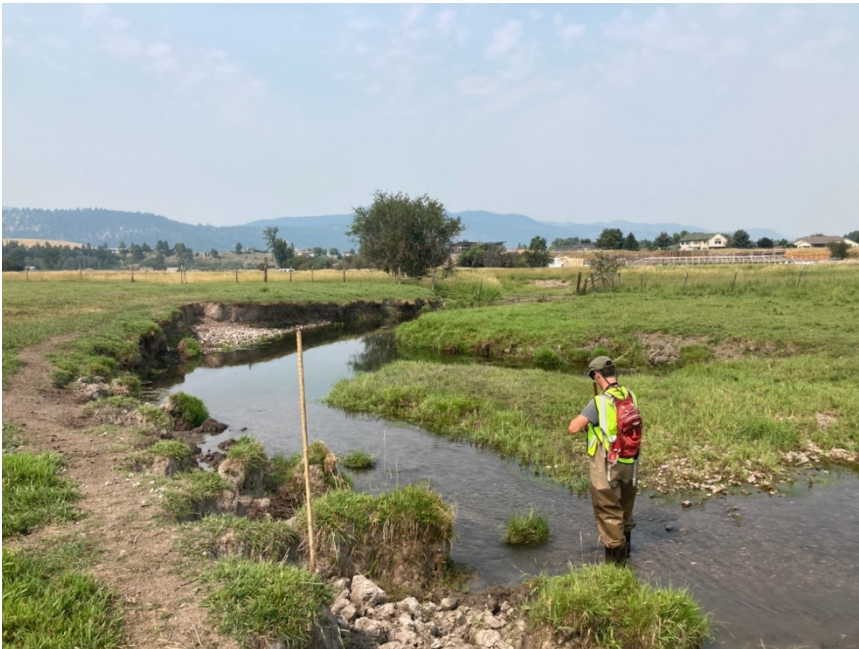
Impacts from livestock grazing

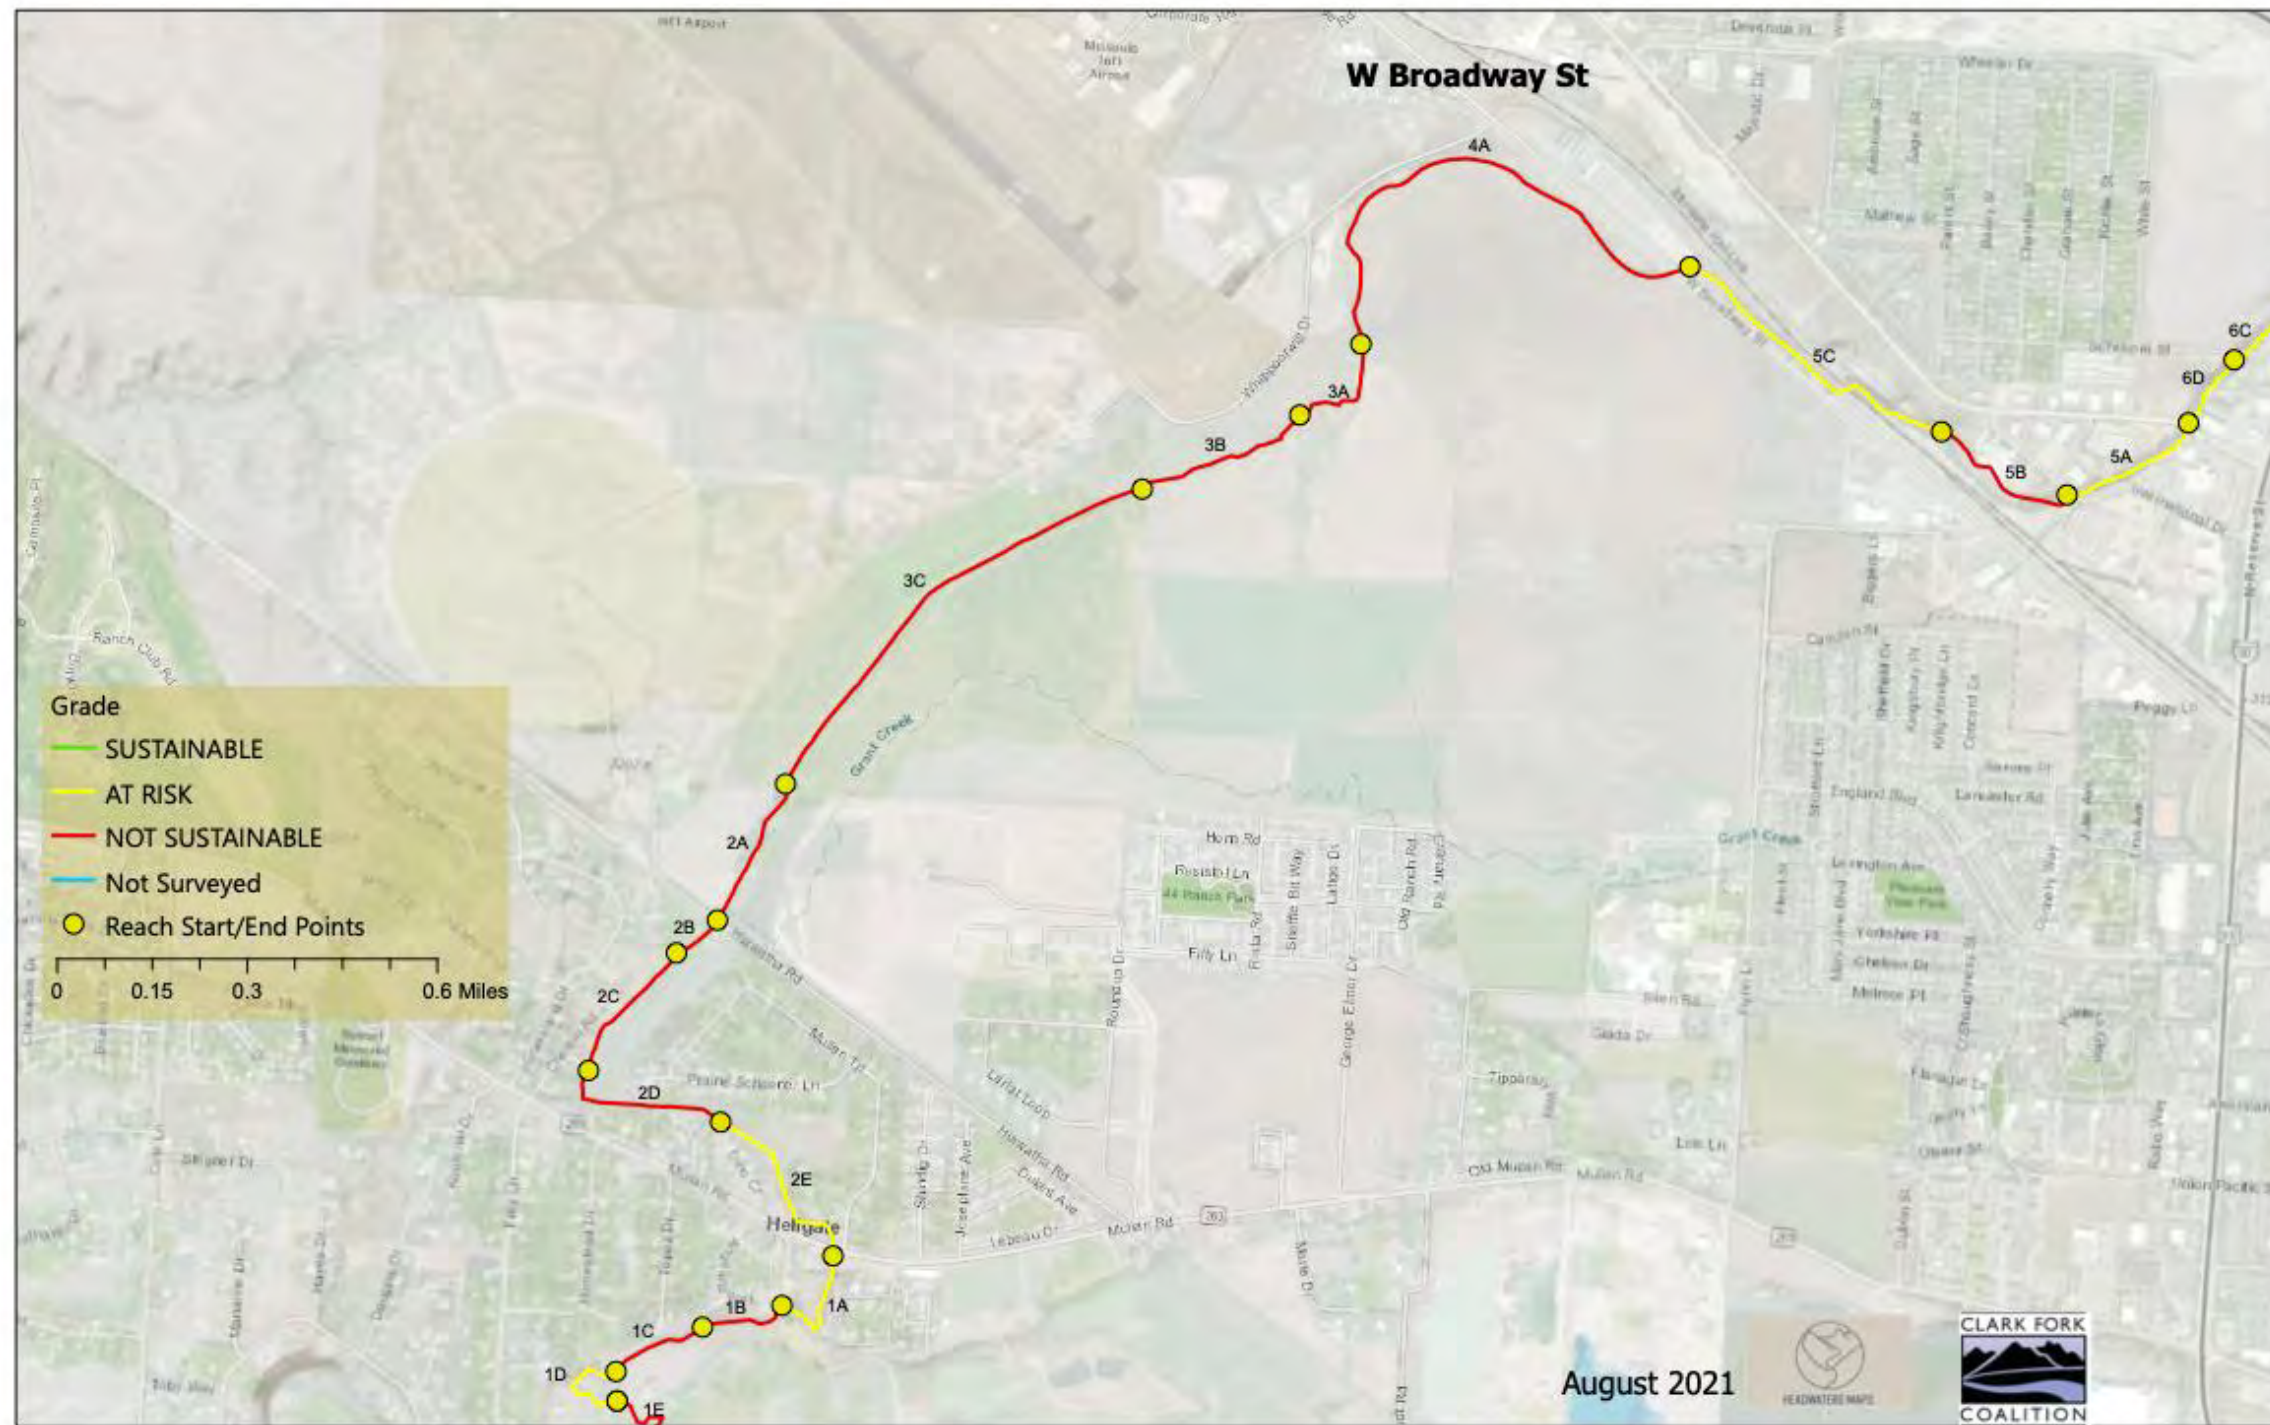
Figure 4.4 NRCS riparian assessment sustainability ratings results for Segment 3: Broadway to Mullan Road

All of these sub-reaches were significantly degraded, with 8 sub-reaches scoring as Not Sustainable, and one sub-reach scoring as low as 18%. Only one (1) sub-reach scored as At Risk, with a fairly low score of 52%, and none of the sub-reaches scored as “Sustainable” (Figure 4.4, Table 4-2) Fish habitat was predominantly Poor throughout the segment, in part because this segment was dry, and substrates were silty or clay when surveyed in July, 2021. However, at the top of sub-reach 3B, a large inflow from the

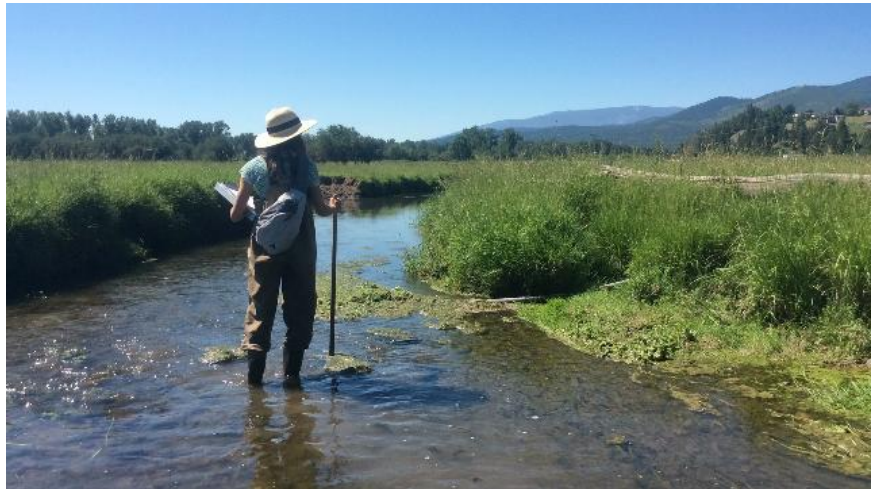
Typical conditions of the perennial reach downstream of Mullan Road

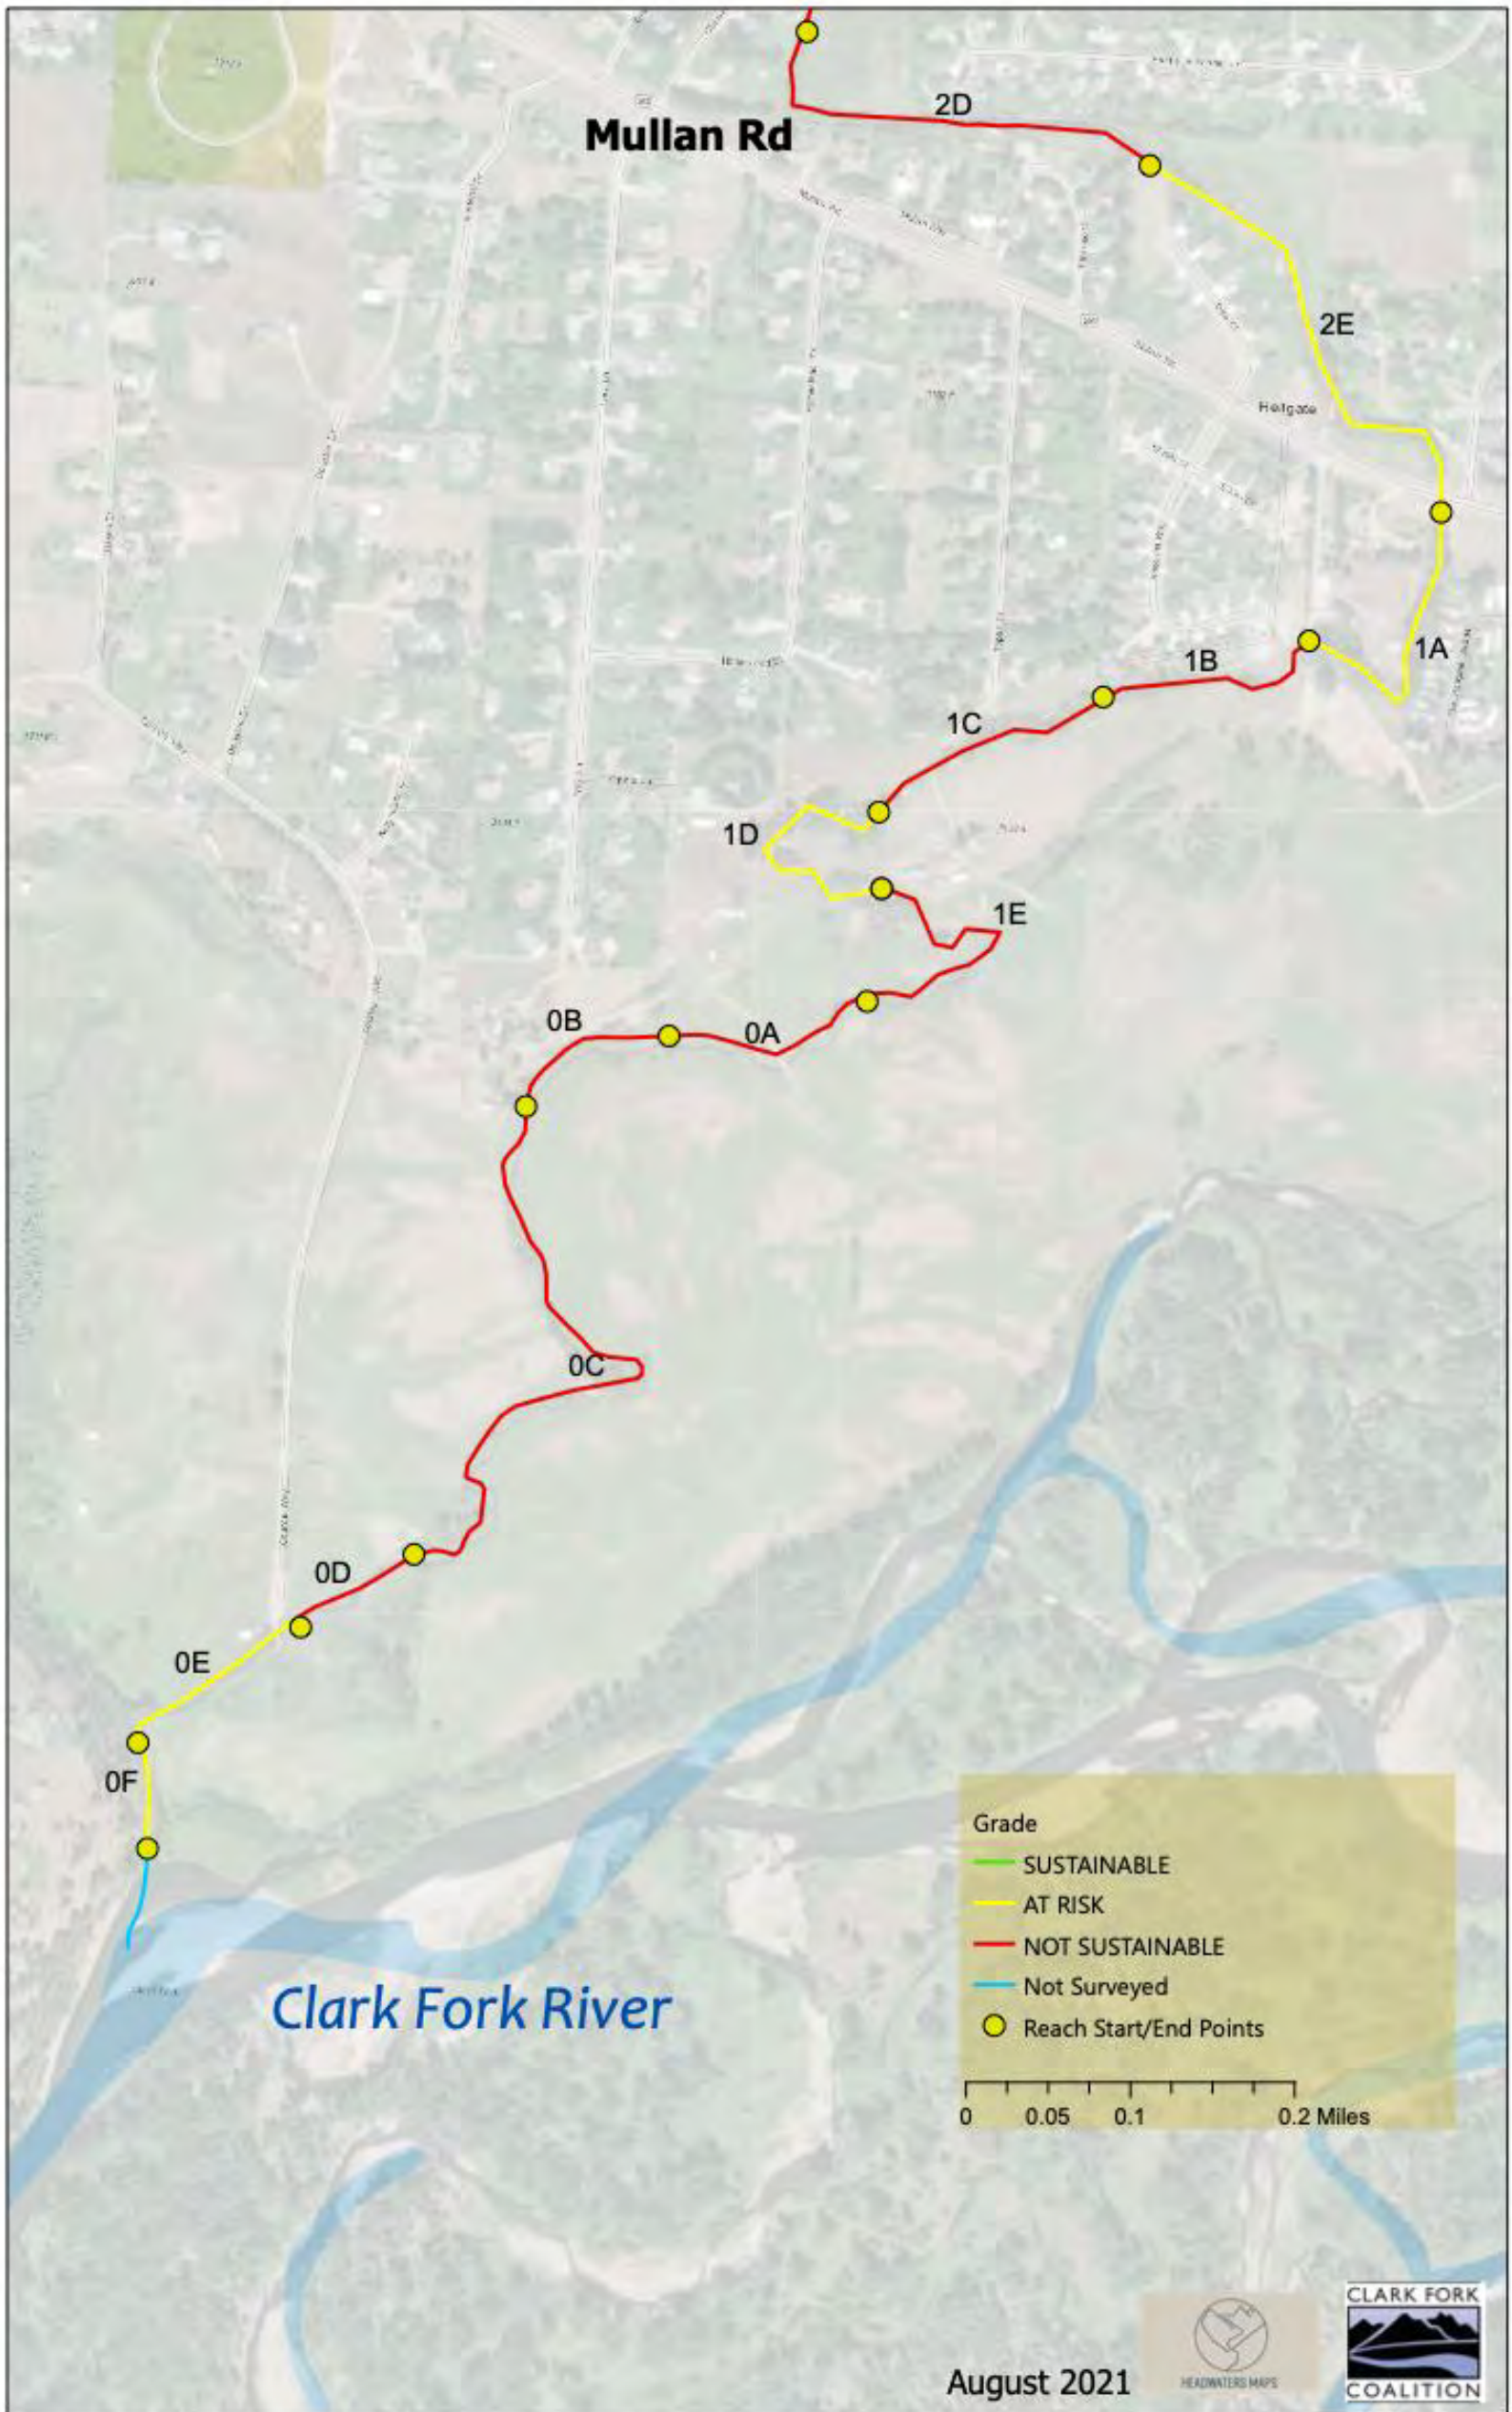
Figure 4.5 NRCS riparian assessment sustainability ratings results for Segment 4: Mullan Road to Confluence

The aquatic habitat varied from Poor in the dry and ditched sub-reaches to Fair where there was perennial water and the presence of some pools. Some of the slow moving spring-fed sub-reaches in the last mile (1E to 0F) appeared to host good fish rearing habitat, with many schools of small fish seen in late summer. One landowner claimed that at least one large bull trout had entered the creek in the recent past. However, the lack of overhead cover and the presence of

abundant eroding banks, over-widened channel, and suspended sediment created detrimental conditions for fish habitat. Beaver in the lower sub-reaches (OD to OF) have made significant impacts to the floodplain, but have been managed by landowners in recent years.
