Grant Creek Riparian Assessment

SUMMARY OF FIELD WORK CONDUCTED, SUMMER 2021

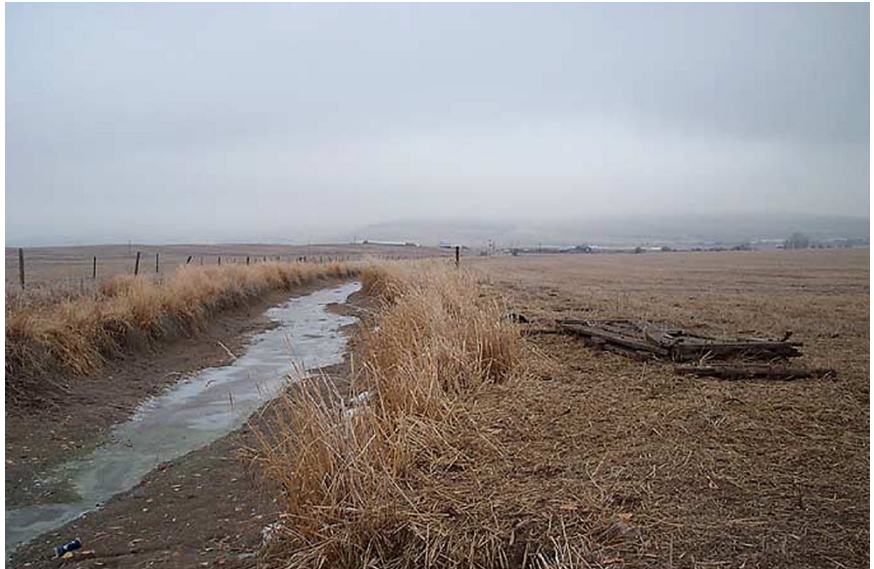
Grazing and dewatering impacts

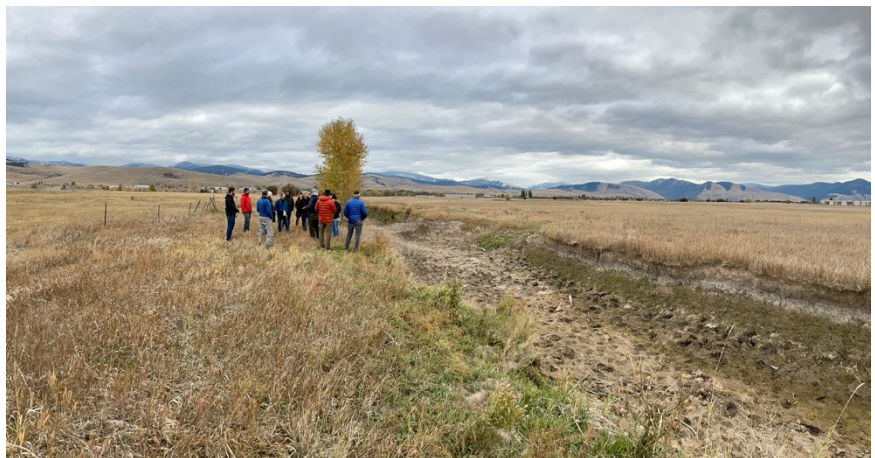
Late fall CFC 2021 tour of Grant Creek – a dewatered reach near the airport

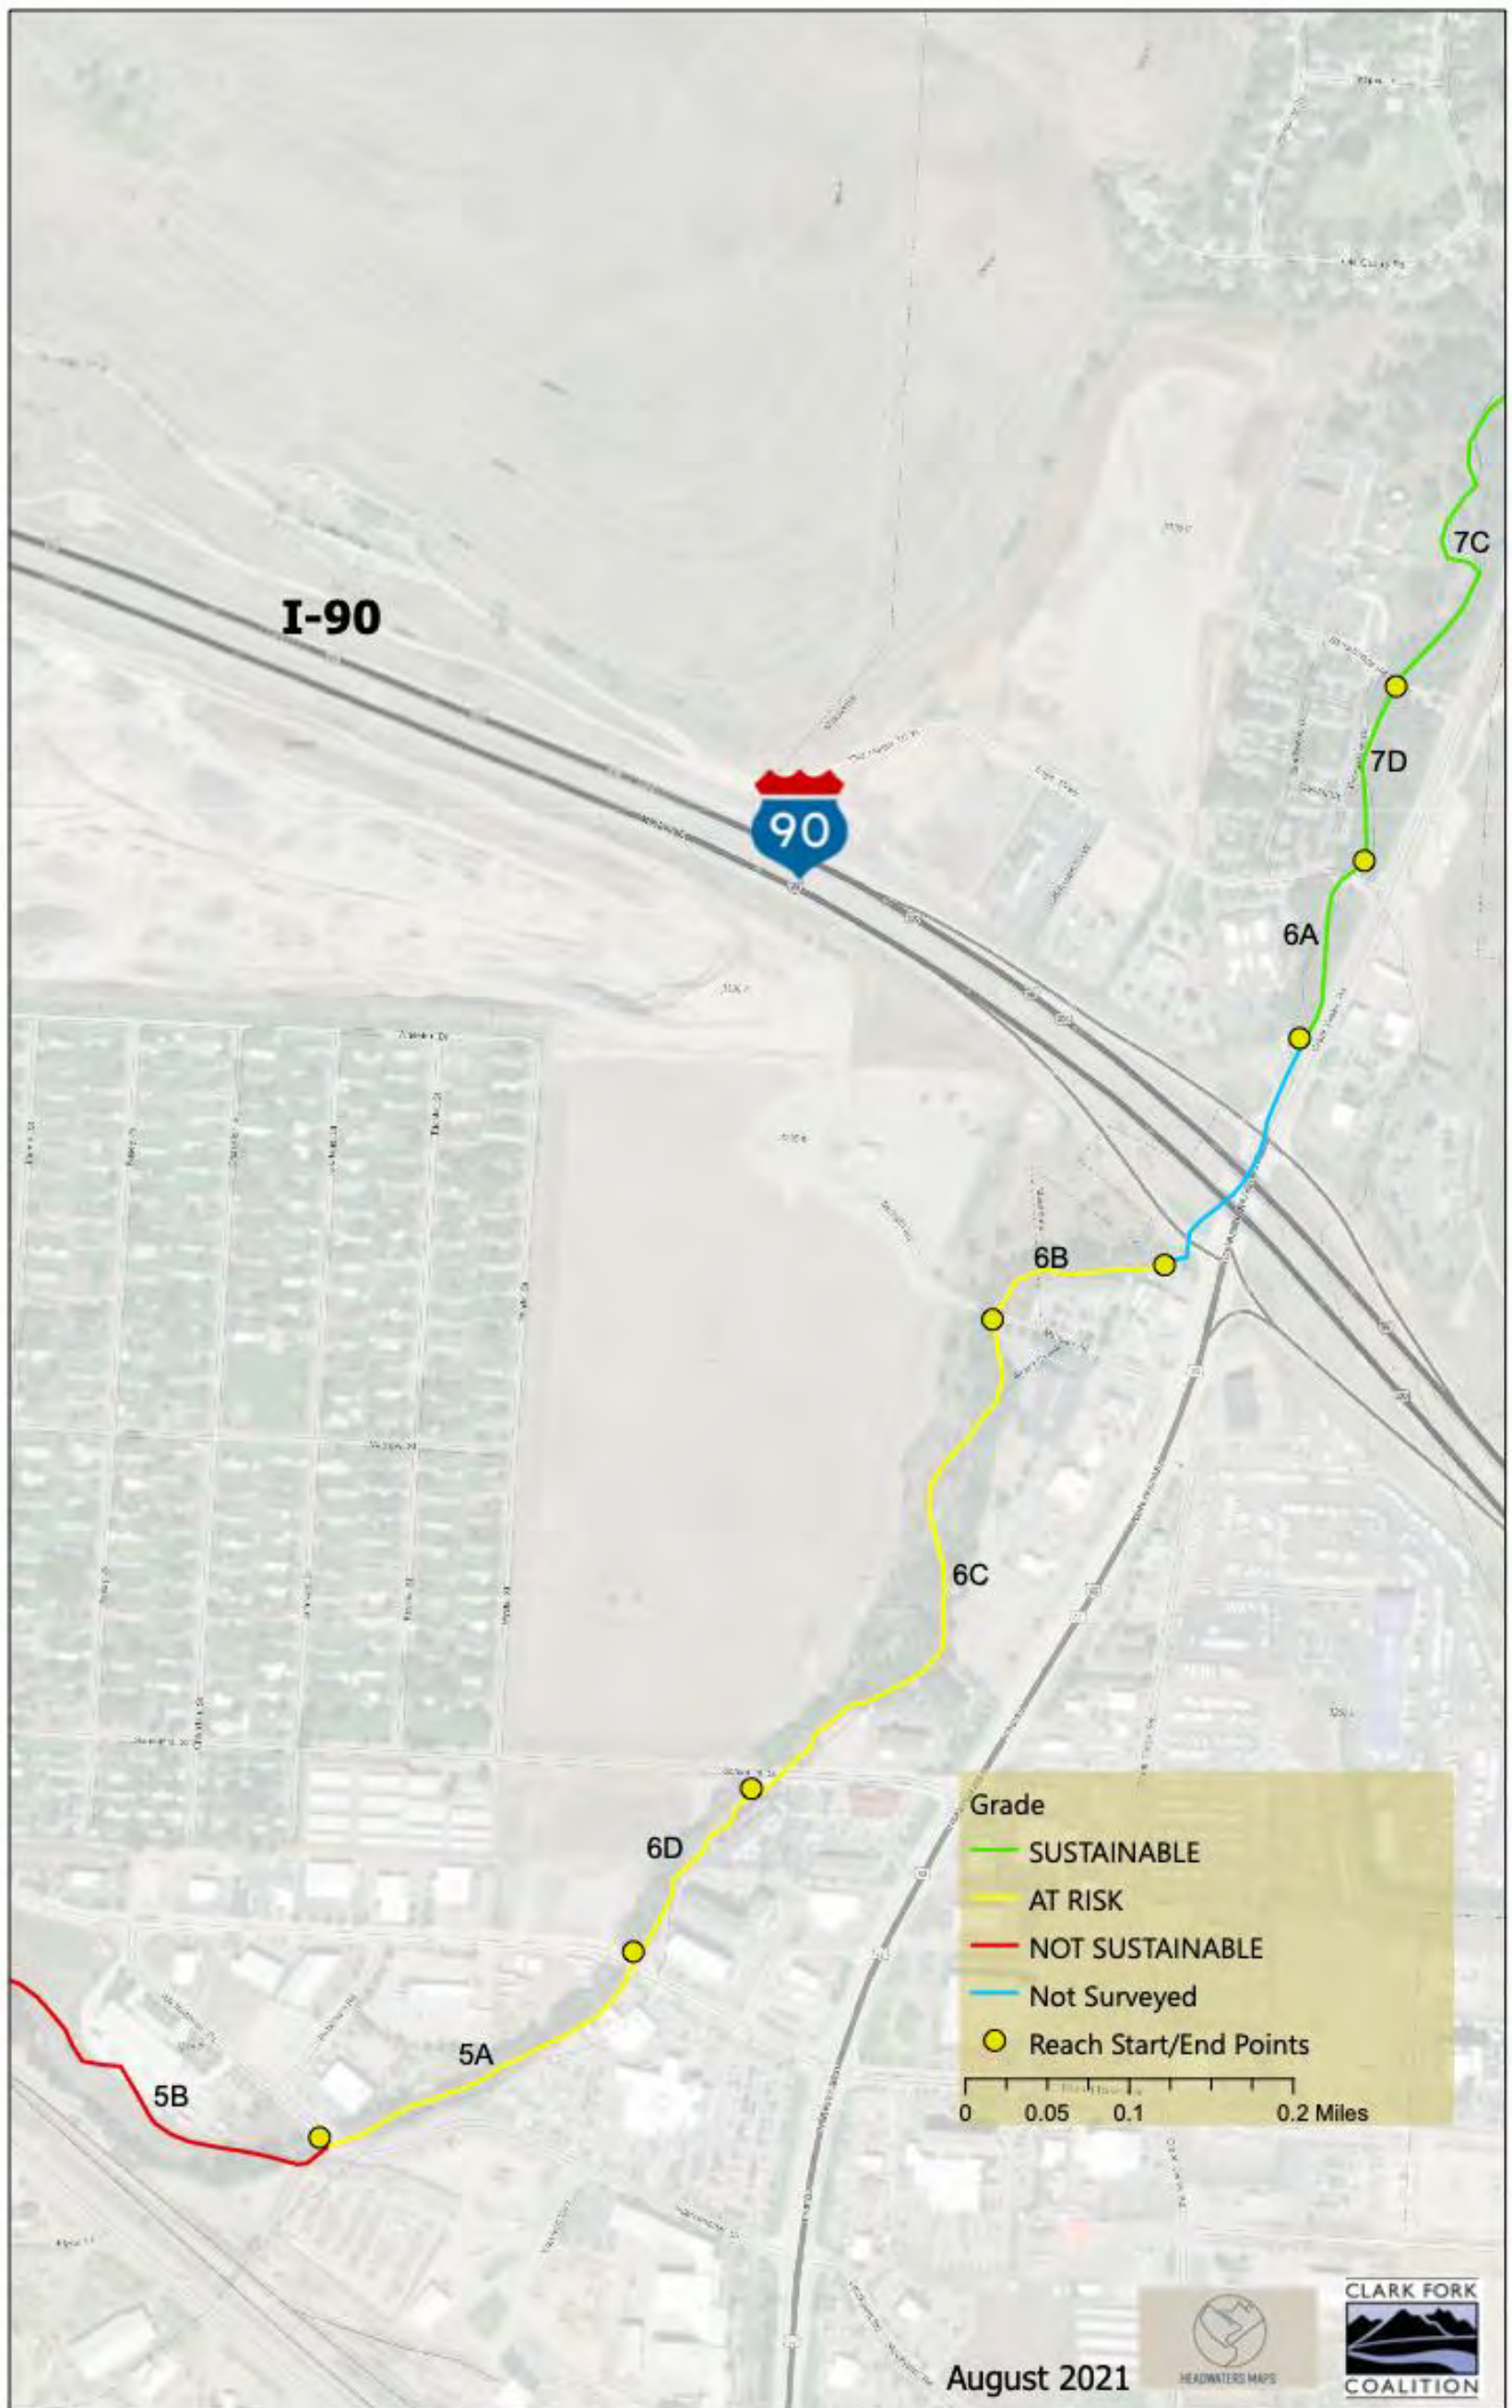
Figure 4.3 NRCS riparian assessment sustainability ratings results for Segment 2: Interstate 90 to Broadway

The 6 sub-reaches surveyed in this segment had many common characteristics. Throughout much of the segment there is very little available floodplain to dissipate energy. The channel is constricted by terraces made of gravel fill and sometimes topped with pavement. The lowest riparian score was 38%, or Not Sustainable (5B), while the rest of the sub-reaches were classified as At Risk, with a high score of 68% (**Figure 4.3, Table 4-2**).

When it was surveyed in late July of 2021, Grant Creek went dry just below a large irrigation diversion (Grant Creek Ditch) about 130 feet below International Drive. This diversion uses a 36-inch diameter concrete culvert, and at lower flows (below 5 CFS) takes nearly all the remaining water in the creek. Below this point the fish habitat scores dropped to Poor, due to dewatering. The constructed, entrenched channel flows west/northwest (5B,5C) along the railroad tracks for nearly three-quarters of a mile before passing under a railroad trestle, and then under Broadway in a triple barrel CMP culvert. Historically, the channel of Grant Creek apparently flowed southwest directly across the Broadway alignment near upper end of sub-reach 5B, closer to where the Grant Creek Ditch flows today. The constructed channel along the railroad posed risks to the banks and some infrastructure, and created significant lateral erosion.

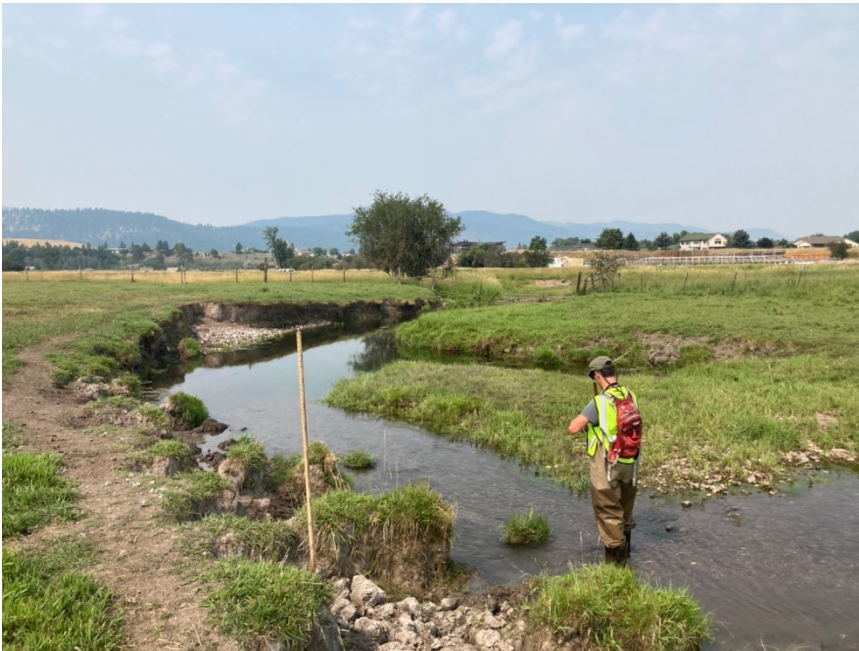
Impacts from livestock grazing
