2019 Upper Clark Fork Stream Survey
Clark Fork Coalition
May, 2019

Introduction

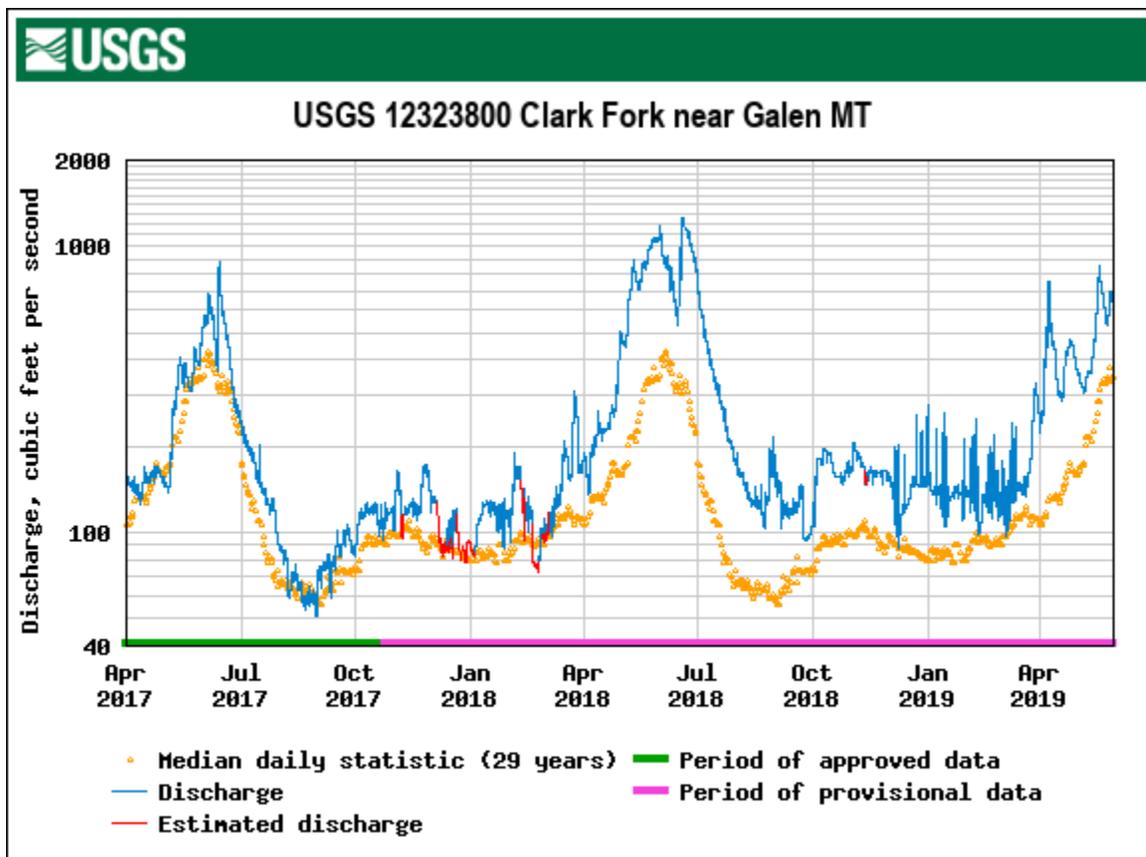
Although the June event may be responsible for some of the recent bank destabilization on the upper river, long and sustained high flows during 2018 likely compounded those issues. The Galen gage reported flows in excess of 700 cfs for over a month during May/June 2018 (Figure 1).

Figure 1- Hydrograph showing streamflow conditions on the upper Clark Fork from April 2017 to present. The yellow points represent average conditions and the blue line shows actual recorded streamflows. Note the period of significantly above average flows that started in the spring of 2018 and have continued through spring 2019.
