Grant Creek Riparian Assessment

SUMMARY OF FIELD WORK CONDUCTED, SUMMER 2021

BY: Seamus Land • Masters Candidate • University of Montana
Will McDowell • Restoration Director • Clark Fork Coalition
John DeArment • Science Director • Clark Fork Coalition

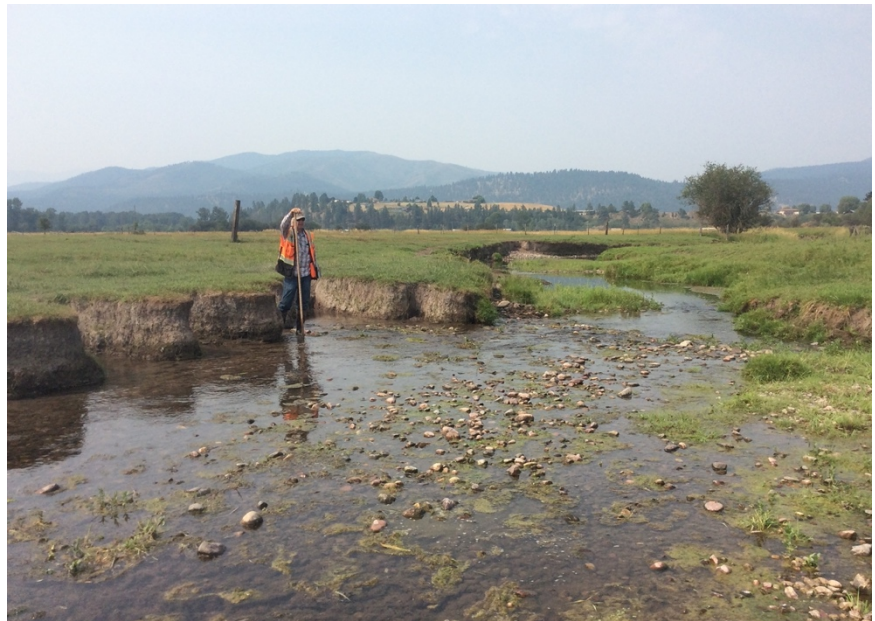
Widened channel, eroded banks in a highly grazed pasture – an “at risk” rating

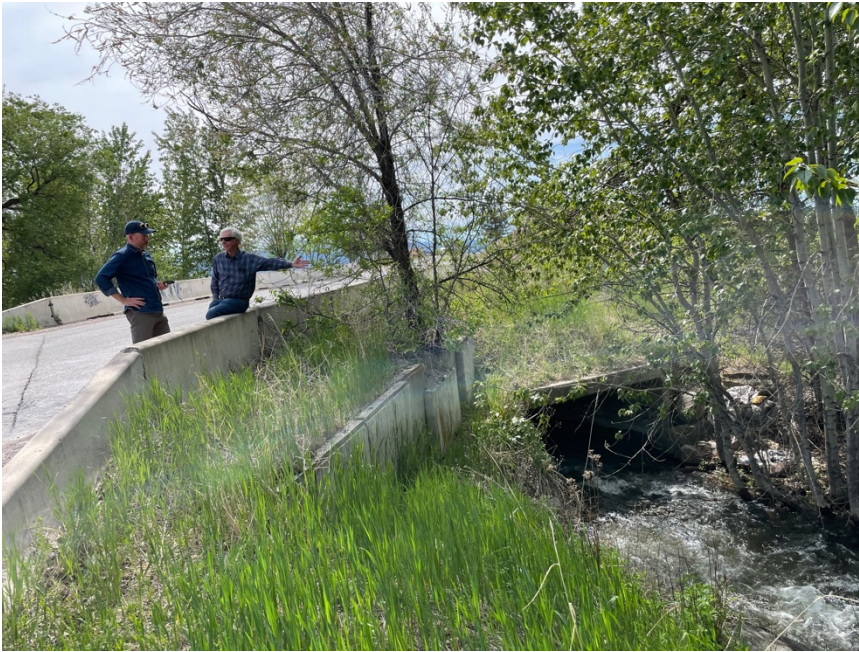
The 1.5-mile segment from Interstate 90 to Broadway begins by flowing out from under Interstate 90 in an 800 foot-long 12' wide by 7' tall concrete box culvert. Our team walked through the culvert, which had some natural channel substrates and “resting” rocks placed to aid fish migration. However, the I-90 culvert was not included as a separate sub-reach in the assessment. The dominant land use in this segment is Industrial/Commercial, and several hotel parking lots or construction sites encroach significantly on the floodplain area. The riparian corridor was very narrow as a result.

Grant Creek flowing through an under-sized culvert
