Grant Creek Riparian Assessment

SUMMARY OF FIELD WORK CONDUCTED, SUMMER 2021

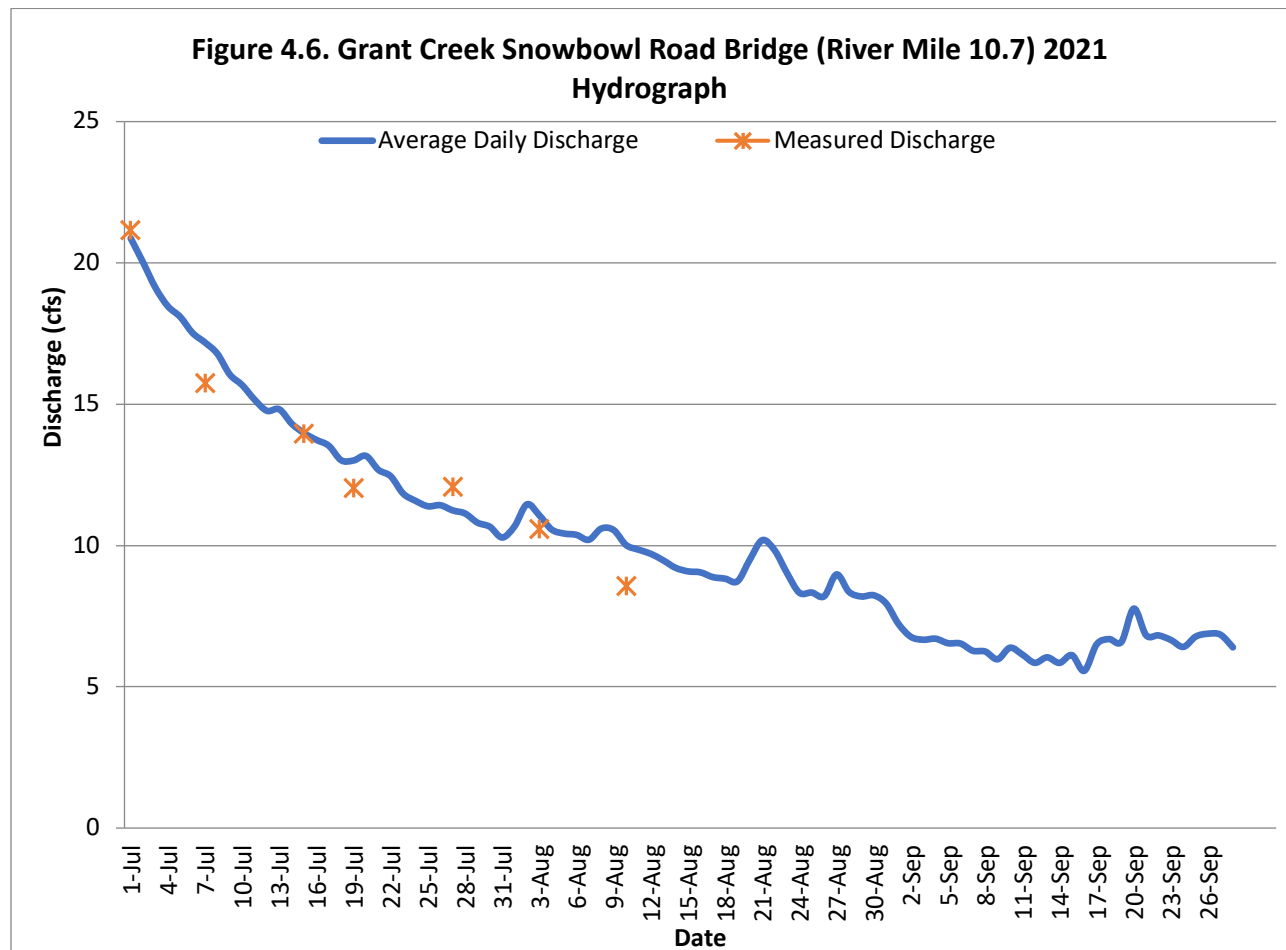
4.5.1 Stream Flow at Snowbowl Road Bridge

Stream flows at Snowbowl Road Bridge represent conditions during summer 2021 upstream of any irrigation withdrawals (**Figure 4.5**). Across the July 1 to late September period of record, the site saw a recession of flow rate from 21 CFS to 6 CFS, typical of the general pattern expected in a snowmelt-driven western Montana stream. Flows in June were much higher, but could not be easily measured with the available equipment and wading rod technique. A number of surface water diversions and some small pumps were found in the stream between Snowbowl Road and Old Grant Creek Road—these reflect the large number of valid irrigation water rights, although water rights were not verified.

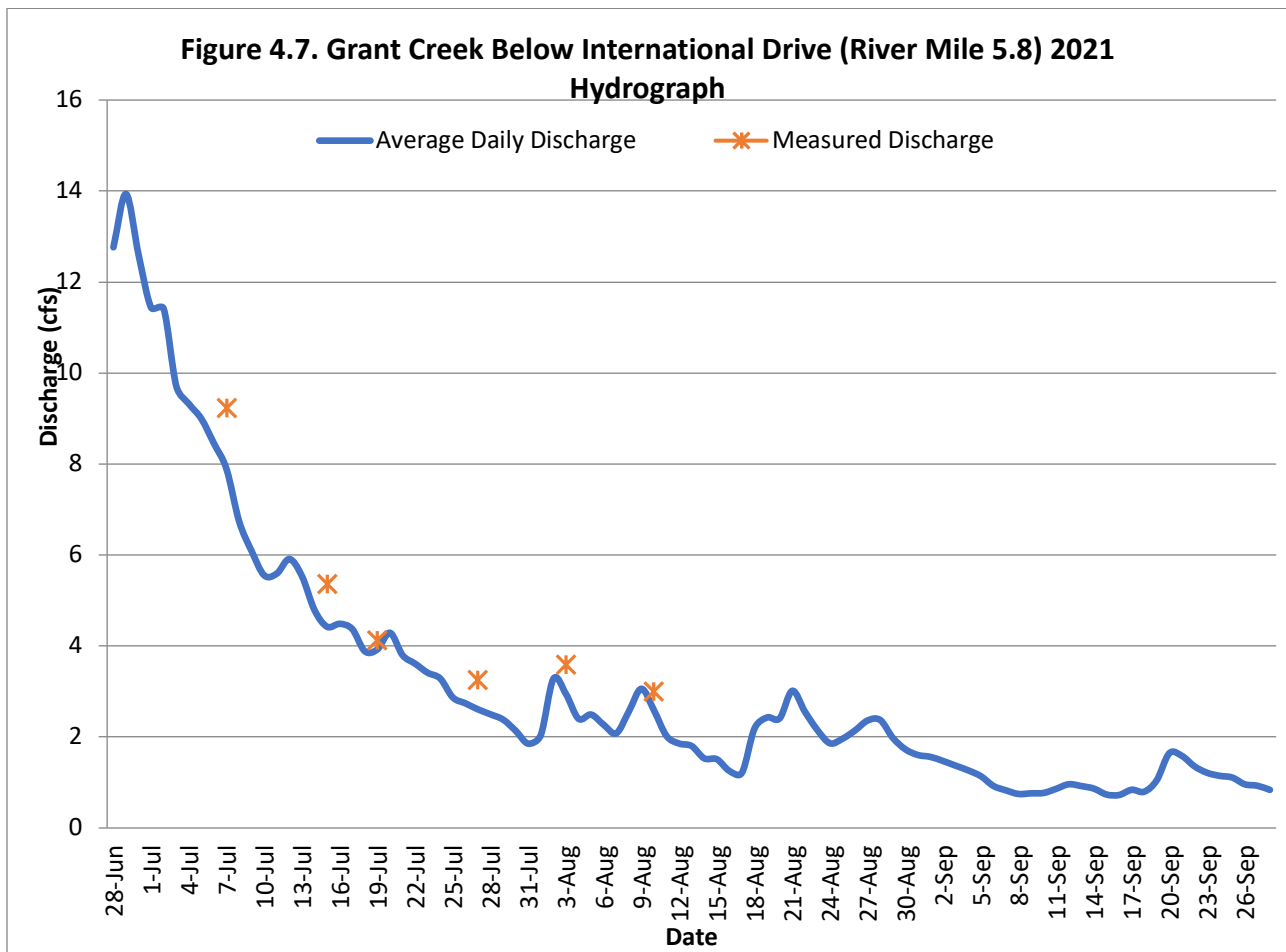
4.5.2 Stream Flow near International Drive

The hydrograph for the site “below International Drive” reflects three important factors: first, the flow is diminished from upstream by irrigation withdrawals and by natural infiltration of streamflow into the groundwater; second, the flows at International Drive become very low in late July, and almost disappear by late August; third, just 50 yds. downstream of the measurement point at “below International Drive” there is an active irrigation diversion (rustic rock weir with 36” concrete pipe headgate), which in late July and August was diverting all or nearly all the streamflow, leaving the channel completely dry from that point downstream. Streamflow at this location ranged from approximately 14 CFS in early July to approximately 1 CFS in late September (Figure 4.6).
