Grant Creek Riparian Assessment

SUMMARY OF FIELD WORK CONDUCTED, SUMMER 2021

BY: Seamus Land • Masters Candidate • University of Montana
Will McDowell • Restoration Director • Clark Fork Coalition
John DeArment • Science Director • Clark Fork Coalition

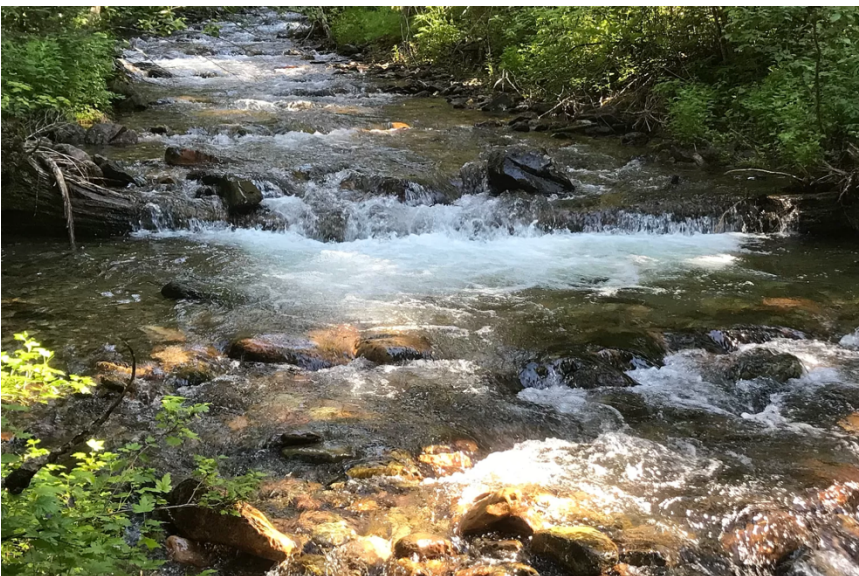
Healthy, complex riparian zone – a “sustainable” health rating

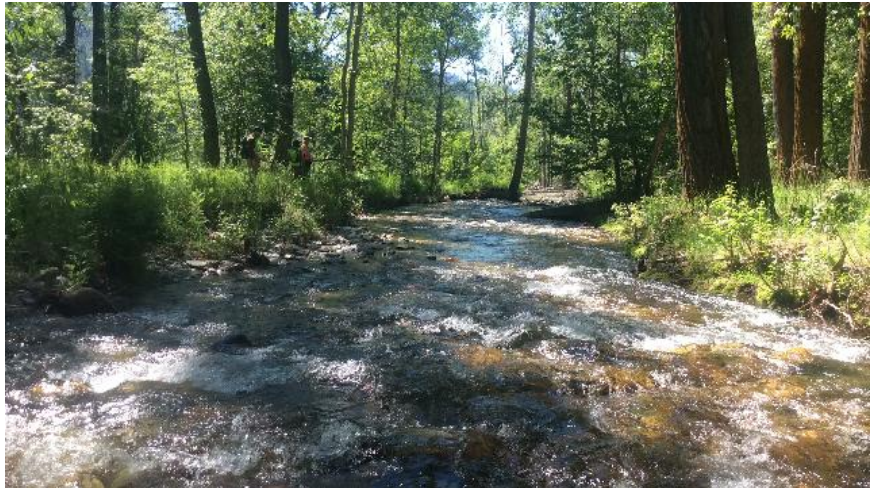
Natural, stable, resilient channel in cottonwood stand below Snowbowl Road
